SITULA EMT09-554.665 - TIN BRONZE - IRON AGE - SWITZERLAND

Situla EMT09-554.665

Christian. Degrigny (HE-Arc CR, Neuchâtel, Neuchâtel, Switzerland) & Marie-Jeanne. Scholl (HE-Arc CR, Neuchâtel, Neuchâtel, Switzerland) & Valentin. Boissonnas (HE-Arc CR, Neuchâtel, Neuchâtel, Switzerland)

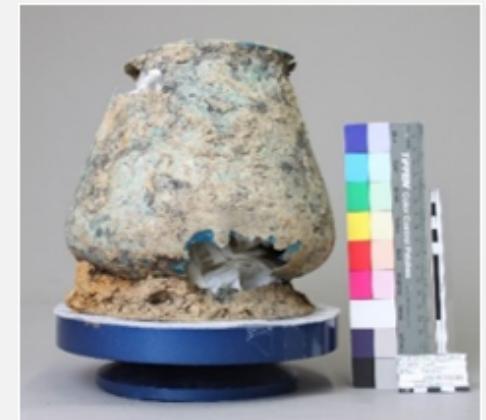
Fig. 1: Situla (Archeodunum (Gollion), 2009) inverted as found

Description of the artefact	Situla (Fig. 1) covered with blue-green corrosion products and sediments. Attached to two riveted iron loops is an iron handle terminating in two swan heads (not shown here). Dimensions of the main body: Hmax = 340mm, Ømax = 220mm.		
Type of artefact	Situla		
Origin	Mormont sanctuary, La Sarraz, Vaud, Switzerland		
Recovering date	Excavated in 2011		
Chronology category	Iron Age		
chronology tpq	140 B.C. 🗸		
chronology taq	30 B.C. ⋎		
Chronology comment	La Tène D

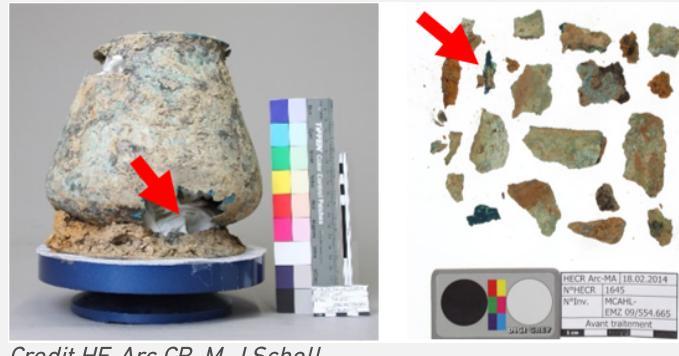
Fig. 2: Location of sampling area and sample selected from detached fragments,

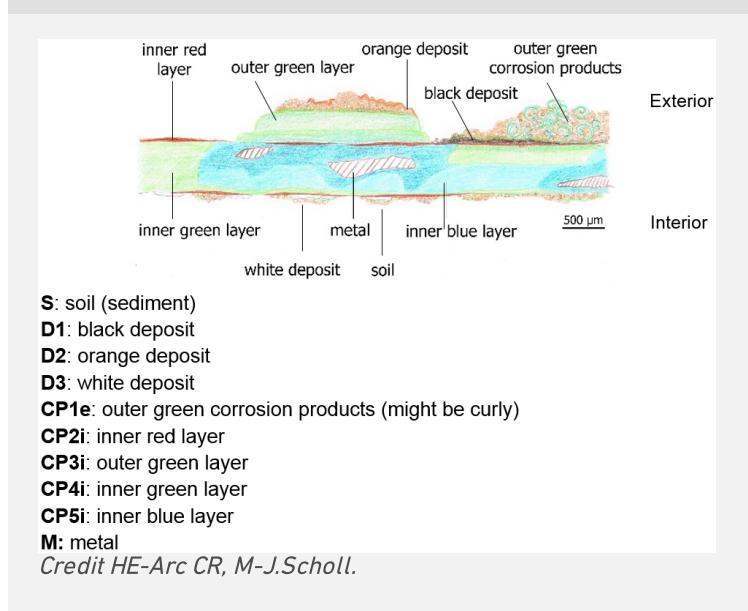
The schematic representation below gives an overview of the corrosion layers encountered on the situla from a first visual macroscopic observation (additional e and i within the coding correspond to strata in contact with the environment (e) and internal strata (i)).

Fig. 3: Stratigraphic representation of the situla by macroscopic observation,

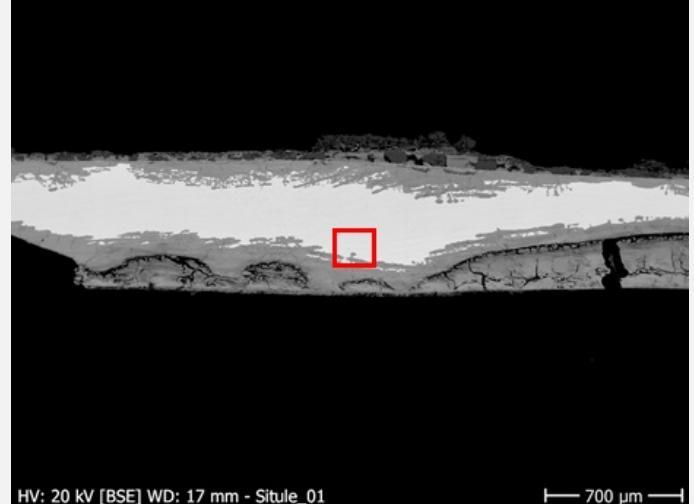
The remaining metal is a dense tin bronze (Fig. 5, Table 1), showing no inclusion. In bright field, the etched alloy shows a structure principally consisting of polygonal alpha phase grains (Fig. 6). Some of the grains include twin lines (Fig. 7). The presence of strain lines (slip lines) indicates a final cold work without annealing.

Fig. 5: SEM image, BSE-mode, of the metal sample from Fig. 4. Area of Fig. 6 is marked by a red square,

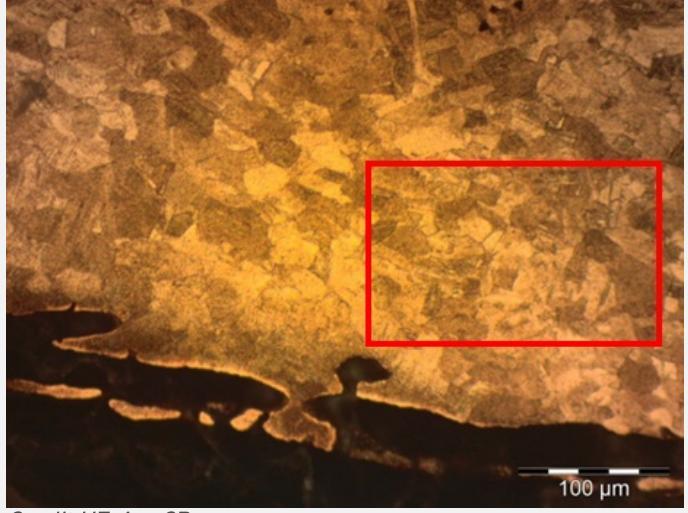
Fig. 6: Micrograph of the metal structure from Fig. 5 (detail), etched, bright field, 50x. The alpha phase of the alloy shows polygonal grains. Area of Fig. 7 is marked by a red rectangle,

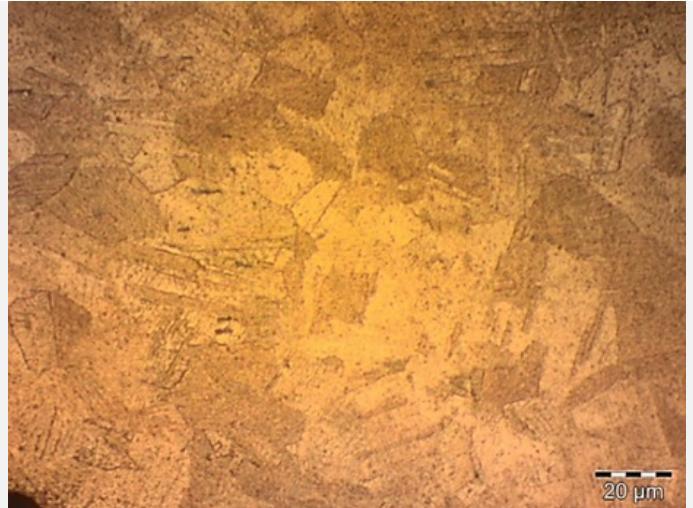
Fig. 7: Micrograph of the selected area of Fig. 6, etched, bright field, 500x. The grains show both twin and strain lines,

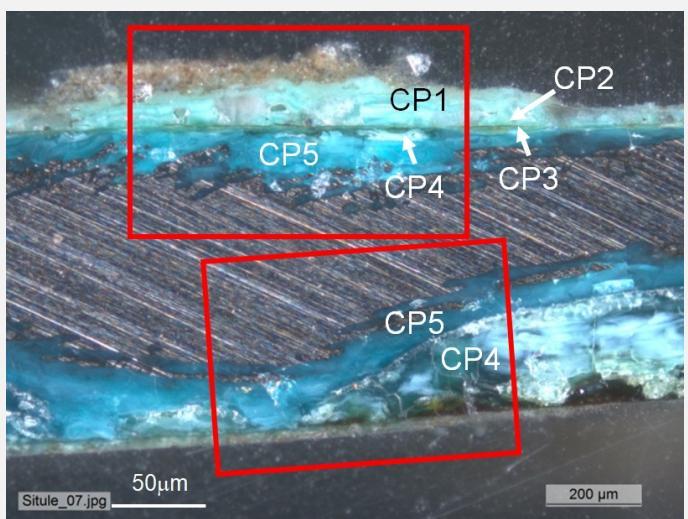
The corrosion crust is heterogeneous and has in places completely replaced the metal. The metal – corrosion products interface is irregular due to transgranular corrosion (Figs 5-6). In most cases, the corrosion crust can be divided in three main layers: first, an inner compact blue layer directly on the metal core (CP5, Figs. 8, 10 and 15 and CP3, Fig. 14). In areas of extensive corrosion this blue layer coexists with a friable light blue-green layer (CP4, Figs. 8, 10 and 15 and CP2, Fig. 14). Secondly, and depending on the area, either a very fine dark green (CP3, Figs. 8 and 15) or red corrosion layer (CP2, Figs. 10 and 15) marks the limit of the original surface. Finally, there is a fourth outer layer, consisting of friable and sometimes curly pale green corrosion products, interspersed with soil products (CP1, Figs. 8, 10 and 15). In heavily worked and fragile parts of the object a cleavage between the inner layers of blue and light blue-green corrosion is present, rendering the light blue-green corrosion vulnerable to loss (Fig. 9).

Fig. 8: Micrograph of the metal sample from Fig. 4, unetched, dark field, 50x. Areas of Fig. 9 (bottom, corresponding to the stratigraphy of Fig. 14) and Figs. 10 and 11 (top, corresponding to the stratigraphy of Fig. 15) are marked by a rectangle. Codes are those of Fig. 15,

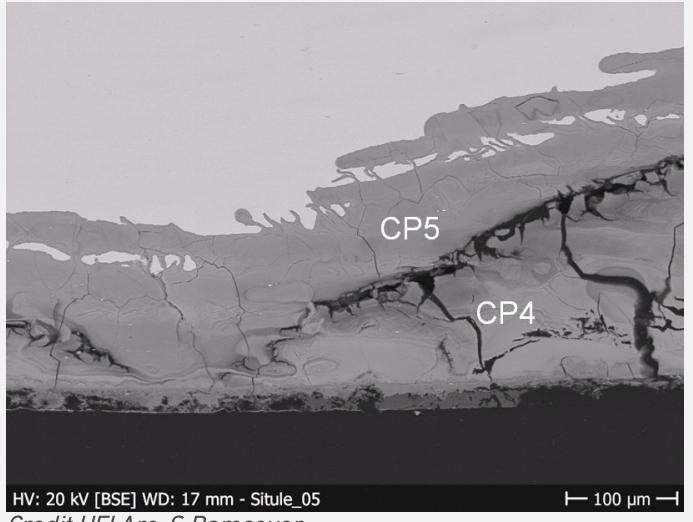
Fig. 9: SEM image, BSE-mode of the metal sample from Fig. 8 (detail) showing cleavage between the inner blue (CP5) and green (CP4) layers of Fig. 15,

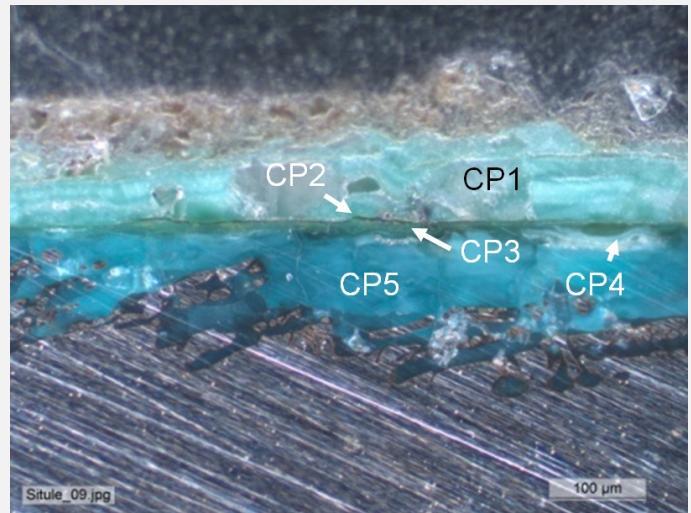
The limit of the original surface is well defined (interface of CP1 and CP2) but due to the fragility of the inner corrosion layers it was difficult to uncover.

Fig. 10: Micrograph of the metal / corrosion interface (detail of Fig. 8) unetched, dark field, 100x. The outer layer (CP1 of Fig. 15) incorporates soil material and the thin dark layer (CP2 of Fig. 15) highlights the limit of the original surface,

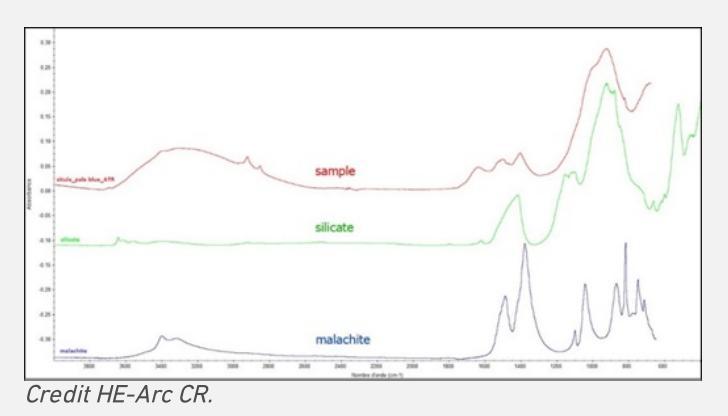
Fig. 12: FTIR spectrum (ATR mode) of the inner blue layer (CP5) compared to the silicate and malachite standard spectrum. Method of analysis: FTIR spectroscopy, HE- Arc CR,

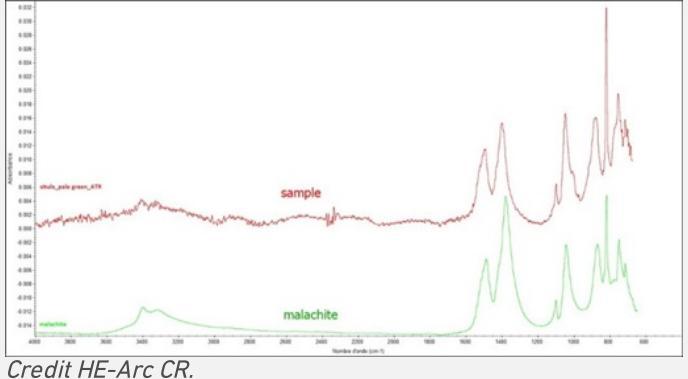
Fig. 13: FTIR spectrum (ATR mode) of the outer green layer (CP1) compared to the malachite standard spectrum. Method of analysis: FTIR spectroscopy, HE-Arc CR,

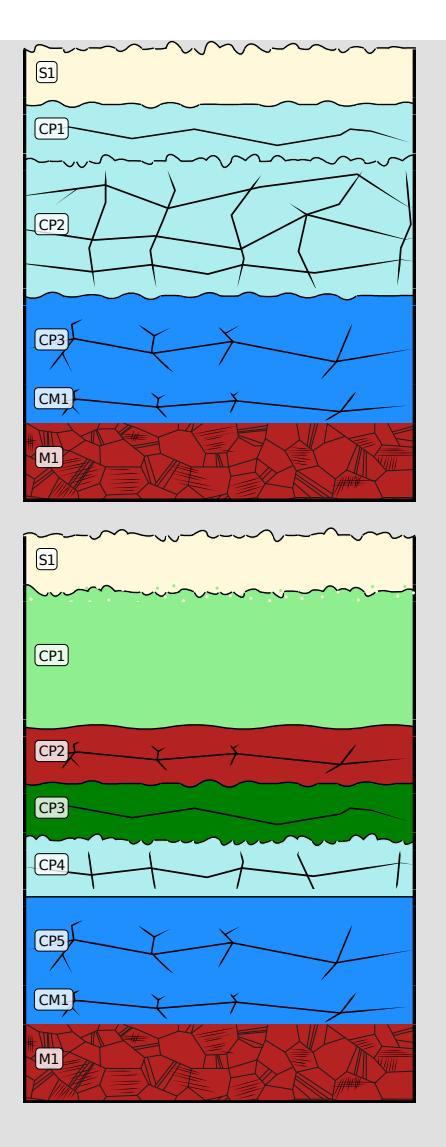
There are 2 stratigraphies (Fig. 14 corresponding to the interior face of the situla and Fig. 15 to its exterior face). The strata are similar in composition but their coding is different: CP1 to CP3 in Fig. 14 correspond to CP3 to CP5 in Fig. 15. Since the stratigraphy of Fig. 15 is more complete, the composition of each of its strata is given below.

Fig. 14: Stratigraphic representation of the sample taken from the detached fragment of the situla in cross-section (dark field) using the MiCorr application. The characteristics

of the strata are only accessible by clicking on the drawing that redirects you to the search tool by stratigraphy representation. This representation shows the interior face and can be compared to Fig. 8 (bottom red rectangle), Credit HE-Arc CR, M-J.Scholl.

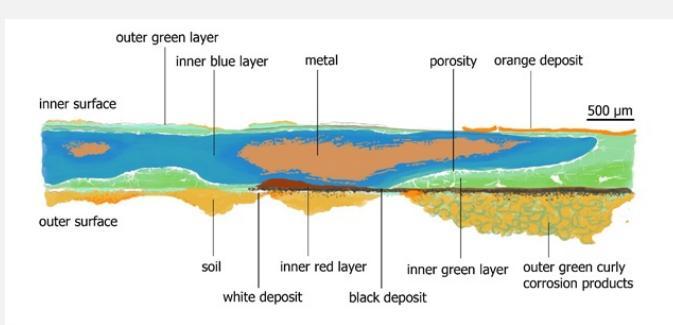
The schematic representation of corrosion layers of Fig. 3 integrating additional information (e and i within the coding correspond to strata in contact with the environment (e) and internal strata (i)) based on the analyses carried out is given in Fig. 16.

Composition	
Ca, Si, Al, Fe	
С	
Ferrous oxides	
Ca	
Copper carbonates (curly malachite)	
Copper oxide (cuprite ?)	
Copper carbonates (malachite)	
Copper carbonates (?) + Sn	
Copper carbonates (?) + Sn	
Bronze (90%Cu, 10% Sn)

Fig. 16: Improved stratigraphic representation of the situla from visual observations and analyses,
