HISPANO-SUIZA WATER PUMP - AL ALLOY - FRANCE

Artefact name Hispano-Suiza water pump

Authors Christian. Degrigny (HE-Arc CR, Neuchâtel, Neuchâtel, Switzerland) & Elodie. Granget (HE-Arc CR,

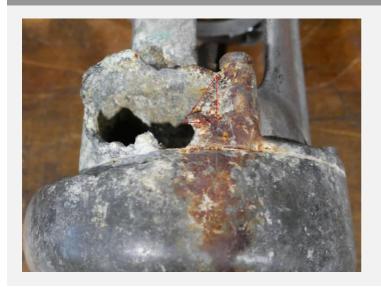
Fig. 3: Location of sampling area on the Hispano water pump,

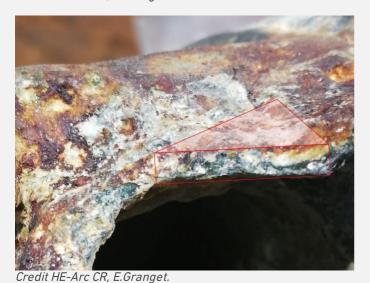
Fig. 4: Close-up view of the Hispano water pump, with the exit pipe sampling area,

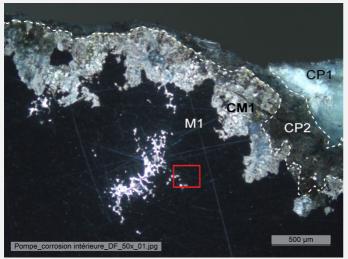
Fig. 8: Micrograph of the selected area (in red) of the sample shown on Fig. 7, unetched, dark field with location of Fig. 10,

Fig. 9: Micrograph similar to Fig. 8, unetched, bright field,

The porosity of this aluminium-copper alloy (Table 1) has been confirmed by optical (Figs. 8 and 9) and SEM observations on the cross-section of the fastening part's fragment (Fig. 10). The metal has a dendritic microstructure (Fig. 10).

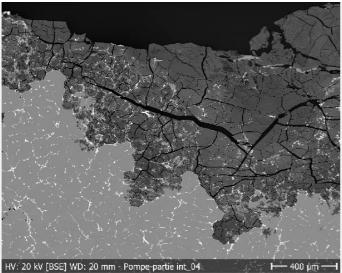
Fig. 11: SEM image (BSE mode) of the selected area (in blue) of the sample shown on Fig. 7, showing the remaining metal on the bottom and CM1 /CPs on top,

The SEM image of Fig. 11 clearly shows a network of cracks throughout CM1 and CPs. These cracks are not marking any clear separation between strata, but seem to affect all corrosion layers. The main Al phase is preferentially oxidized, while the interdendritic phase seems to be preserved in the corrosion products (Figs. 11 to 13). Na and K but no Fe are detected in the corrosion layers CM1 and CPs (Fig. 14). This surface is in contact with the coolant (glycol + additives, usually mixed 1/1 in water), which sometimes contain Na or K-based corrosion inhibitors. A cluster of CaCO3 was identified on the very surface of the sample (Fig. 15). CaCO3 can sometimes precipitate if the water used to mix the coolant is hard.

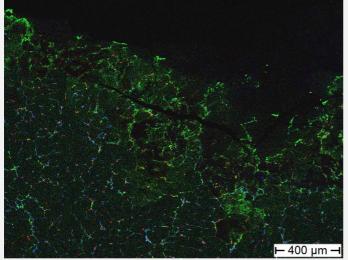
Fig. 13: Sn (red), Fe (blue) and Cu (green) distribution of the area of Fig. 11. Method of analysis: SEM-EDS. Lab. of Electronic Microscopy and Microanalysis, Néode, HEI Arc,

Local analyses on each phase appearing on Fig. 10 showed that the main phase is composed of Al and the interdendritic phases are composed of Al, Cu and Fe as well as Sn precipitates. This distribution is given through EDS elemental chemical distributions (Figs. 12 to 14).

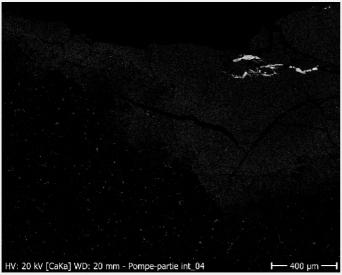
Fig. 15: Ca distribution of the area of Fig. 11. Method of analysis: SEM-EDS. Lab. of Electronic Microscopy and Microanalysis, Néode, HEI Arc,
