# FRAGMENT OF THE SUPPORT STRUCTURE OF AN ENGINE VHS-404 - GREY CAST IRON - MODERN TIMES

**Artefact name** Fragment of the support structure of an engine VHS-404

**Authors** Marianne. Senn (EMPA, Dübendorf, Zurich, Switzerland) & Christian. Degrigny (HE-Arc CR, Neuchâtel, Neuchâtel, Switzerland)

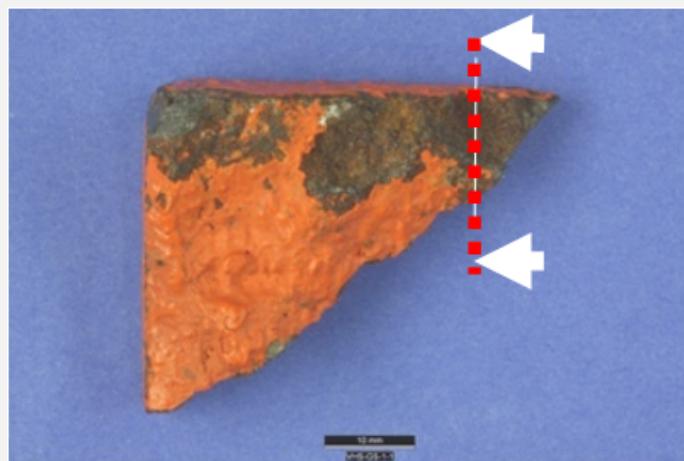
Fig. 2: Location of sampling area,

**Description of the artefact** Fragment of the support structure of the engine from the SS Rigi (oldest surviving flush-deck side-wheel paddle steamer in the world, Fig. 1), painted (Fig. 2).

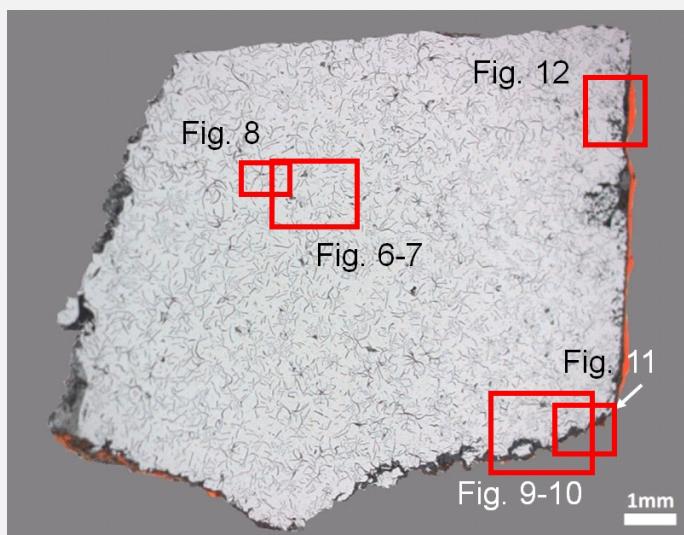
Fig. 3: Micrograph of the cross-section showing the location of Figs. 5 to 12,

<b>Description of sample</b>	The sample is a cross-section through the fragment of the machine support (Fig. 3). Dimensions: Lmax = 10mm; Wmax = 10mm.
<b>Alloy</b>	Grey cast iron
<b>Technology</b>	As-cast
<b>Lab number of sample</b>	VHS-G-1
<b>Sample location</b>	Empa (Marianne Senn)
<b>Responsible institution</b>	Swiss Museum of Transport, Luzern, Lucerne
<b>Date and aim of sampling</b>	07/09/2009 metallography

The thin corrosion crust (CP1) is limited to three sides of the sample and some remains of a paint coating (orange) are visible (Fig. 3). In bright field, the corrosion crust appears light-grey (Fig. 9), under polarised light-orange (Fig. 10). It is mainly composed of iron oxides (Table 3 and Fig. 11). The Pb and Ba-rich paint system has been applied directly onto the oxidized Fe, Si and Mn-rich casting skin (Fig. 11). The paint layer is probably an anodic inhibitor made from minium (red lead) with a barium sulphate filler. Because of the interference of Pb with S in the EDS spectra S is difficult to detect.

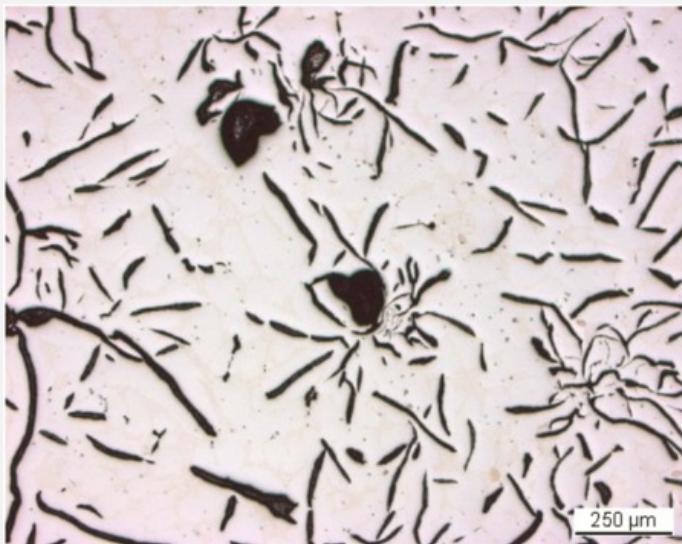
Fig. 5: Micrograph of the metal sample from Fig. 3 (inverted picture, detail), unetched, bright field. We observe graphite flakes and irregular nodules in black and the metal in white. The small grey spots are manganese sulphide inclusions.

The remaining metal is a high P and Si grey cast iron with elevated Mn and V contents (Tables 1 and 2). The structure contains black graphite flakes and graphite nodules (Fig. 5) as well as angular grey manganese sulphide inclusions which can contain a dark alumina-rich centre (Fig. 5 and Table 1). The graphite flakes are irregular and vary in size. At low magnification the flakes are evenly spread over the entire surface with a tendency to form clusters. Some porosity is noticeable. Under SEM, in the BSD-mode, an additional eutectic phase is visible (Fig. 6). After etching one can see how the graphite is surrounded by alpha-iron in a pearlite matrix (Figs. 7 and 8). The lamellar pearlite includes steadite ( $Fe_3P$ ) and manganese sulphide ( $MnS$ ) inclusions. According to the cast iron diagram after Maurer (Bargel and Schulze 2008, 257), the structure is typical for a hypoeutectic pearlitic grey cast iron (C content <4.3 mass%, Si content ca. 2.0 mass%) including pearlite, steadite and graphite. The slow cooling rate and the higher Si level have favoured the formation of graphite. The high P content favours the growth of interconnected networks of steadite. The average hardness of the metal is HV1 160. This hardness is only approximate. Normally cast iron hardness is determined with a Brinell test, but due to the small size of the sample this could not be carried out. The calculated HB is about 150.

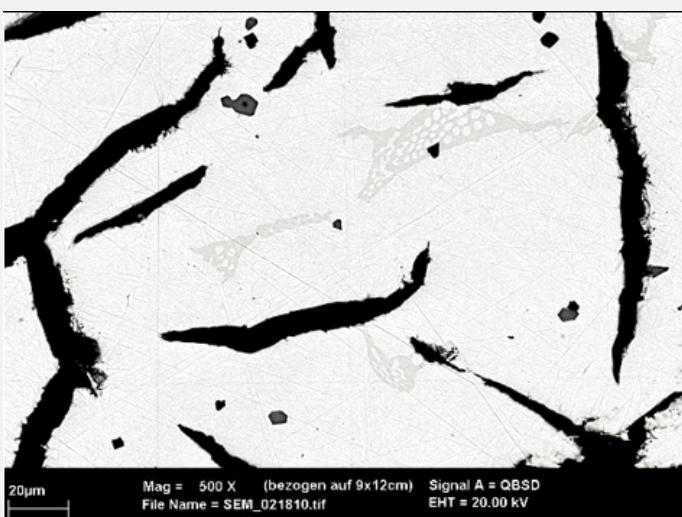
Fig. 6: SEM image from Fig. 3 (detail), BSE-mode, unetched. We observe the graphite flakes in black, the manganese sulphide inclusions in grey and the eutectic mixture in light-grey,

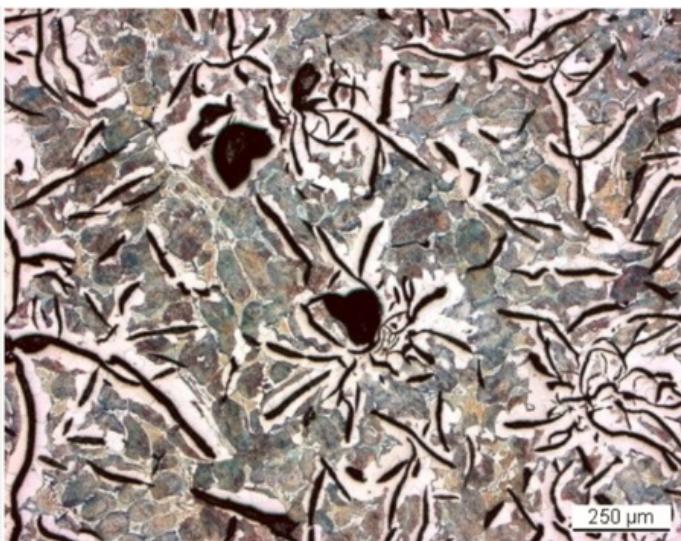
Fig. 7: Micrograph (same as Fig. 5), etched, bright field. In between the black graphite flakes we observe alpha-iron in white and pearlite / steadite in grey,

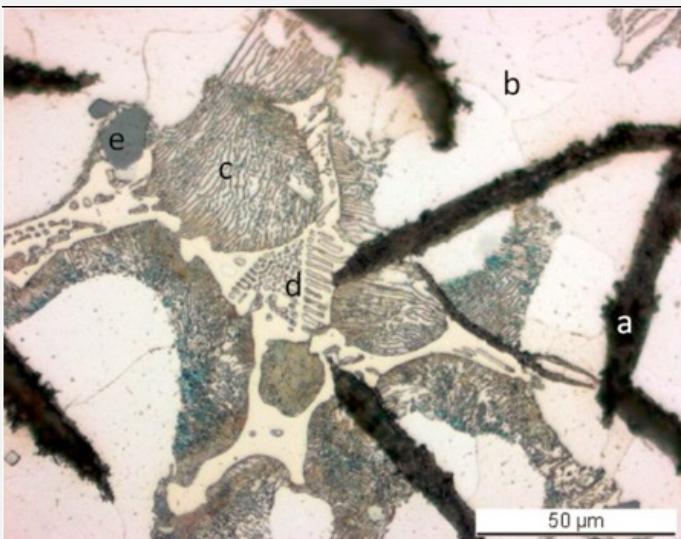
Fig. 8: Micrograph of the metal sample from Fig. 3 (detail), etched, bright field. The structure is composed of graphite (a), ferrite (b), pearlite (c), steadite (d) and MnS inclusions (e),

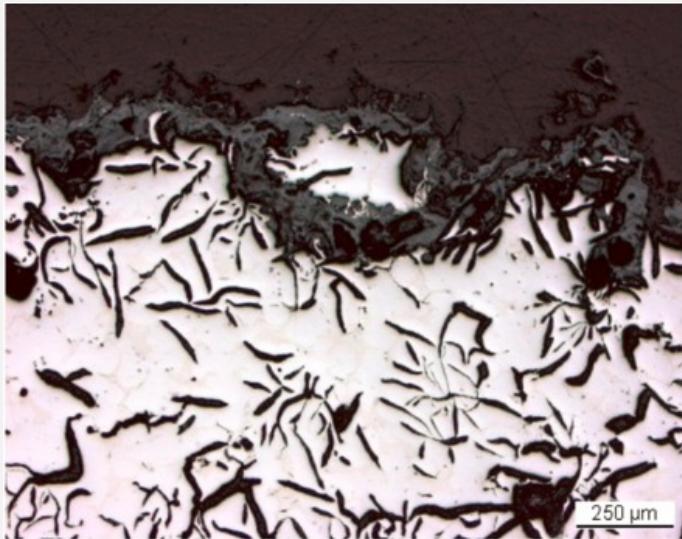
Fig. 9: Micrograph showing the metal - corrosion layer interface from Fig. 3 (inverted picture, detail), unetched, bright field. We observe in white the metal, in light-grey the corrosion layer, in black the graphite flakes,

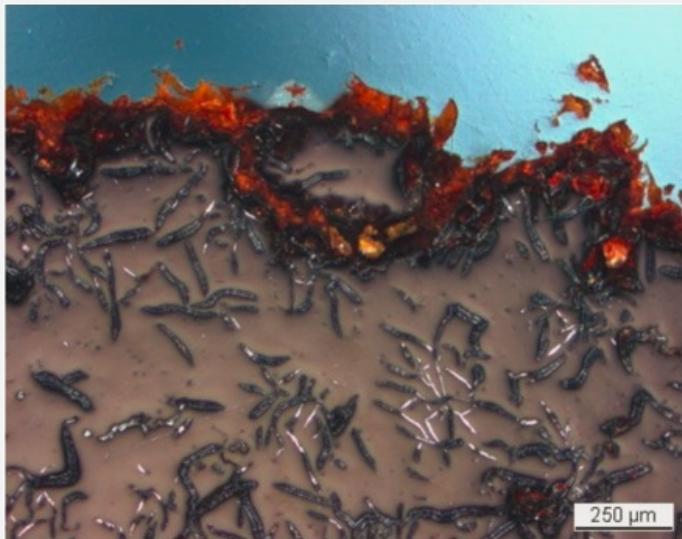
Fig. 10: Micrograph (same as Fig. 9) corresponding to the stratigraphy of Fig. 4, unetched, polarised light. We observe in violet the metal, in orange the corrosion, in blue the resin,

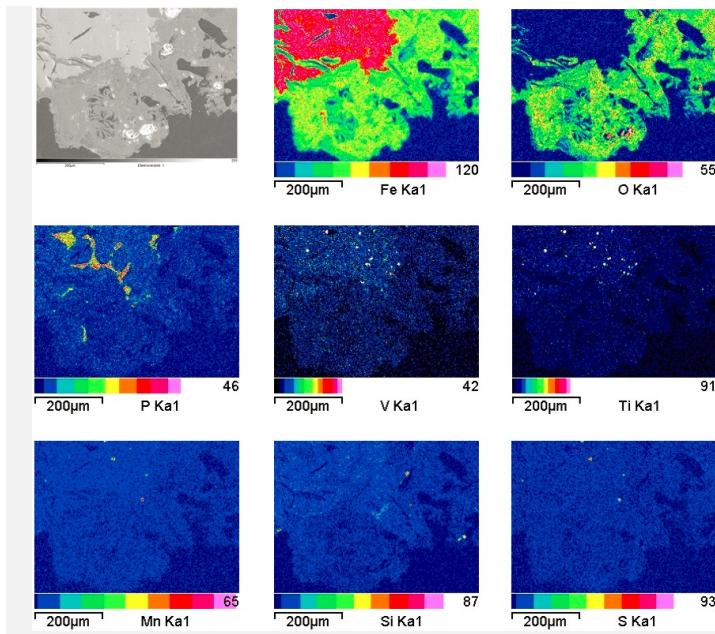
Fig. 11: SEM image, SE-mode, and elemental chemical distribution of the selected area from Fig. 3 (detail). Method of examination: SEM/EDS, Laboratory of Analytical Chemistry, Empa,

Dark-grey casting skin (Fig. 12)	27	<	14	<	<	21	33	<	<	95
Paint system (Fig. 12)	20	<	<	<	<	<	<	18	55	93
Grey corrosion layer (Fig. 11)	35	<	1.1	<	0.6	<	59	<	<	97

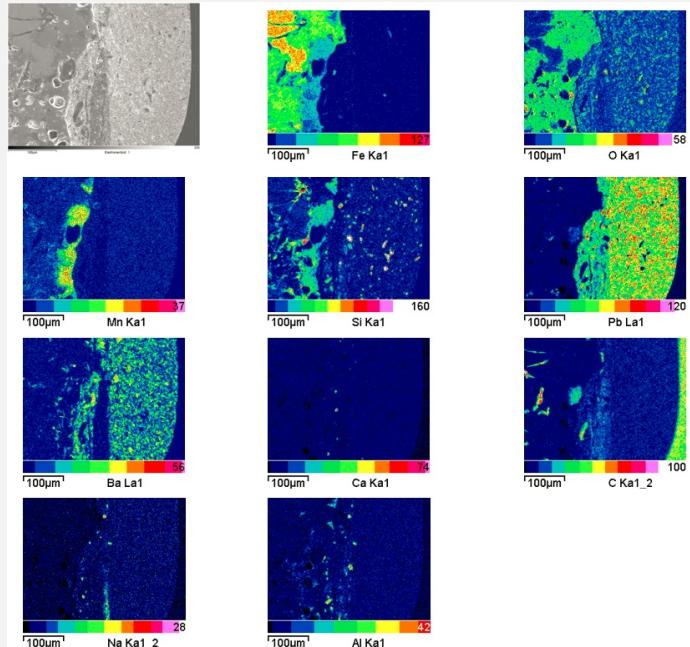
Fig. 12: SEM image, SE-mode, and elemental chemical distribution of the selected area from Fig. 3 (detail). Method of examination: SEM/EDS, Laboratory of Analytical Chemistry, Empa,

Elements	O	Mg	Si	P	S	Mn	Fe	Ba	Pb	Total
Inner light-grey corrosion layer (Fig. 12)	20	<	<	<	<	1.3	76	<	<	98
