FRAGMENT OF THE SUPPORT STRUCTURE OF AN ENGINE VHS-404 – GREY CAST IRON – MODERN TIMES

Artefact name Fragment of the support structure of an engine VHS-404

Authors Marianne. Senn (EMPA, Dübendorf, Zurich, Switzerland) & Christian. Degriy (HE-Arc CR, Neuchâtel, Neuchâtel, Switzerland)

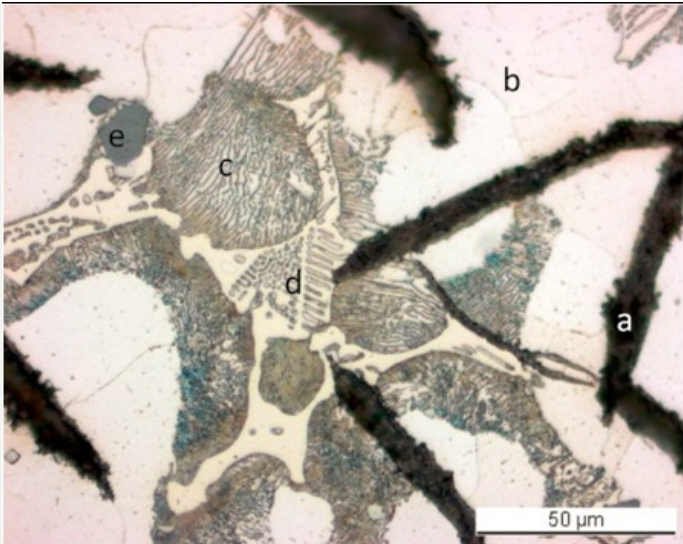
Fig. 8: Micrograph of the metal sample from Fig. 3 (detail), etched, bright field. The structure is composed of graphite (a), ferrite (b), pearlite (c), steadite (d) and MnS inclusions (e),
