# FRAGMENT OF THE SUPPORT STRUCTURE OF AN ENGINE VHS-404 – GREY CAST IRON – MODERN TIMES

<b>Artefact name</b>	Fragment of the support structure of an engine VHS-404
<b>Authors</b>	Marianne. Senn (EMPA, Dübendorf, Zurich, Switzerland) & Christian. Degriigny (HE-Arc CR, Neuchâtel, Neuchâtel, Switzerland)
<b>Url</b>	/artefacts/433/

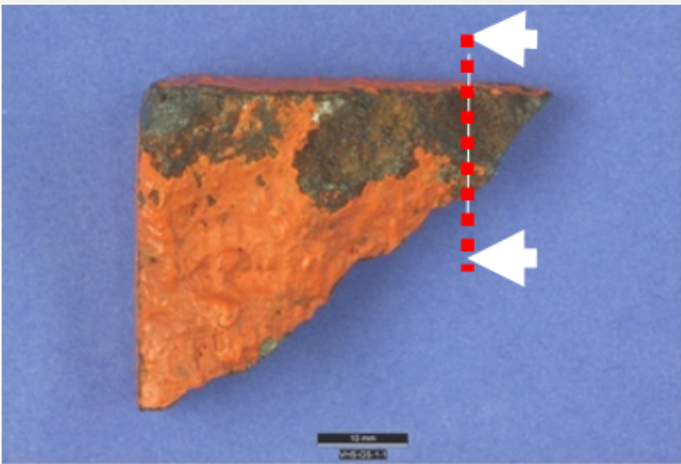
Fig. 2: Location of sampling area,

<b>Description of the artefact</b>	Fragment of the support structure of the engine from the SS Rigi (oldest surviving flush-deck side-wheel paddle steamer in the world, Fig. 1), painted (Fig. 2).
<b>Type of artefact</b>	Supporting structure
<b>Origin</b>	Flush-deck side-wheel paddle steamer SS Rigi
<b>Recovering date</b>	Removed in 1952 during the last renovation
<b>Chronology category</b>	Modern Times
<b>chronology tpq</b>	1860 A.D. ▼
<b>chronology taq</b>	1896 A.D. ▼
<b>Chronology comment</b>	Cast by Escher Wyss
<b>Burial conditions / environment</b>	Outdoor to indoor atmosphere
<b>Artefact location</b>	Swiss Museum of Transport, Luzern, Lucerne
<b>Owner</b>	Swiss Museum of Transport, Luzern, Lucerne
<b>Inv. number</b>	VHS-404
<b>Recorded conservation data</b>	Renovated in 1860 and 1880. The engine was replaced in 1894 and in 1952.

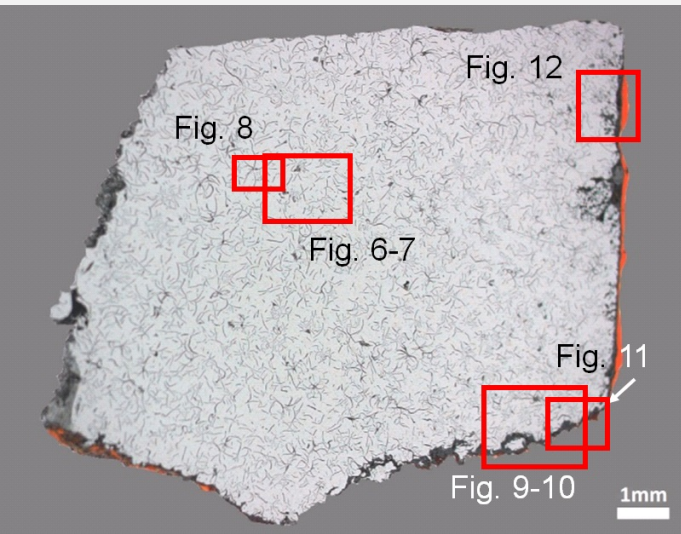
Fig. 3: Micrograph of the cross-section showing the location of Figs. 5 to 12,

The sample is a cross-section through the fragment of the machine support (Fig. 3). Dimensions: Lmax = 10mm; Wmax = 10mm.

The thin corrosion crust (CP1) is limited to three sides of the sample and some remains of a paint coating (orange) are visible (Fig. 3). In bright field, the corrosion crust appears light-grey (Fig. 9), under polarised light-orange (Fig. 10). It is mainly composed of iron oxides (Table 3 and Fig. 11). The Pb and Ba-rich paint system has been applied directly onto the oxidized Fe, Si and Mn-rich casting skin (Fig. 11). The paint layer is probably an anodic inhibitor made from minium (red lead) with a barium sulphate filler. Because of the interference of Pb with S in the EDS spectra S is difficult to detect.

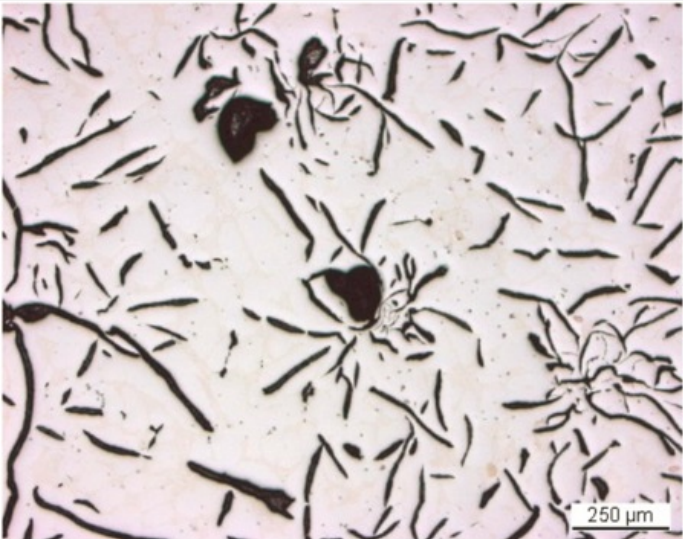
Fig. 5: Micrograph of the metal sample from Fig. 3 (inverted picture, detail), unetched, bright field. We observe graphite flakes and irregular nodules in black and the metal in white. The small grey spots are manganese sulphide inclusions,

The remaining metal is a high P and Si grey cast iron with elevated Mn and V contents (Tables 1 and 2). The structure contains black graphite flakes and graphite nodules (Fig. 5) as well as angular grey manganese sulphide inclusions which can contain a dark alumina-rich centre (Fig. 5 and Table 1). The graphite flakes are irregular and vary in size. At low magnification the flakes are evenly spread over the entire surface with a tendency to form clusters. Some porosity is noticeable. Under SEM, in the BSD-mode, an additional eutectic phase is visible (Fig. 6). After etching one can see how the graphite is surrounded by alpha-iron in a pearlite matrix (Figs. 7 and 8). The lamellar pearlite includes steadite ( $\text{Fe}_3\text{P}$ ) and manganese sulphide (MnS) inclusions. According to the cast iron diagram after Maurer (Bargel and Schulze 2008, 257), the structure is typical for a hypoeutectic pearlitic grey cast iron (C content <4.3 mass%, Si content ca. 2.0 mass%) including pearlite, steadite and graphite. The slow cooling rate and the higher Si level have favoured the formation of graphite. The high P content favours the growth of interconnected networks of steadite. The average hardness of the metal is HV1 160. This hardness is only approximate. Normally cast iron hardness is determined with a Brinell test, but due to the small size of the sample this could not be carried out. The calculated HB is about 150.

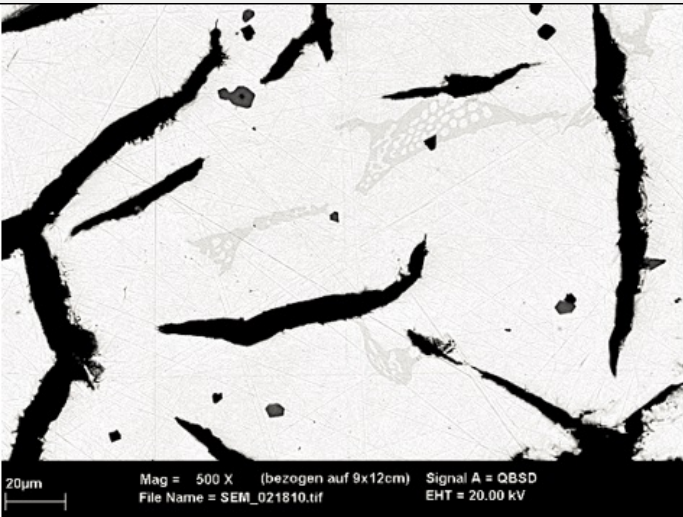
Fig. 6: SEM image from Fig. 3 (detail), BSE-mode, unetched. We observe the graphite flakes in black, the manganese sulphide inclusions in grey and the eutectic mixture in light-grey,

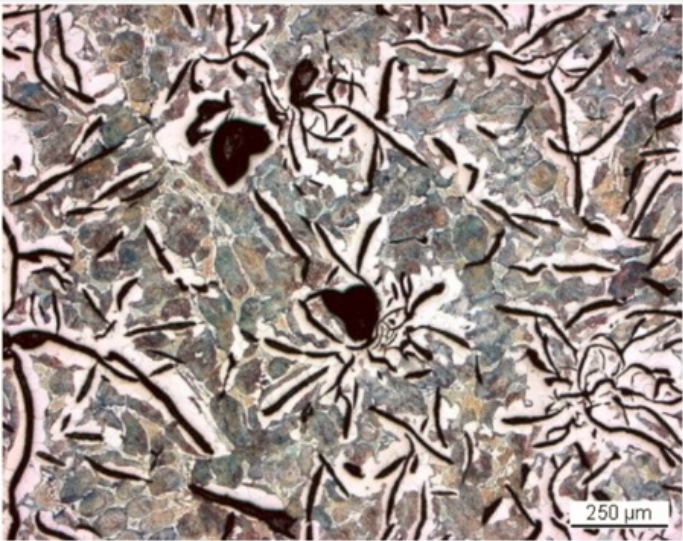
Fig. 7: Micrograph (same as Fig. 5), etched, bright field. In between the black graphite flakes we observe alpha-iron in white and pearlite / steadite in grey,

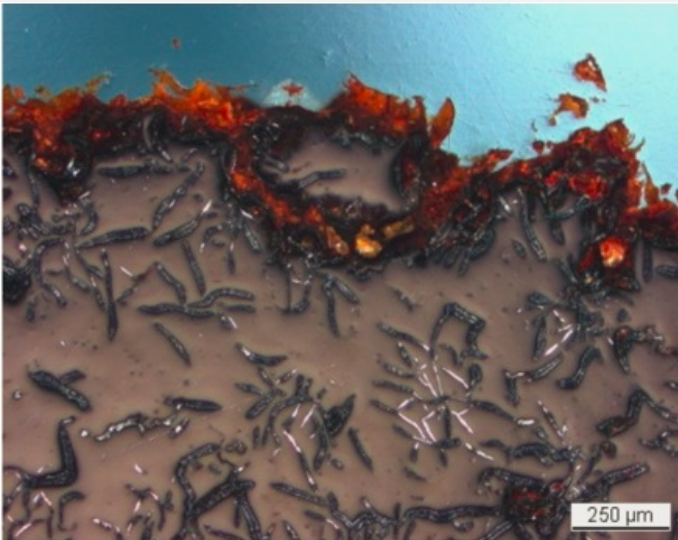
Fig. 10: Micrograph (same as Fig. 9) corresponding to the stratigraphy of Fig. 4, unetched, polarised light. We observe in violet the metal, in orange the corrosion, in blue the resin,

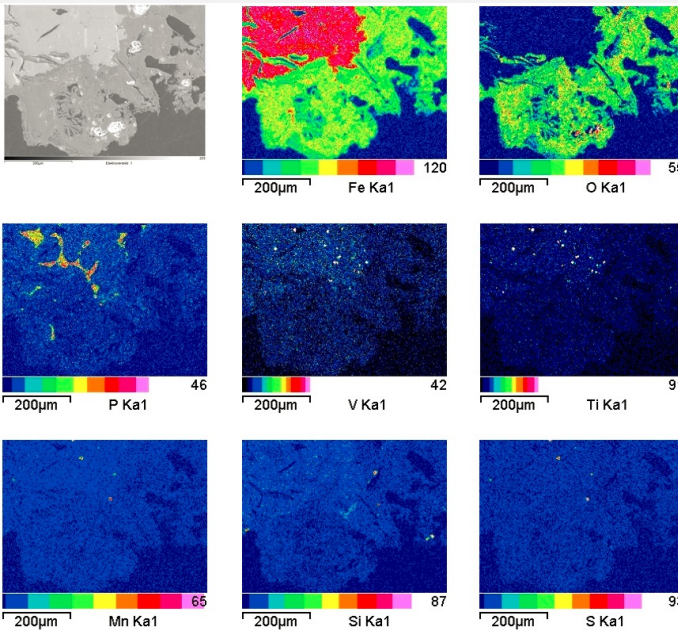
Fig. 11: SEM image, SE-mode, and elemental chemical distribution of the selected area from Fig. 3 (detail). Method of examination: SEM/EDS, Laboratory of Analytical Chemistry, Empa,

Elements	O	Mg	Si	P	S	Mn	Fe	Ba	Pb	Total
Inner light-grey corrosion layer (Fig. 12)	20	<	<	<	<	1.3	76	<	<	98
Dark-grey casting skin (Fig. 12)	27	<	14	<	<	21	33	<	<	95
Paint system (Fig. 12)	20	<	<	<	<	<	<	18	55	93
Grey corrosion layer (Fig. 11)	35	<	1.1	<	0.6	<	59	<	<	97
