FRAGMENT OF THE SUPPORT STRUCTURE OF AN ENGINE VHS-404 – GREY CAST IRON – MODERN TIMES

Artefact name	Fragment of the support structure of an engine VHS-404
Authors	Marianne. Senn (EMPA, Dübendorf, Zurich, Switzerland) & Christian. Degriigny (HE-Arc CR, Neuchâtel, Neuchâtel, Switzerland)
Url	/artefacts/433/

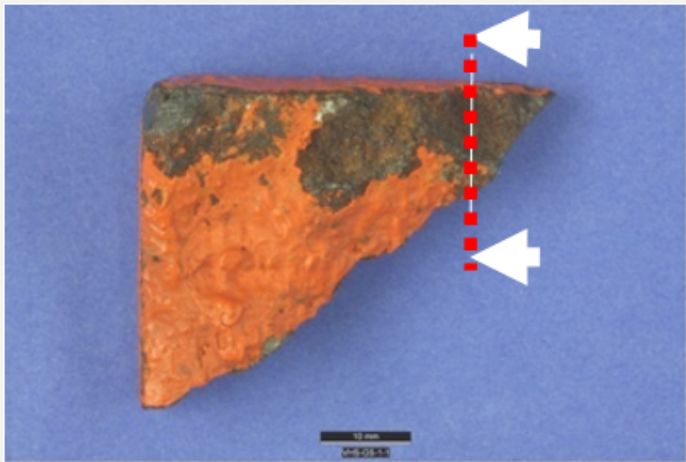
Fig. 2: Location of sampling area,

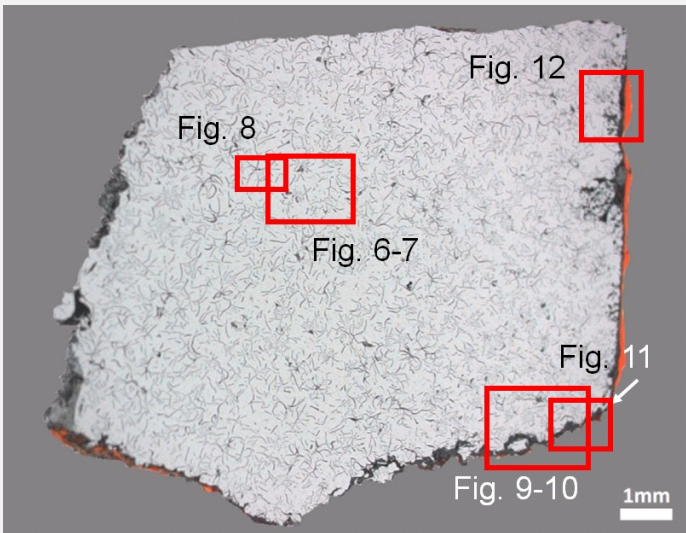
Fig. 3: Micrograph of the cross-section showing the location of Figs. 5 to 12,

Description of sample	The sample is a cross-section through the fragment of the machine support (Fig. 3). Dimensions: Lmax = 10mm; Wmax = 10mm.
Alloy	Grey cast iron
Technology	As-cast
Lab number of sample	VHS-G-1
Sample location	Empa (Marianne Senn)
Responsible institution	Swiss Museum of Transport, Luzern, Lucerne
Date and aim of sampling	07/09/2009 metallography

The thin corrosion crust (CP1) is limited to three sides of the sample and some remains of a paint coating (orange) are visible (Fig. 3). In bright field, the corrosion crust appears light-grey (Fig. 9), under polarised light-orange (Fig. 10). It is mainly composed of iron oxides (Table 3 and Fig. 11). The Pb and Ba-rich paint system has been applied directly onto the oxidized Fe, Si and Mn-rich casting skin (Fig. 11). The paint layer is probably an anodic inhibitor made from minium (red lead) with a barium sulphate filler. Because of the interference of Pb with S in the EDS spectra S is difficult to detect.

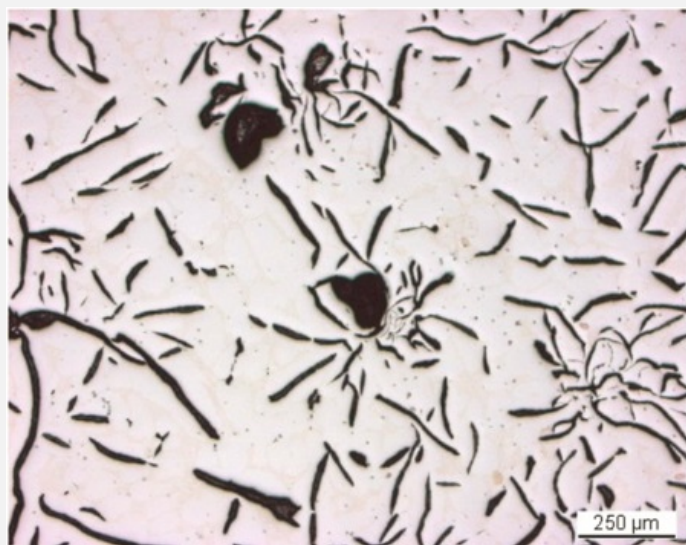
Fig. 5: Micrograph of the metal sample from Fig. 3 (inverted picture, detail), unetched, bright field. We observe graphite flakes and irregular nodules in black and the metal in white. The small grey spots are manganese sulphide inclusions,

The remaining metal is a high P and Si grey cast iron with elevated Mn and V contents (Tables 1 and 2). The structure contains black graphite flakes and graphite nodules (Fig. 5) as well as angular grey manganese sulphide inclusions which can contain a dark alumina-rich centre (Fig. 5 and Table 1). The graphite flakes are irregular and vary in size. At low magnification the flakes are evenly spread over the entire surface with a tendency to form clusters. Some porosity is noticeable. Under SEM, in the BSD-mode, an additional eutectic phase is visible (Fig. 6). After etching one can see how the graphite is surrounded by alpha-iron in a pearlite matrix (Figs. 7 and 8). The lamellar pearlite includes steadite (Fe₃P) and manganese sulphide (MnS) inclusions. According to the cast iron diagram after Maurer (Bargel and Schulze 2008, 257), the structure is typical for a hypoeutectic pearlitic grey cast iron (C content <4.3 mass%, Si content ca. 2.0 mass%) including pearlite, steadite and graphite. The slow cooling rate and the higher Si level have favoured the formation of graphite. The high P content favours the growth of interconnected networks of steadite. The average hardness of the metal is HV1 160. This hardness is only approximate. Normally cast iron hardness is determined with a Brinell test, but due to the small size of the sample this could not be carried out. The calculated HB is about 150.

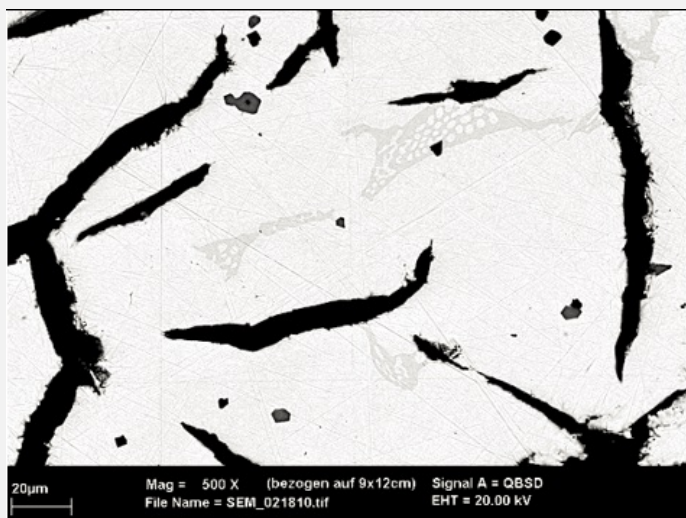
Fig. 6: SEM image from Fig. 3 (detail), BSE-mode, unetched. We observe the graphite flakes in black, the manganese sulphide inclusions in grey and the eutectic mixture in light-grey,

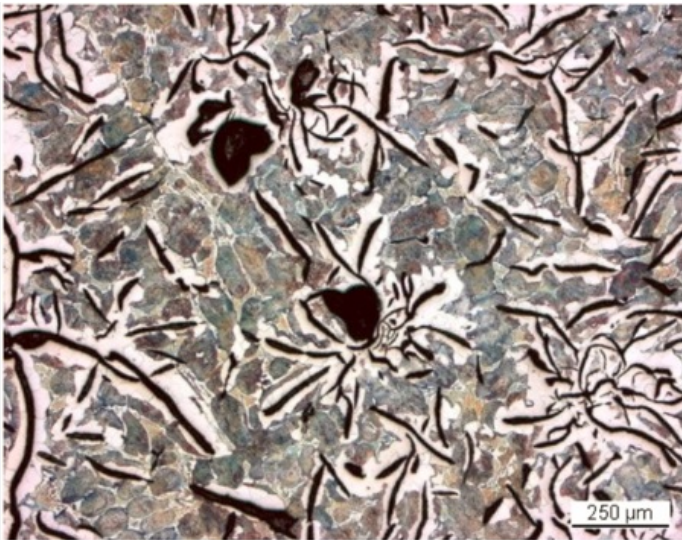
Fig. 7: Micrograph (same as Fig. 5), etched, bright field. In between the black graphite flakes we observe alpha-iron in white and pearlite / steadite in grey,

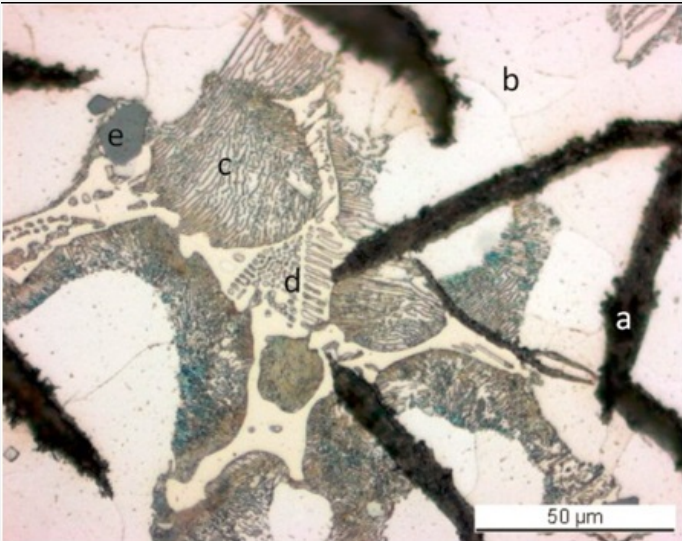
Fig. 8: Micrograph of the metal sample from Fig. 3 (detail), etched, bright field. The structure is composed of graphite (a), ferrite (b), pearlite (c), steadite (d) and MnS inclusions (e),

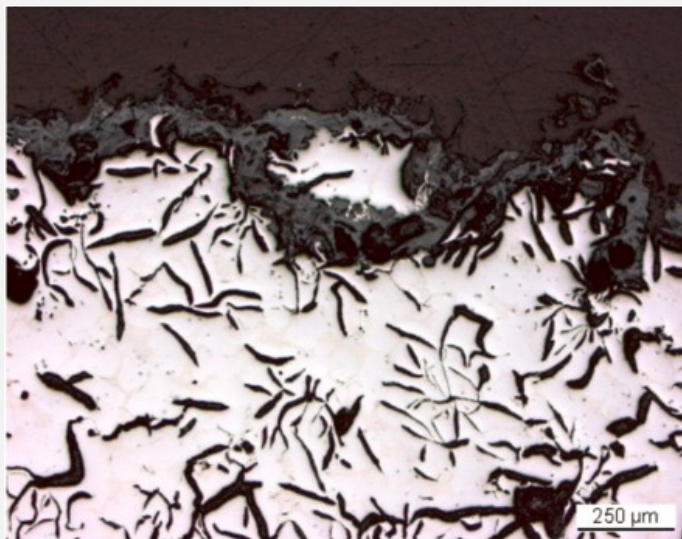
Fig. 9: Micrograph showing the metal - corrosion layer interface from Fig. 3 (inverted picture, detail), unetched, bright field. We observe in white the metal, in light-grey the corrosion layer, in black the graphite flakes,

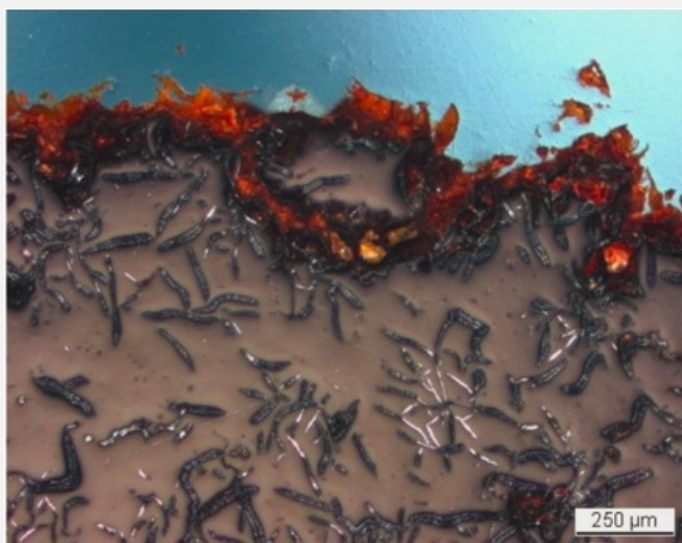
Fig. 10: Micrograph (same as Fig. 9) corresponding to the stratigraphy of Fig. 4, unetched, polarised light. We observe in violet the metal, in orange the corrosion, in blue the resin,

Fig. 4: Stratigraphic representation of the object in cross-section using the MiCorr application. The characteristics of the strata are only accessible by clicking on the drawing that redirects you to the search tool by stratigraphy representation. This representation can be compared to Fig. 10, Credit HE-Arc CR.

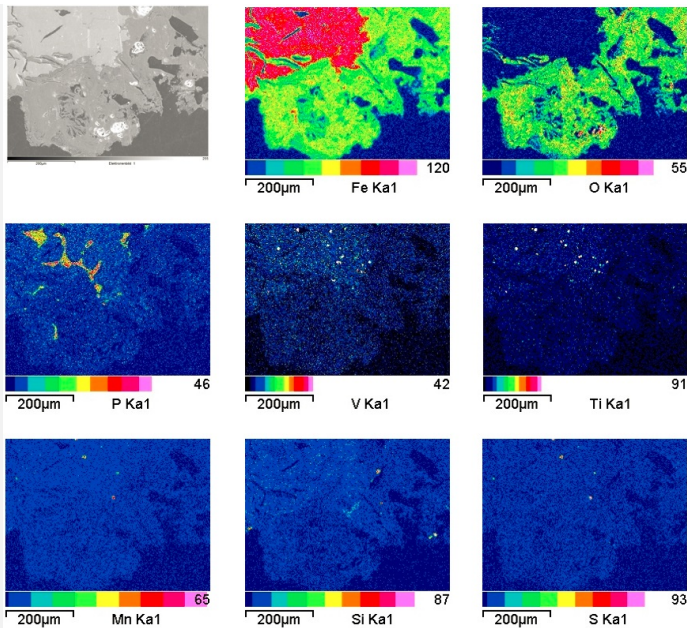
Fig. 11: SEM image, SE-mode, and elemental chemical distribution of the selected area from Fig. 3 (detail). Method of examination: SEM/EDS, Laboratory of Analytical Chemistry, Empa,

Dark-grey casting skin (Fig. 12)	27	<	14	<	<	21	33	<	<	95
Paint system (Fig. 12)	20	<	<	<	<	<	<	18	55	93
Grey corrosion layer (Fig. 11)	35	<	1.1	<	0.6	<	59	<	<	97

Table 3: Chemical composition (mass %) of the corrosion layer (from Figs. 11 and 12). Method of analysis: SEM/EDS, Laboratory of Analytical Chemistry, Empa.

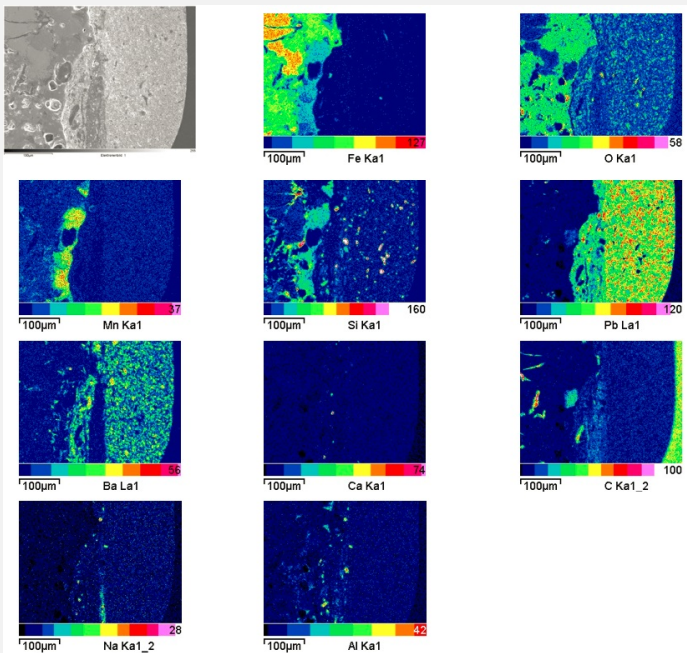
Fig. 12: SEM image, SE-mode, and elemental chemical distribution of the selected area from Fig. 3 (detail). Method of examination: SEM/EDS, Laboratory of Analytical Chemistry, Empa,

Elements	O	Mg	Si	P	S	Mn	Fe	Ba	Pb	Total
Inner light-grey corrosion layer (Fig. 12)	20	<	<	<	<	1.3	76	<	<	98
