FRAGMENT OF THE SUPPORT STRUCTURE OF AN ENGINE VHS-404 – GREY CAST IRON – MODERN TIMES

Artefact name	Fragment of the support structure of an engine VHS-404
Authors	Marianne. Senn (EMPA, Dübendorf, Zurich, Switzerland) & Christian. Degrigny (HE-Arc CR, Neuchâtel, Neuchâtel, Switzerland)
Url	/artefacts/433/

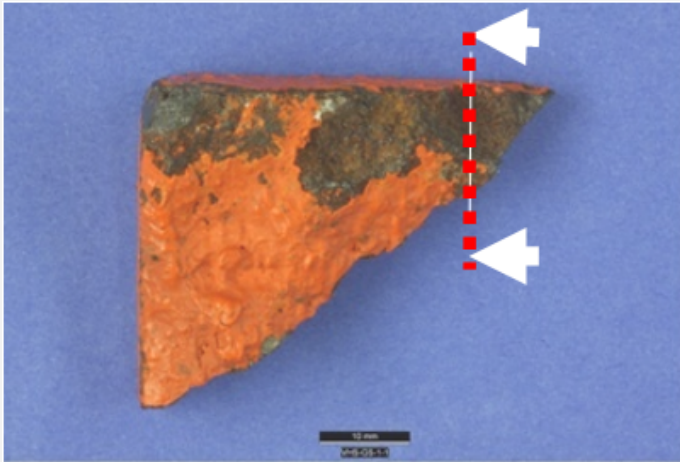
Fig. 2: Location of sampling area,

Description of the artefact	Fragment of the support structure of the engine from the SS Rigi (oldest surviving flush-deck side-wheel paddle steamer in the world, Fig. 1), painted (Fig. 2).
Type of artefact	Supporting structure
Origin	Flush-deck side-wheel paddle steamer SS Rigi
Recovering date	Removed in 1952 during the last renovation
Chronology category	Modern Times
chronology tpq	<input type="text" value="1860"/> A.D. ▾
chronology taq	<input type="text" value="1896"/> A.D. ▾
Chronology comment	Cast by Escher Wyss
Burial conditions / environment	Outdoor to indoor atmosphere
Artefact location	Swiss Museum of Transport, Luzern, Lucerne
Owner	Swiss Museum of Transport, Luzern, Lucerne
Inv. number	VHS-404
Recorded conservation data	Renovated in 1860 and 1880. The engine was replaced in 1894 and in 1952.

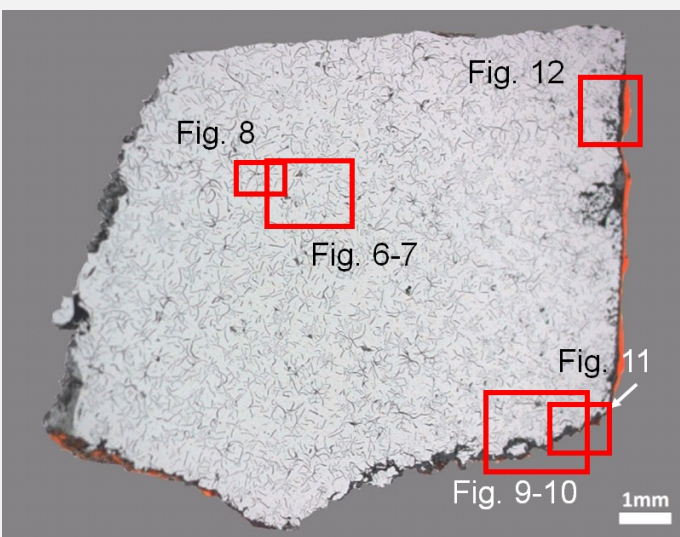
Fig. 3: Micrograph of the cross-section showing the location of Figs. 5 to 12,

The sample is a cross-section through the fragment of the machine support (Fig. 3). Dimensions: Lmax = 10mm; Wmax = 10mm.

The thin corrosion crust (CP1) is limited to three sides of the sample and some remains of a paint coating (orange) are visible (Fig. 3). In bright field, the corrosion crust appears light-grey (Fig. 9), under polarised light-orange (Fig. 10). It is mainly composed of iron oxides (Table 3 and Fig. 11). The Pb and Ba-rich paint system has been applied directly onto the oxidized Fe, Si and Mn-rich casting skin (Fig. 11). The paint layer is probably an anodic inhibitor made from minium (red lead) with a barium sulphate filler. Because of the interference of Pb with S in the EDS spectra S is difficult to detect.

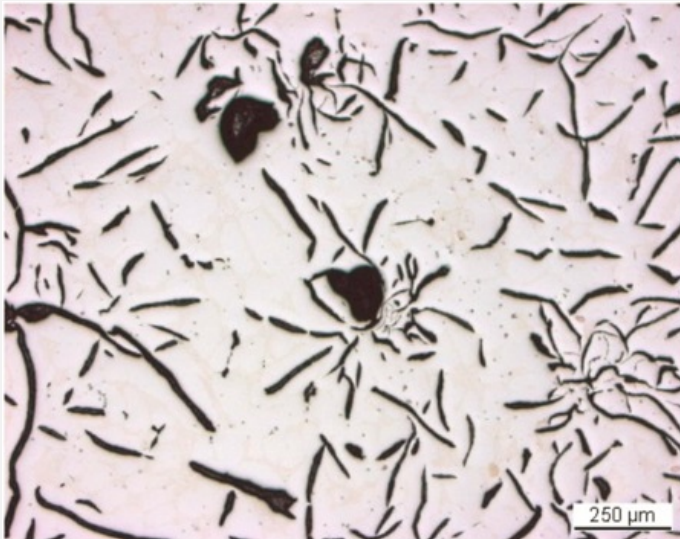
Fig. 5: Micrograph of the metal sample from Fig. 3 (inverted picture, detail), unetched, bright field. We observe graphite flakes and irregular nodules in black and the metal in white. The small grey spots are manganese sulphide inclusions,

The remaining metal is a high P and Si grey cast iron with elevated Mn and V contents (Tables 1 and 2). The structure contains black graphite flakes and graphite nodules (Fig. 5) as well as angular grey manganese sulphide inclusions which can contain a dark alumina-rich centre (Fig. 5 and Table 1). The graphite flakes are irregular and vary in size. At low magnification the flakes are evenly spread over the entire surface with a tendency to form clusters. Some porosity is noticeable. Under SEM, in the BSD-mode, an additional eutectic phase is visible (Fig. 6). After etching one can see how the graphite is surrounded by alpha-iron in a pearlite matrix (Figs. 7 and 8). The lamellar pearlite includes steadite (Fe₃P) and manganese sulphide (MnS) inclusions. According to the cast iron diagram after Maurer (Bargel and Schulze 2008, 257), the structure is typical for a hypoeutectic pearlitic grey cast iron (C content <4.3 mass%, Si content ca. 2.0 mass%) including pearlite, steadite and graphite. The slow cooling rate and the higher Si level have favoured the formation of graphite. The high P content favours the growth of interconnected networks of steadite. The average hardness of the metal is HV1 160. This hardness is only approximate. Normally cast iron hardness is determined with a Brinell test, but due to the small size of the sample this could not be carried out. The calculated HB is about 150.

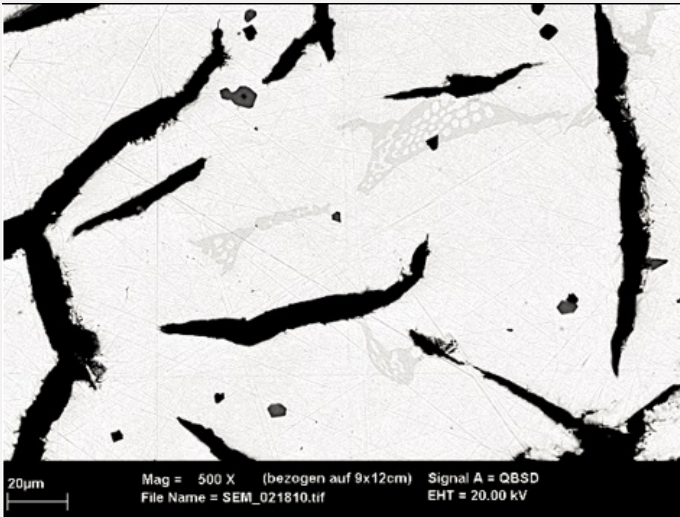
Fig. 6: SEM image from Fig. 3 (detail), BSE-mode, unetched. We observe the graphite flakes in black, the manganese sulphide inclusions in grey and the eutectic mixture in light-grey,

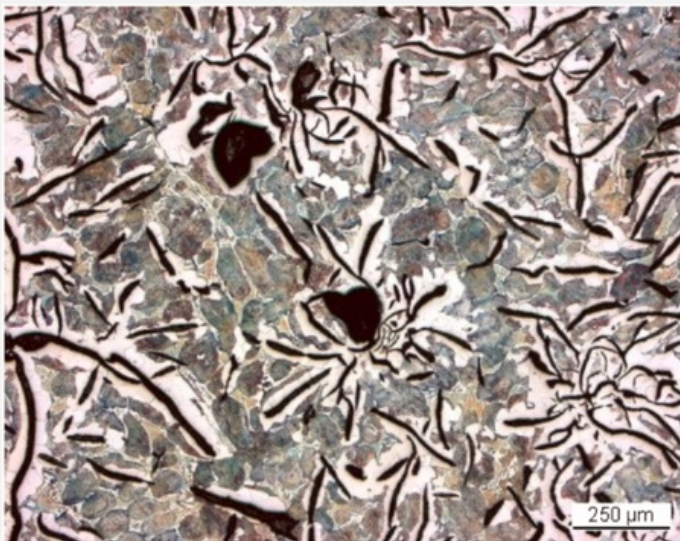
Fig. 7: Micrograph (same as Fig. 5), etched, bright field. In between the black graphite flakes we observe alpha-iron in white and pearlite / steadite in grey,

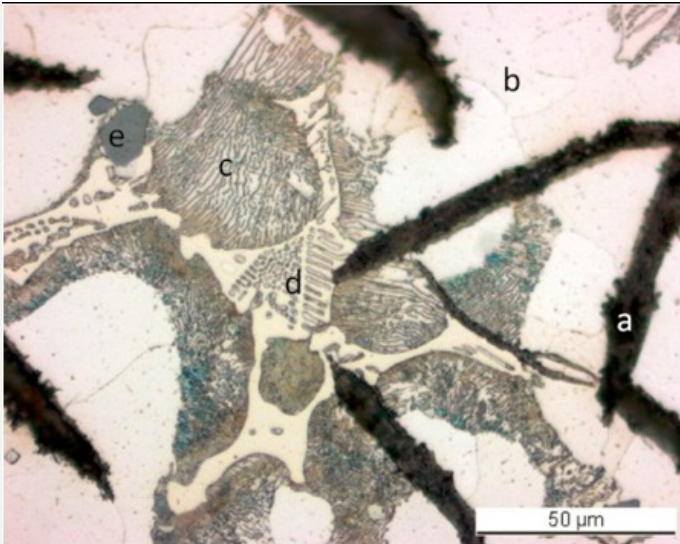
Fig. 8: Micrograph of the metal sample from Fig. 3 (detail), etched, bright field. The structure is composed of graphite (a), ferrite (b), pearlite (c), steadite (d) and MnS inclusions (e),

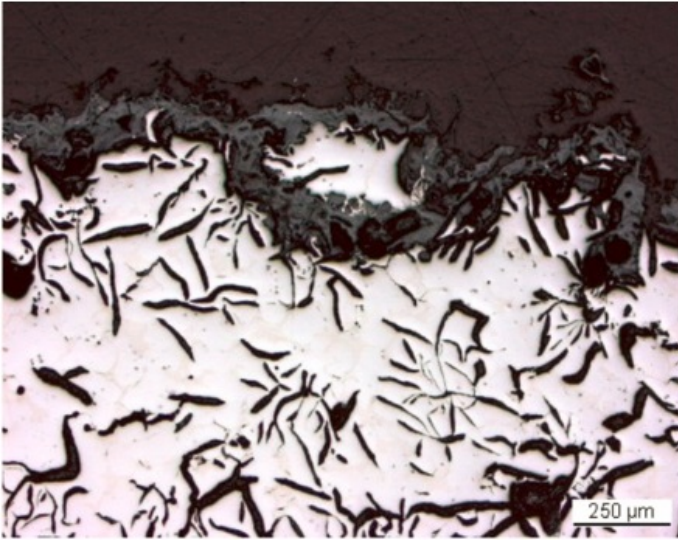
Fig. 9: Micrograph showing the metal - corrosion layer interface from Fig. 3 (inverted picture, detail), unetched, bright field. We observe in white the metal, in light-grey the corrosion layer, in black the graphite flakes,

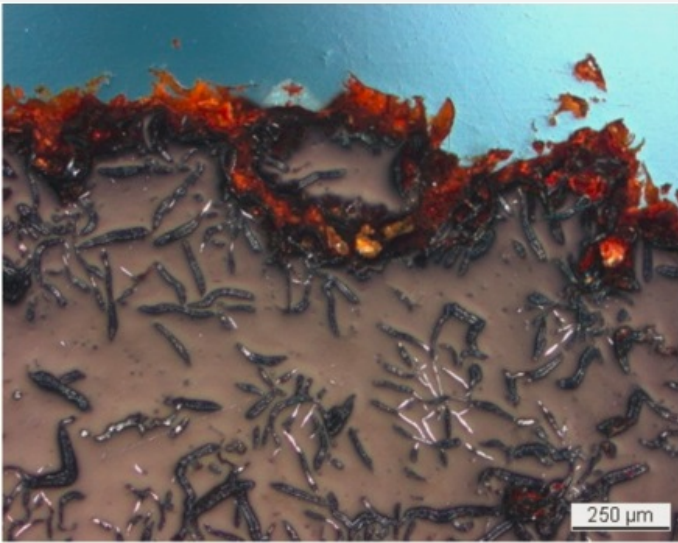
Fig. 10: Micrograph (same as Fig. 9) corresponding to the stratigraphy of Fig. 4, unetched, polarised light. We observe in violet the metal, in orange the corrosion, in blue the resin,

Fig. 4: Stratigraphic representation of the object in cross-section using the MiCorr application. The characteristics of the strata are only accessible by clicking on the drawing that redirects you to the search tool by stratigraphy representation. This representation can be compared to Fig. 10, Credit HE-Arc CR.

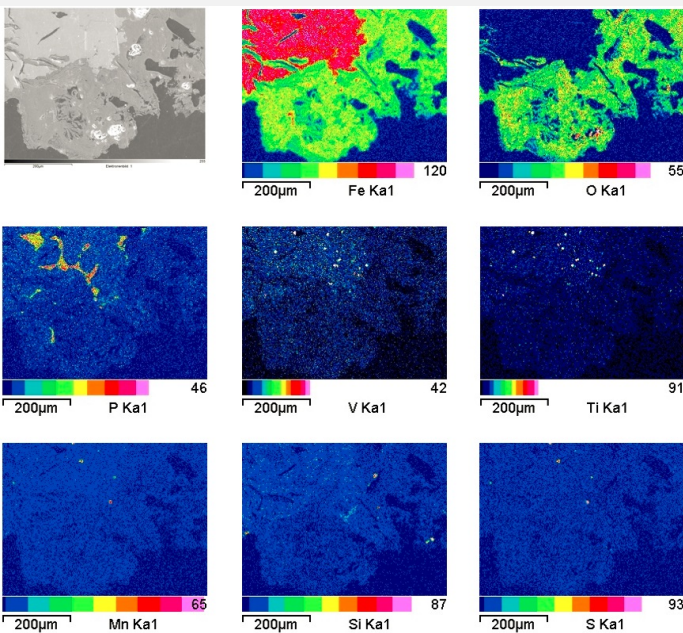
Fig. 11: SEM image, SE-mode, and elemental chemical distribution of the selected area from Fig. 3 (detail). Method of examination: SEM/EDS, Laboratory of Analytical Chemistry, Empa,

Elements	O	Mg	Si	P	S	Mn	Fe	Ba	Pb	Total
Inner light-grey corrosion layer (Fig. 12)	20	<	<	<	<	1.3	76	<	<	98
Dark-grey casting skin (Fig. 12)	27	<	14	<	<	21	33	<	<	95
Paint system (Fig. 12)	20	<	<	<	<	<	<	18	55	93
Grey corrosion layer (Fig. 11)	35	<	1.1	<	0.6	<	59	<	<	97

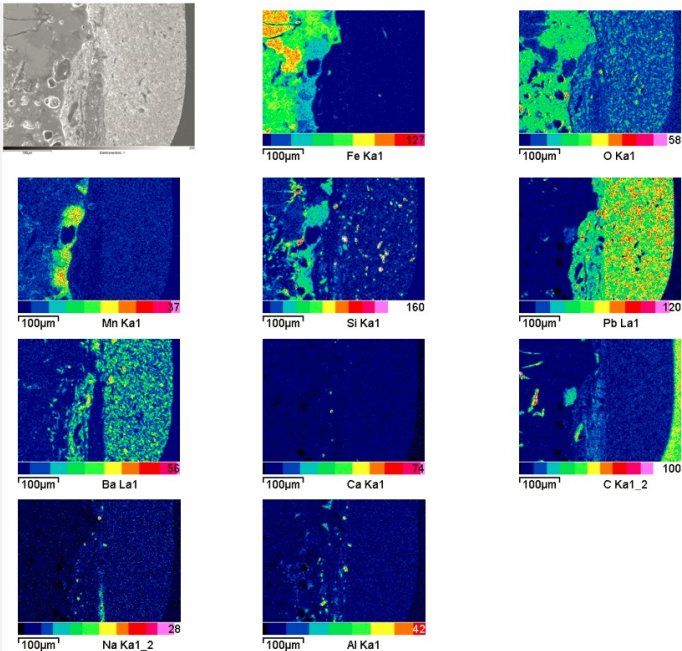
Fig. 12: SEM image, SE-mode, and elemental chemical distribution of the selected area from Fig. 3 (detail). Method of examination: SEM/EDS, Laboratory of Analytical Chemistry, Empa,
