HISPANO-SUIZA WATER PUMP - AL ALLOY - FRANCE

Artefact name Hispano-Suiza water pump

This Hispano-suiza water pump (Fig. 1), measuring around 15x15x20 cm, is made of 3 parts (Fig. 2):

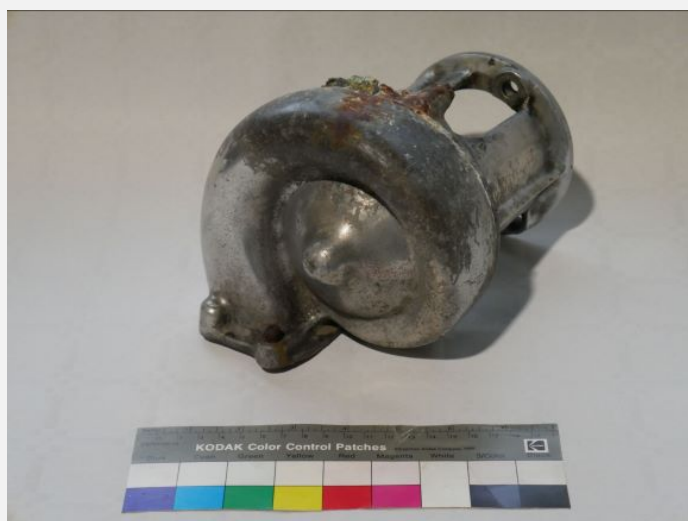
Fig. 1: Hispano-suiza water pump, unknown model,

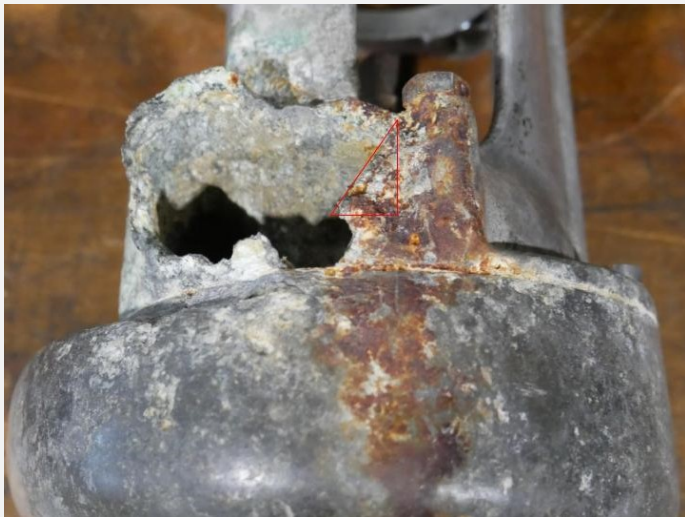
Fig. 3: Location of sampling area on the Hispano water pump,

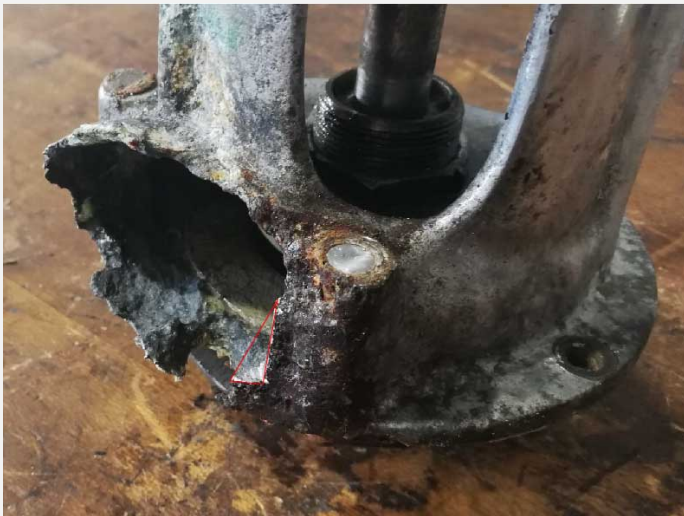
Fig. 5: Close-up view of the corroded exit pipe of the disassembled Hispano water pump, showing the sampled area,
