HISPANO-SUIZA WATER PUMP - AL ALLOY - FRANCE

Artefact name	Hispano-Suiza water pump
Authors	Granget. Elodie (, None) & . (MNAM (Musée National de l'Automobile de Mulhouse), Mulhouse, Alsace, France)
Url	/artefacts/669/

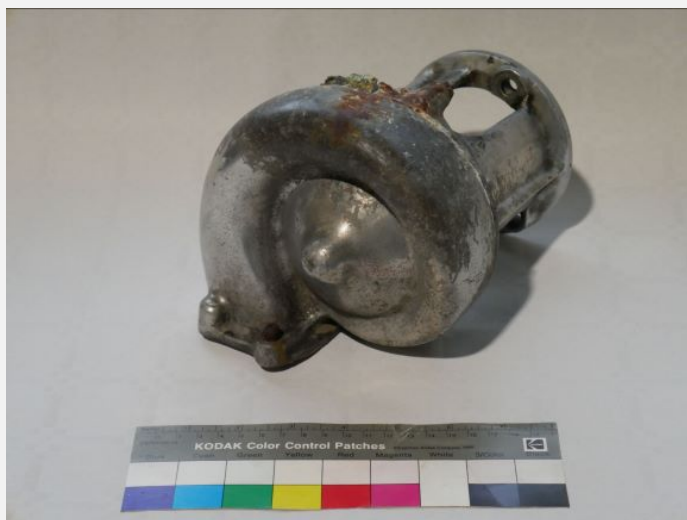
Fig. 1: Hispano-suiza water pump, unknown model,

This Hispano-suiza water pump (Fig. 1), measuring around 15x15x20 cm, is made of 3 parts (Fig. 2):

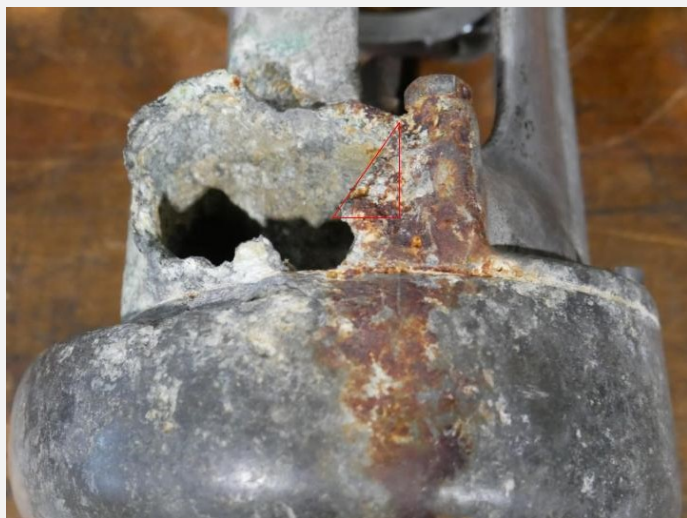
Fig. 3: Location of sampling area on the Hispano water pump,

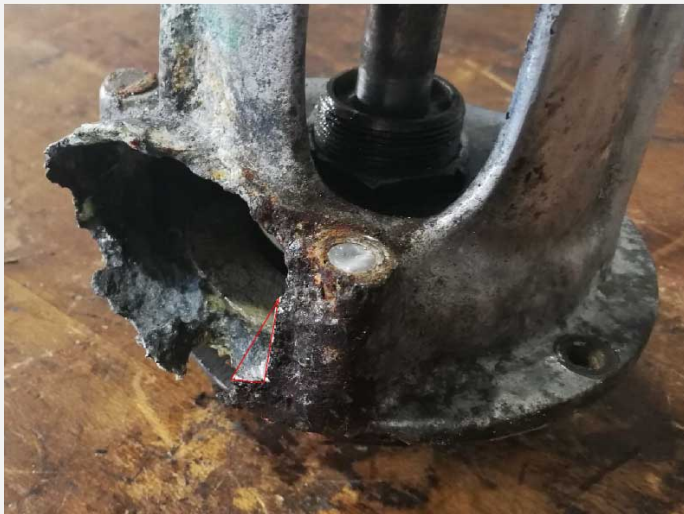
The exit pipe of the fastening part considered within this study is heavily corroded.

Fig. 5: Close-up view of the corroded exit pipe of the disassembled Hispano water pump, showing the sampled area,

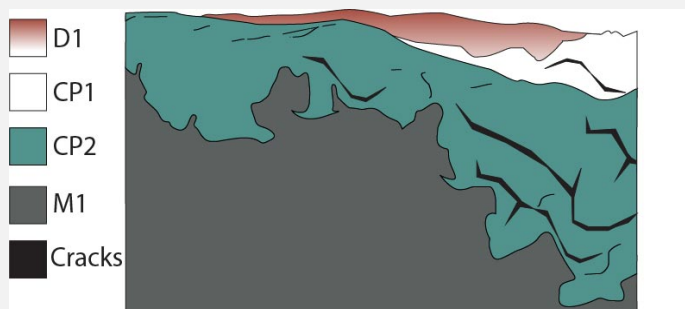
The schematic representation below gives an overview of the corrosion layers encountered on the corroded pipe of the fastening part of the pump.

The CP strata show big cracks and can be removed with a bit of scratching (severable). CP2 has a green-blueish color. Over most of the corroded part there is a thick red-orange deposit. This is probably coming from the corroded steel screws, used to fasten the parts of the water-pump.

Fig. 6: Stratigraphic representation of the corroded exit pipe of the water pump in cross-section by macroscopic observation, M = metal, CP = corrosion product, D = deposit,

During the sampling, the orange colored deposit layer (D1 on Fig. 6) was lost.
