HISPANO-SUIZA WATER PUMP - AL ALLOY - FRANCE

Artefact name	Hispano-Suiza water pump
Authors	Granget. Elodie (, None) & . (MNAM (Musée National de l'Automobile de Mulhouse), Mulhouse, Alsace, France)
Url	/artefacts/669/

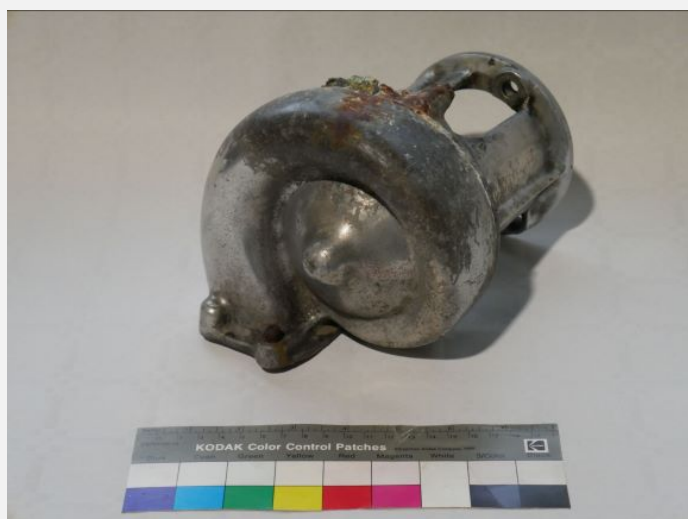
Fig. 1: Hispano-suiza water pump, unknown model,

This Hispano-suiza water pump (Fig. 1), measuring around 15x15x20 cm, is made of 3 parts (Fig. 2):

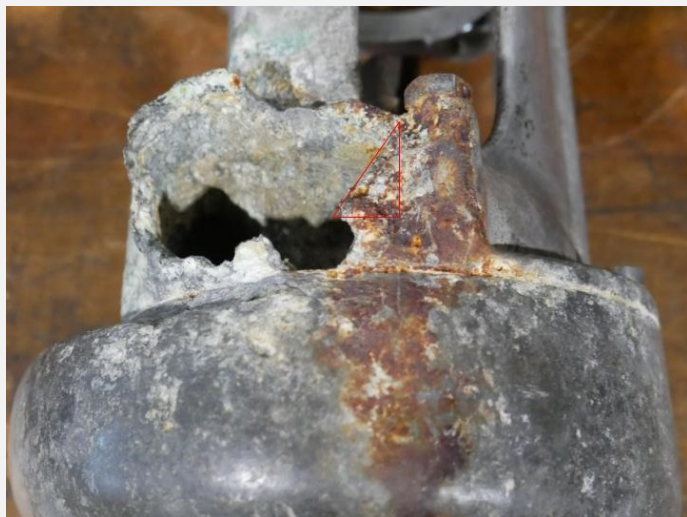
Fig. 3: Location of sampling area on the Hispano water pump,

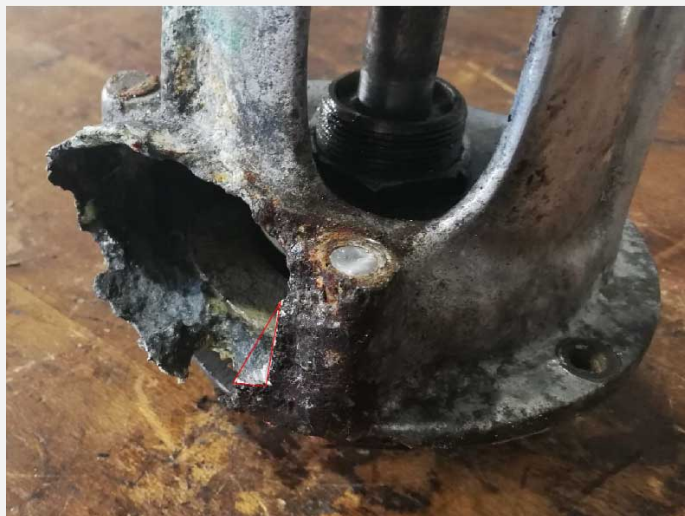
Fig. 5: Close-up view of the corroded exit pipe of the disassembled Hispano water pump, showing the sampled area,
