BUGATTI 37 CYLINDER HEAD GASKET 0416 - AL ALLOY - MODERN TIMES - FRANCE

Artefact name Bugatti 37 cylinder head gasket 0416

Authors Granget. Elodie (, None) & . (MNAM (Musée National de l'Automobile de Mulhouse), Mulhouse, Alsace, France)

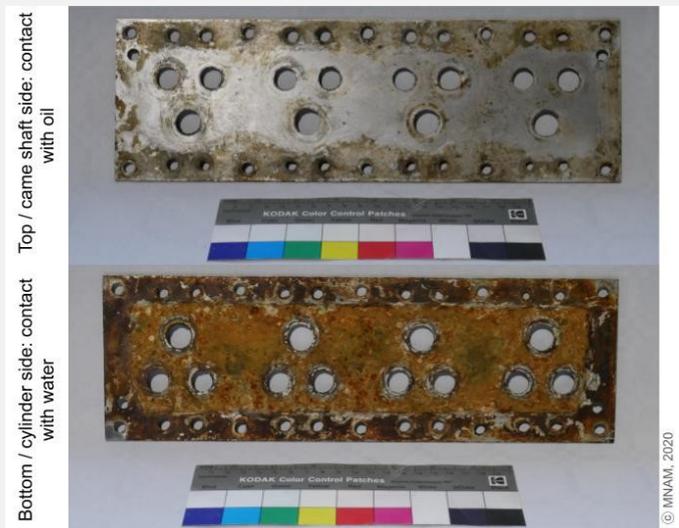
Fig. 1: General picture of the corroded cylinder head gasket of the Bugatti Type 37. Top side facing the camshaft and bottom part in contact with the coolant of the block,

The Bugatti Type 37 will be restored. When the car was dismantled, this gasket was deemed too corroded to be kept. A new part will be put in its place during the restoration. Consequently, this part has been classified as study material, allowing for sampling for metallography.

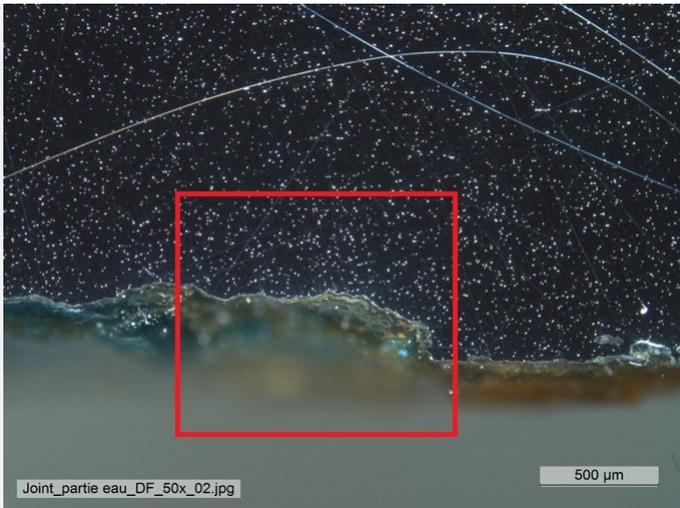
Fig. 10: Micrograph of the cross-section of the gasket, zone 2, shown on Fig. 5 unetched, dark field, showing the location of the SEM image of Fig. 11 (in red),

Fig. 9 shows that the corrosion products progress through M1 and develop a network of cracks. Fig. 10 shows that the corrosion can expand even further through M2, the corrosion products being more stratified (Fig. 11).
