# BUGATTI 37 CYLINDER HEAD GASKET 0416 - AL ALLOY - MODERN TIMES - FRANCE

**Artefact name** Bugatti 37 cylinder head gasket 0416

**Authors** Granget. Elodie (, None) & . (Mnam (Musée National de l'Automobile de Mulhouse), Mulhouse, Alsace, France)

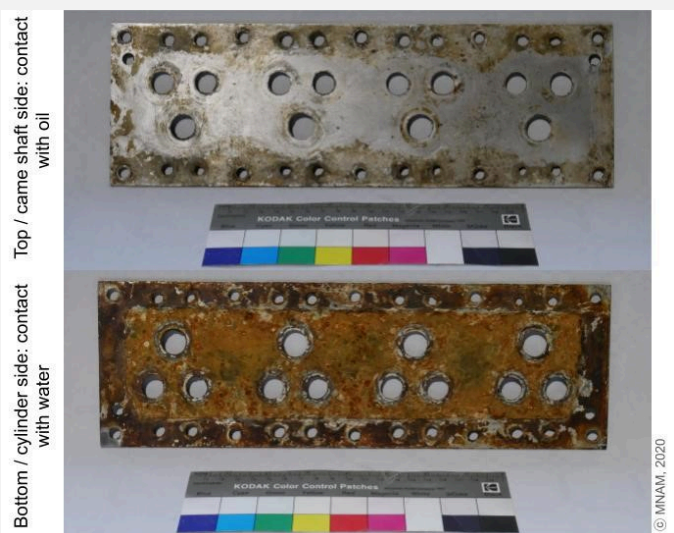
Fig. 1: General picture of the corroded cylinder head gasket of the Bugatti Type 37. Top side facing the camshaft and bottom part in contact with the coolant of the block,

The Bugatti Type 37 will be restored. When the car was dismantled, this gasket was deemed too corroded to be kept. A new part will be put in its place during the restoration. Consequently, this part has been classified as study material, allowing for sampling for metallography.

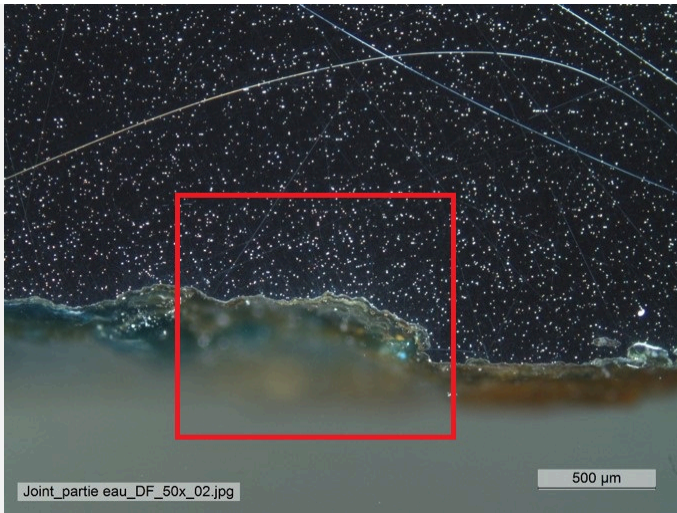
Fig. 9 shows that the corrosion products progress through M1 and develop a network of cracks. Fig. 10 shows that the corrosion can expand even further through M2, the corrosion products being more stratified (Fig. 11).

Fig. 10: Micrograph of the cross-section of the gasket, zone 2, shown on Fig. 5 unetched, dark field, showing the location of the SEM image of Fig. 11 (in red),
