FRAGMENT OF THE SUPPORT STRUCTURE OF AN ENGINE VHS-404 - GREY CAST IRON - MODERN TIMES

Artefact name	Fragment of the support structure of an engine VHS-404
Authors	Marianne. Senn (EMPA, Dübendorf, Zurich, Switzerland) & Christian. Degriigny (HE-Arc CR, Neuchâtel, Neuchâtel, Switzerland)
Url	/artefacts/702/

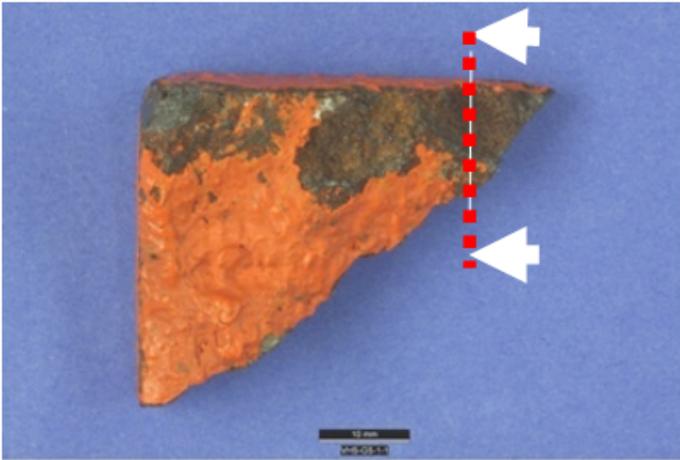
Fig. 2: Location of sampling area,

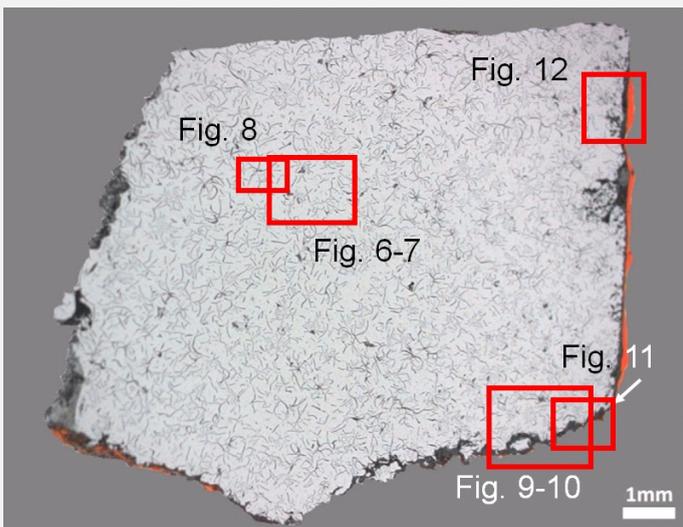
Fig. 3: Micrograph of the cross-section of the fragment showing the location of Figs. 5 to 12,

Description of sample	The sample is a cross-section through the fragment of the support structure of the engine (Fig. 3). Dimensions: Lmax = 10mm; Wmax = 10mm.
Alloy	Grey cast iron
Technology	As-cast
Lab number of sample	VHS-G-1
Sample location	Empa (Marianne Senn)
Responsible institution	Swiss Museum of Transport, Luzern, Lucerne
Date and aim of sampling	07/09/2009 metallography

The thin corrosion crust (CP1) is limited to three sides of the sample and some remains of a paint coating (orange) are visible (Fig. 3). In bright field, the corrosion crust appears light-grey (Fig. 9), under polarised light-orange (Fig. 10). It is mainly composed of iron oxides (Table 3 and Fig. 11). The Pb and Ba-rich paint system has been applied directly onto the oxidized Fe, Si and Mn-rich casting skin (Fig. 12). The paint layer is probably an anodic inhibitor made from minium (red lead) with a barium sulphate filler. Because of the interference of Pb with S in the EDS spectra S is difficult to detect.

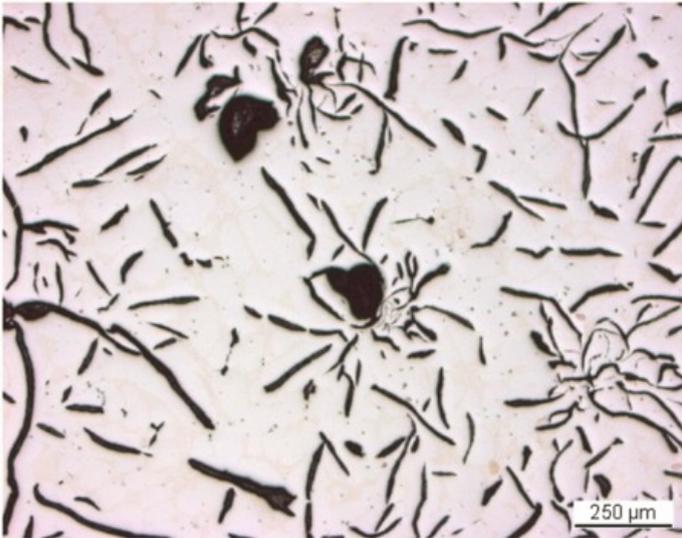
Fig. 5: Micrograph of the metal sample from Fig. 3 (inverted picture, detail), unetched, bright field. We observe graphite flakes and irregular nodules in black and the metal in white. The small grey spots are manganese sulphide inclusions,

The remaining metal is a high P and Si grey cast iron with elevated Mn and V contents (Tables 1 and 2). The structure contains black graphite flakes and graphite nodules (Fig. 5) as well as angular grey manganese sulphide inclusions which can contain a dark alumina-rich centre (Fig. 5 and Table 1). The graphite flakes are irregular and vary in size. At low magnification the flakes are evenly spread over the entire surface with a tendency to form clusters. Some porosity is noticeable. Under SEM, in the BSD-mode, an additional eutectic phase is visible (Fig. 6). After etching one can see how the graphite is surrounded by alpha-iron in a pearlite matrix (Figs. 7 and 8). The lamellar pearlite includes steadite (Fe₃P) and manganese sulphide (MnS) inclusions. According to the cast iron diagram after Maurer (Bargel and Schulze 2008, 257), the structure is typical for a hypoeutectic pearlitic grey cast iron (C content <4.3 mass%, Si content ca. 2.0 mass%) including pearlite, steadite and graphite. The slow cooling rate and the higher Si level have favoured the formation of graphite. The high P content favours the growth of interconnected networks of steadite. The average hardness of the metal is HV1 160. This hardness is only approximate. Normally cast iron hardness is determined with a Brinell test, but due to the small size of the sample this could not be carried out. The calculated HB is about 150.

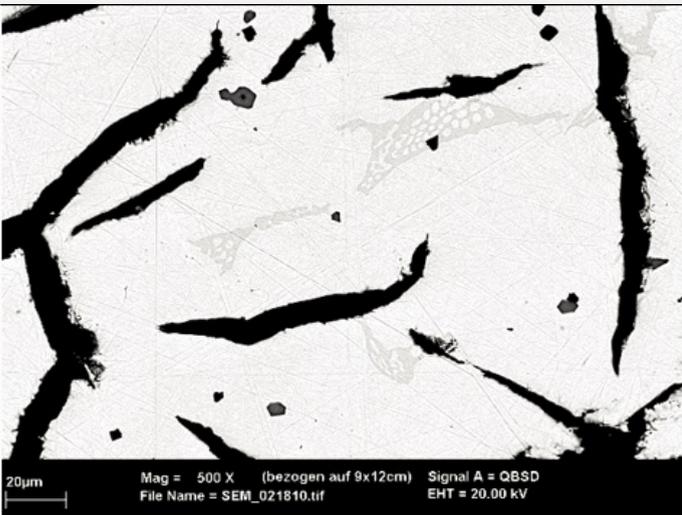
Fig. 6: SEM image from Fig. 3 (detail), BSE-mode, unetched. We observe the graphite flakes in black, the manganese sulphide inclusions in grey and the eutectic mixture in light-grey,

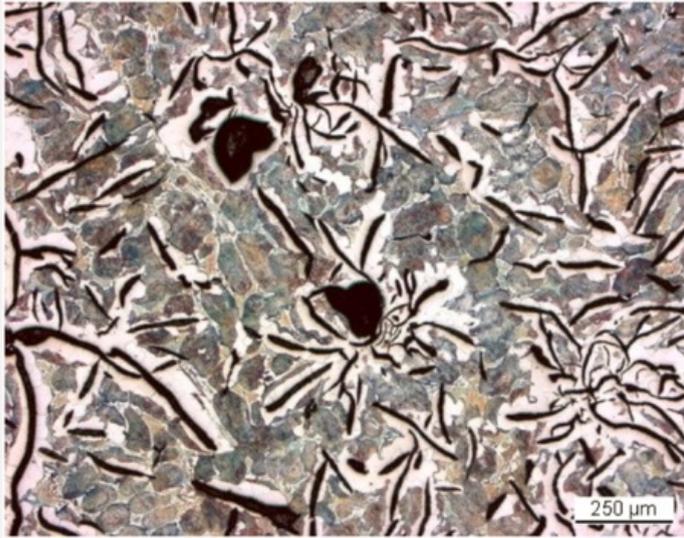
Fig. 7: Micrograph (same as Fig. 5), etched, bright field. In between the black graphite flakes we observe alpha-iron in white and pearlite / steadite in grey,

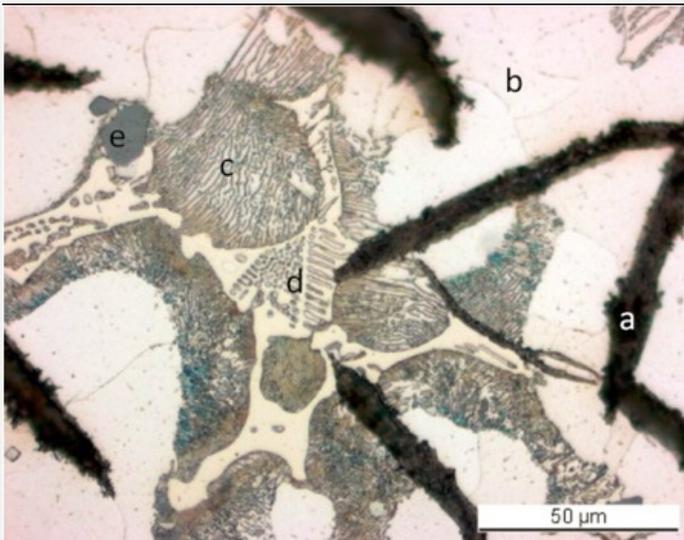
Fig. 8: Micrograph of the metal sample from Fig. 3 (detail), etched, bright field. The structure is composed of graphite (a), ferrite (b), pearlite (c), steadite (d) and MnS inclusions (e),

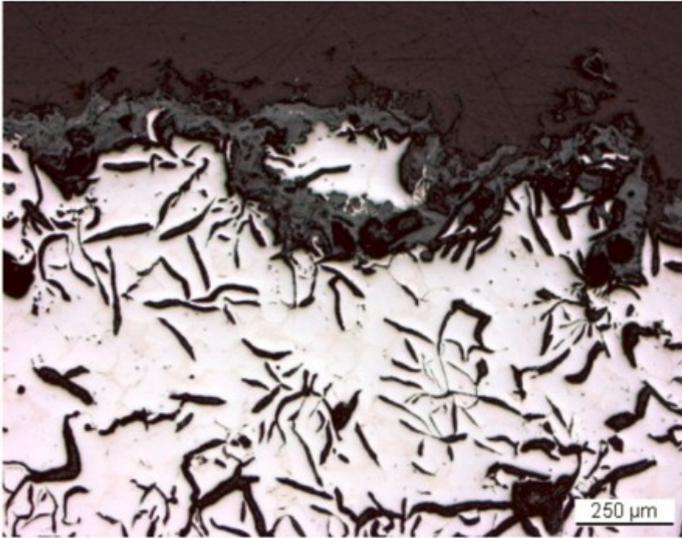
Fig. 9: Micrograph showing the metal - corrosion layer interface from Fig. 3 (inverted picture, detail), unetched, bright field. We observe in white the metal, in light-grey the corrosion layer, in black the graphite flakes,

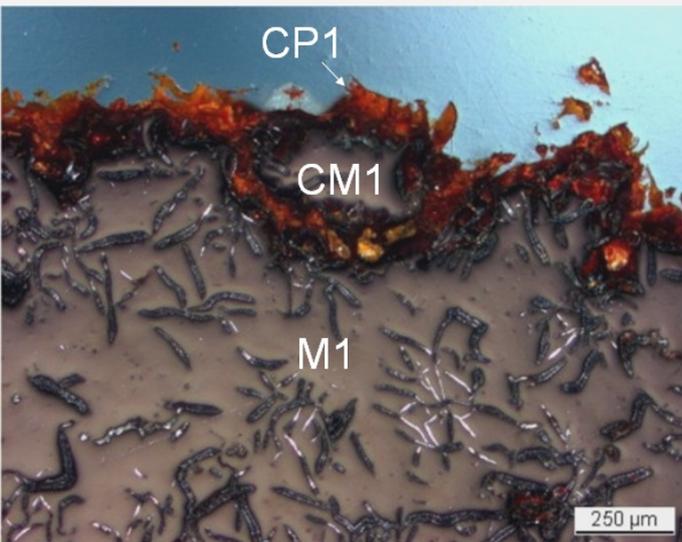
Fig. 10: Micrograph (same as Fig. 9) corresponding to the stratigraphy of Fig. 4, unetched, polarised light. We observe in violet the metal, in orange the corrosion, in blue the resin,

Fig. 4: Stratigraphic representation of an unpainted section of the fragment in cross-section (dark field) using the MiCorr application. The characteristics of the strata are only accessible by clicking on the drawing that redirects you to the search tool by stratigraphy representation. This representation can be compared to Fig. 10, Credit HE-Arc CR.

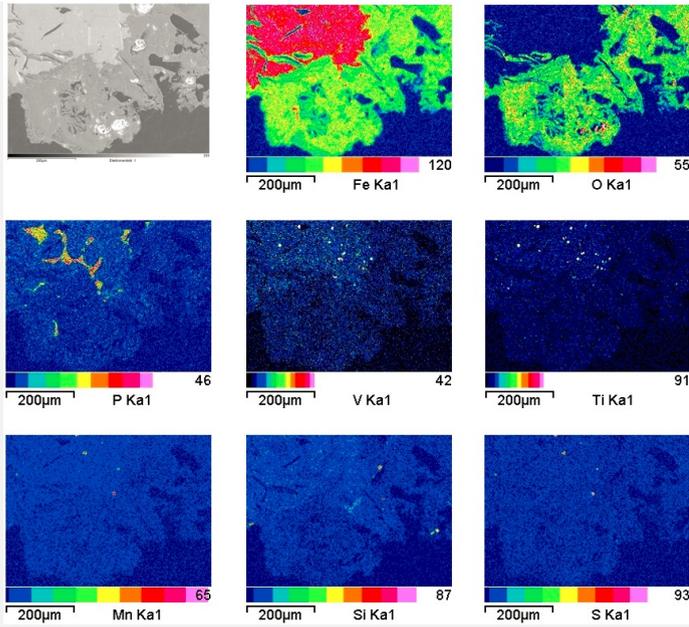
Fig. 11: SEM image, SE-mode, and elemental chemical distribution of the selected area from Fig. 3 (detail). Method of examination: SEM/EDS, Laboratory of Analytical Chemistry, Empa,

Table 3: Chemical composition (mass %) of the corrosion layer (from Figs. 11 and 12). Method of analysis: SEM/EDS, Laboratory of Analytical Chemistry, Empa.

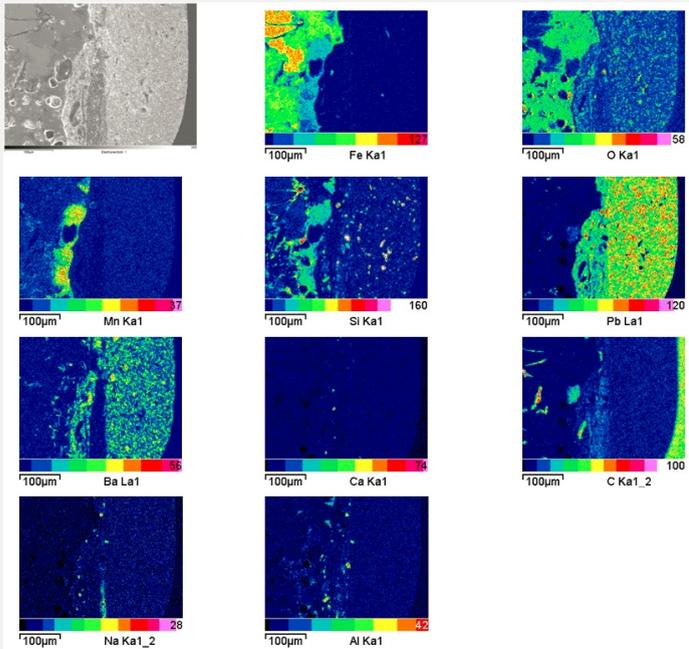
Fig. 12: SEM image, SE-mode, and elemental chemical distribution of the selected area from Fig. 3 (detail). Method of examination: SEM/EDS, Laboratory of Analytical Chemistry, Empa,

Elements	O	Mg	Si	P	S	Mn	Fe	Ba	Pb	Total
Inner light-grey corrosion layer (Fig. 12)	20	<	<	<	<	1.3	76	<	<	98

Dark-grey casting skin (Fig. 12)	27	<	14	<	<	21	33	<	<	95
Paint system (Fig. 12)	20	<	<	<	<	<	<	18	55	93
Grey corrosion layer (Fig. 11)	35	<	1.1	<	0.6	<	59	<	<	97
