# FRAGMENT OF THE SUPPORT STRUCTURE OF AN ENGINE VHS-404 – GREY CAST IRON – MODERN TIMES

Artefact name	Fragment of the support structure of an engine VHS-404
Authors	Marianne. Senn (EMPA, Dübendorf, Zurich, Switzerland) & Christian. Degriigny (HE-Arc CR, Neuchâtel, Neuchâtel, Switzerland)
Url	/artefacts/702/

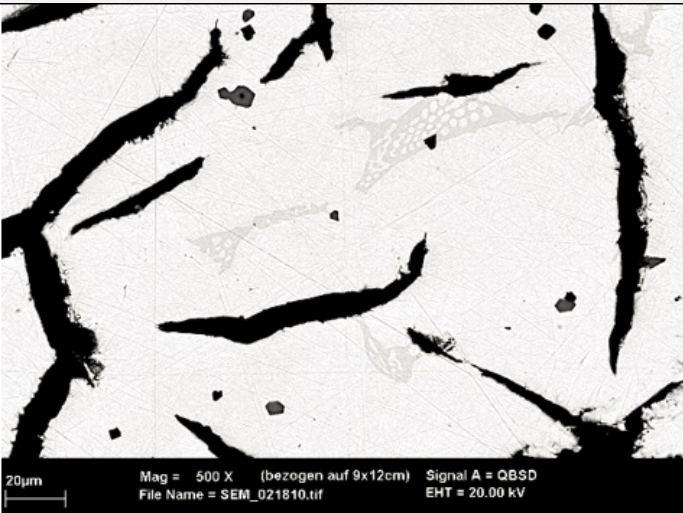
Fig. 6: SEM image from Fig. 3 (detail), BSE-mode, unetched. We observe the graphite flakes in black, the manganese sulphide inclusions in grey and the eutectic mixture in light-grey,
