FITTING ON BACK PANEL OF A MILITARY CARRIAGE – THOMAS STEEL – MODERN TIMES – SWITZERLAND

Artefact name	Fitting on back panel of a military carriage
Authors	Marianne. Senn (Empa, Dübendorf, Zurich, Switzerland) & Christian. Degriigny (HE-Arc CR, Neuchâtel, Neuchâtel, Switzerland)
Url	/artefacts/899/

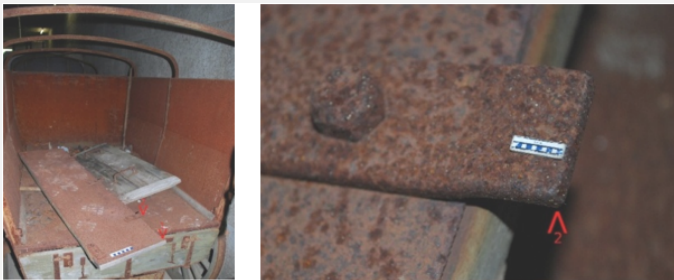
Fig. 1: Fitting on back panel of a military carriage,

Description of the artefact	Fitting on back panel, first exposed outdoors, later indoors (Fig. 1). Uniform corrosion and pitting corrosion are visible.
Type of artefact	Military carriage
Origin	Swiss Army, Thun, Bern, Switzerland
Recovering date	Built by Konstruktions-Werkstätte, 1918
Chronology category	Modern Times
chronology tpq	1918 A.D. ▼
chronology taq	---- ▼
Chronology comment	
Burial conditions / environment	Outdoor to indoor atmosphere
Artefact location	Historical Swiss Army Material Foundation, Burgdorf, Bern

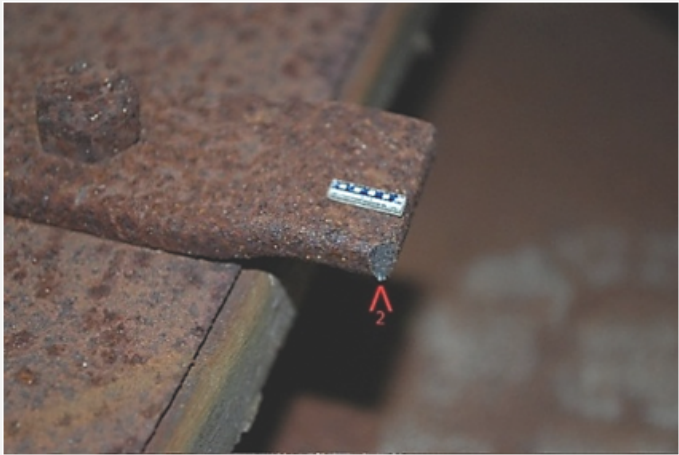
Fig. 2: Location of sampling area,

Description of sample	This sample is a cut from the corner of one of the two fittings on the back panel (Fig. 2). The metal is covered by a thin corrosion layer (Fig. 3).
Alloy	Thomas steel
Technology	Piled from several strips, hot rolled and annealed
Lab number of sample	POINT-Fe2
Sample location	HE-Arc CR, Neuchâtel, Neuchâtel
Responsible institution	Historical Swiss Army Material Foundation, Burgdorf, Bern
Date and aim of sampling	05/2009 metallography
