BRACELET BUS-NA 98 BZ 23 - BRONZE - IRON AGE - SWITZERLAND

Artefact name Bracelet bus-na 98 BZ 23

Authors Christian. Degrigny (HE-Arc CR, Neuchâtel, Neuchâtel, Switzerland) & Naima. Gutknecht (HE-Arc CR, Neuchâtel, Neuchâtel, Switzerland) & Valentina. Valbi (Laboratoire Métallurgie et Culture LMC-IRAMAT-CNRS-UTBM, Belfort, Franche-Comté, France)

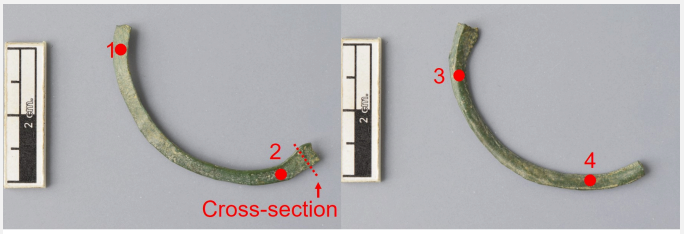
Fig. 1: Bracelet bus-na 98 BZ 23 (side A) from Bussy/Pré de Fond (Switzerland),

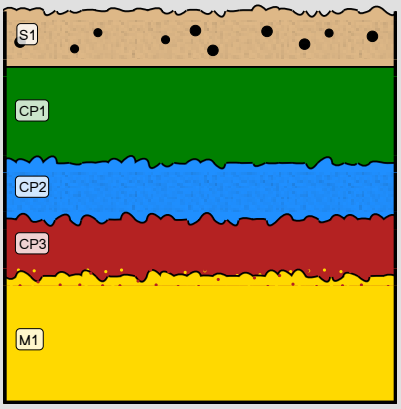
The transition between CP3 and the metal M1 is irregular and rough.

Fig. 3: Stratigraphic representation of the corrosion structure of the bracelet by macroscopic and binocular observation,

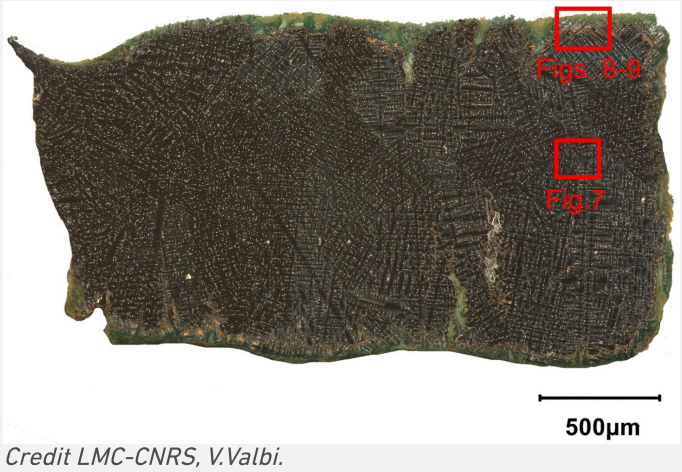
Fig. 5: Micrograph of the cross-section of the sample taken from the bracelet (Fig. 2) in dark field showing the location of Fig. 7 to 9,

Description of sample	The cross-section corresponds to a lateral cut (Fig. 2) and is representative of the entire thickness of the bracelet's body. A metallic core is present below the corrosion layers (Fig. 6).
Alloy	Bronze
Technology	As-cast
Lab number of sample	ébauche 23
Sample location	Archaeological Service of the Fribourg Canton, Fribourg

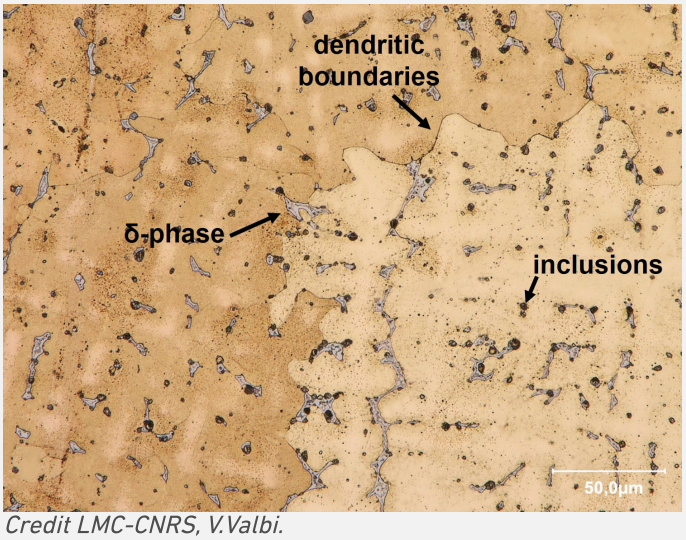
The metal has a dendritic structure (Fig. 6). Different dendritic grains are observed (with boundaries visible on Fig. 7).
The α phase constitutes the dendrites, the α+δ phase (grey) is observed in interdendritic areas.

Fig. 6: Micrograph of the etched cross-section of the sample taken from the bracelet (Fig. 2) in bright field,

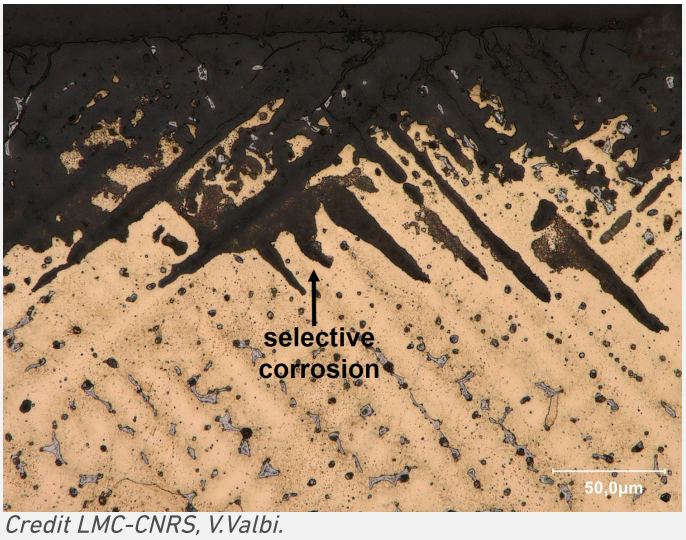
Small Pb inclusions (2-3 µm, Fig. 7) are homogeneously distributed on the whole surface of the sample.

Fig. 7: Micrograph of the metal sample from Fig. 5 (detail), etched, bright field, dendritic structure. Presence of grey Sn-rich α+δ phase and black Pb inclusions,

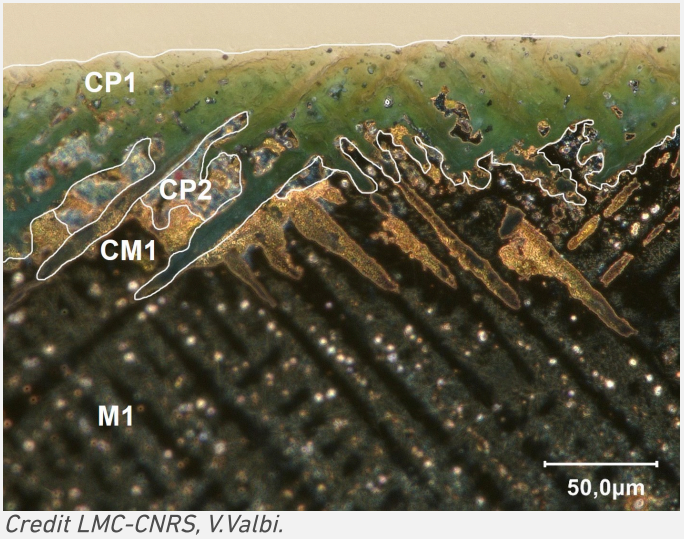
Selective corrosion of the α phase is locally observed following the dendritic microstructure (Fig. 8).

Fig. 8: Micrograph of the metal sample from Fig. 5 (detail), etched, bright field, showing the presence of selective corrosion,

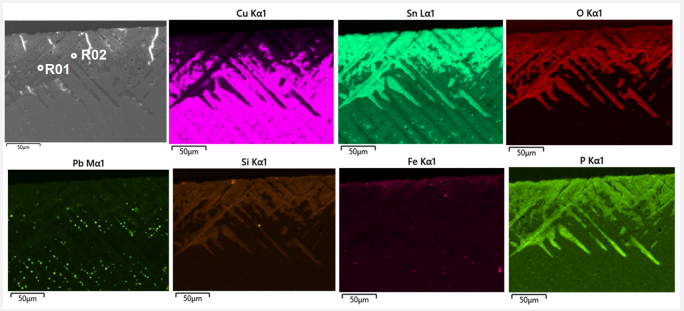
The observation of the sample in cross-section in dark field (Figs. 5 and 9) allowed to identify an external continuous green stratum (CP1), a red discontinuous thin stratum (CP2) and a corroded metal area (CM1) with an interface following the metal dendritic structure. The EDX elemental analysis (Table 4) and mapping (Fig. 10) of the visually identified CPs show that CP1 is Cu depleted, O and Sn enriched and polluted with Si, Ca, Fe and P. No EDX analysis is available for CP2. These results are in agreement with the preliminary XRF analysis.

Fig. 9: Micrograph of the corrosion structure from Fig. 5 (detail): green external CP1, red/gold CP2 following the dendritic structure,

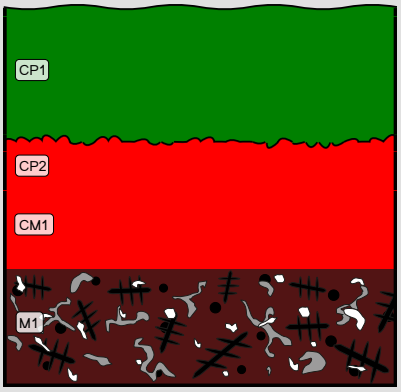
Fig. 12: Stratigraphic representation of the sample of the bracelet observed in cross-section under dark field using the MiCorr application. The characteristics of the strata are only accessible by clicking on the drawing that redirects you to the search tool by stratigraphy representation. This representation was build according to Fig. 9, Credit LMC-CNRS, V.Valbi.

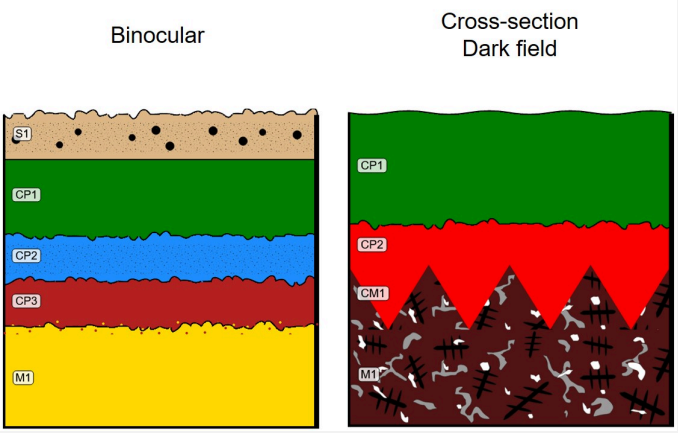
One S and three CPs were identified by binocular observation, while two CPs and a CM were observed in cross-section. It is reasonable to say that the CP1 and CP2 observed in binocular observation correspond to the CP1 observed in cross-section. In fact, in cross-section it is also possible to observe a different shade of green (yellowish) on the outer part of the CP1 that can justify the documentation of two different strata by the conservator. However the difference in color does not correspond in this case to a significant chemical difference, so it was identified as only one stratum in CS. The CP3 layer identified by binocular observation corresponds to the CP2 identified as cuprite in cross-section.

Fig. 13: Stratigraphic representation side by side of binocular view and cross-section (dark field),
