BRACELET BUS-NA 98 BZ 67 - BRONZE - IRON AGE - SWITZERLAND

Artefact name Bracelet bus-na 98 BZ 67

Authors Naima. Gutknecht (HE-Arc CR, Neuchâtel, Neuchâtel, Switzerland) & Valentina. Valbi (Laboratoire Métallurgie et Culture LMC-IRAMAT-CNRS-UTBM, Belfort, Franche-Comté, France)

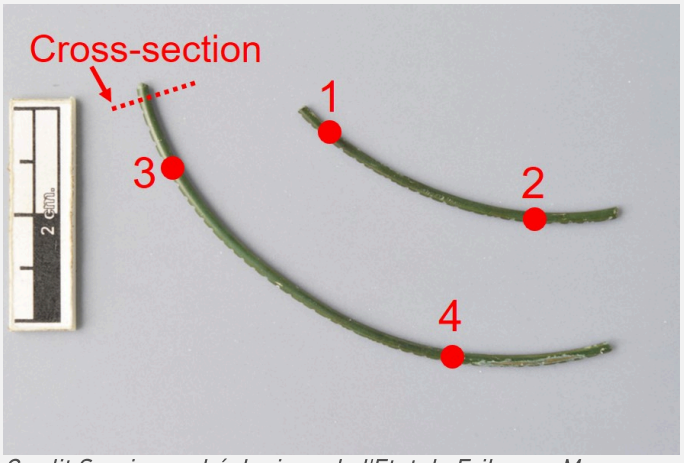
Fig. 1: Two fragments of a bracelet from Bussy/Pré de Fond (Switzerland),

Description of the artefact Fragments of a bracelet with curvature (Fig. 1); internal surface of the curvature with a central rib and hammer marks; external surface of the curvature with decorative incisions; round section.

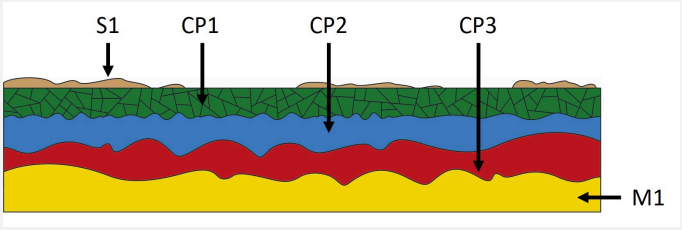
Strata	Type of stratum	Principal characteristics
S1	Soil	light yellow, thin, non-compact, powdery
CP1	Corroded product	dark green, thick, discontinuous, compact, hard, network cracks
CP2	Corroded product	dark blue, thin, discontinuous, non-compact, very soft
CP3	Corroded product	dark red, thin, continuous, compact, soft
M1	Metal	yellow, metallic, compact, soft

The transition between CP3 and the metal M1 is irregular. CP1 shows a network of cracks on the whole stratum.

Fig.3: Stratigraphic representation of the corrosion structure of the bracelet by macroscopic and binocular observation,

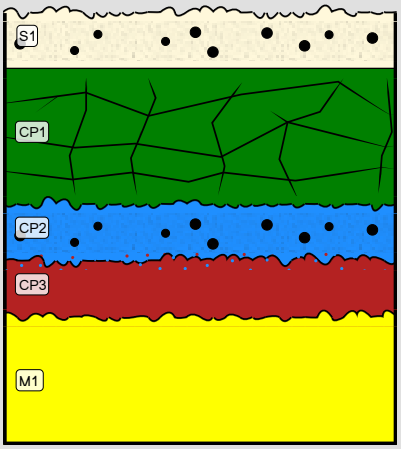
Fig. 4: Stratigraphic representation of the corrosion structure of the bracelet observed macroscopically under binocular microscope using the MiCorr application with reference to the whole Fig. 3. The characteristics of the strata are only accessible by clicking on the drawing that redirects you to the search tool by stratigraphy representation, Credit HE-Arc CR, N.Gutknecht.

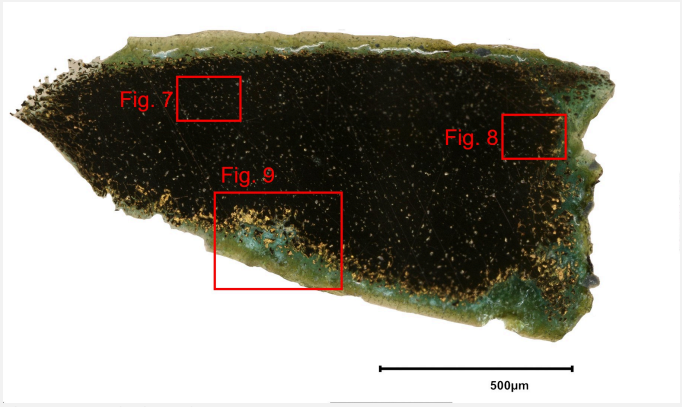
Fig. 5: Micrograph of the cross-section of the sample taken from the bracelet (Fig. 2) in dark field showing the location of Figs. 7 to 9,

Description of sample	The cross-section corresponds to a lateral cut (Fig. 2) and is representative of the entire thickness of the bracelet's body. A metallic core is present below the corrosion layers (Fig. 6)
Alloy	Bronze
Technology	Cold worked with repeated annealing and final cold working
Lab number of sample	ébauche 67
Sample location	Archaeological Service of the Fribourg Canton, Fribourg

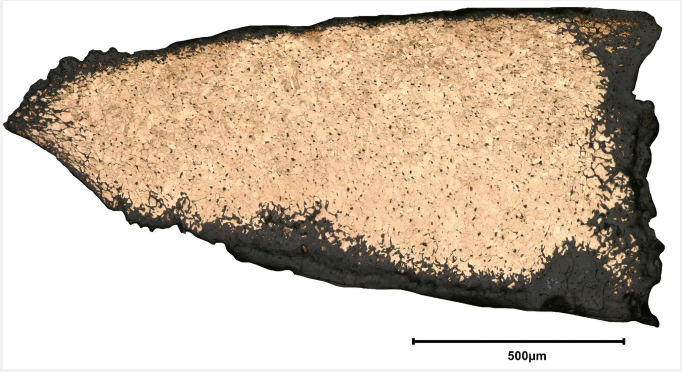
Elements	mass %
Cu	81
Sn	13.9
Pb	4.0
As	<0.5
Ni	<0.5
Si	<0.5

Table 3: Chemical composition of the alloy over a general area of analysis obtained by SEM-EDX.

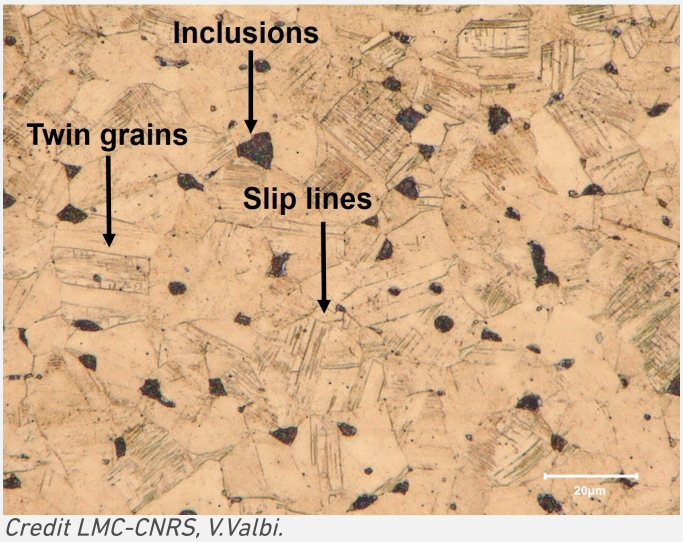
and 8) caused by cold mechanical working of the metal after annealing. Numerous lead inclusions (Figs. 7 and 10) of dimension of around 10 µm are homogeneously distributed on the whole surface of the sample. Intergranular corrosion is observed (Figs. 6 and 8).

Fig. 6: Micrograph of the etched cross-section of the sample taken from the bracelet (Fig. 2) in bright field,

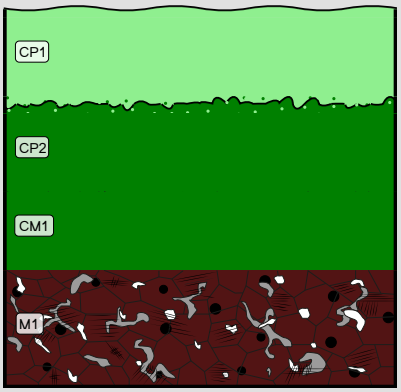
Fig. 12: Stratigraphic representation of the sample observed in cross-section under dark field using the MiCorr application. The characteristics of the strata are only accessible by clicking on the drawing that redirects you to the search tool by stratigraphy representation. This representation was build according to Fig. 9, Credit LMC-CNRS, V.Valbi.

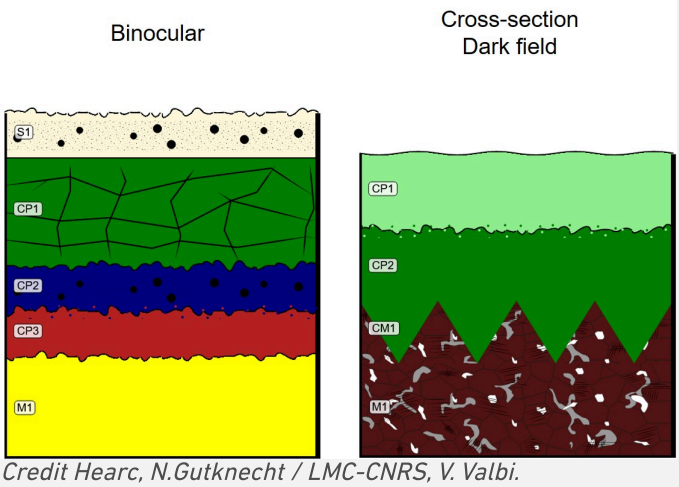
The CP1 and CP2 observed in binocular observation correspond to the CP1 and CP2 observed in cross-section. The internal CP3 layer identified by binocular observation was not observed in cross-section. This could be explained by a discontinuous CP3 strata on the object.

The outer sediment layer (S1), easily identified under binocular, was not visible in the cross-section. On the contrary, the presence of a CM1 stratum was only revealed through cross-section observation. Moreover, information obtained under binocular examination such as brightness, compactness, cohesion, and adherence are not accessible during cross-sectional observation. Conversely, the physico-chemical characteristics obtained by cross-section examination are not easily accessible during the binocular examination. The differences observed underline the necessity and complementarity of these two approaches.

Fig. 13: Stratigraphic representation side by side of binocular view and cross-section (dark field),
