BRACELET BUS-NA 98 BZ 38 - BRONZE - IRON AGE - SWITZERLAND

Artefact name Bracelet bus-na 98 BZ 38

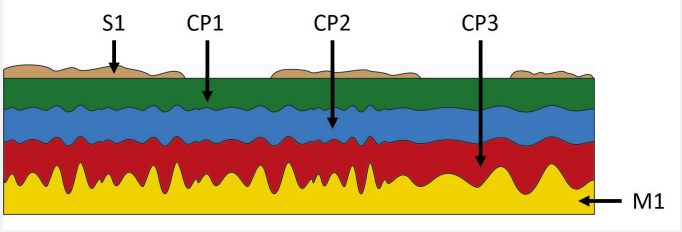
Strata	Type of stratum	Principal characteristics
S1	Soil	light brown, thin, non-compact, powdery
CP1	Corroded product	dark green, medium, continuous, compact, soft
CP2	Corroded product	blue, thin, continuous, compact, very soft
CP3	Corroded product	red, thin, continuous, compact, hard
M1	Metal	dark yellow, metallic, hard

The transition between CP3 and the metal M1 is irregular.

Fig. 3: Stratigraphic representation of the corrosion structure of the bracelet by macroscopic and binocular observation,

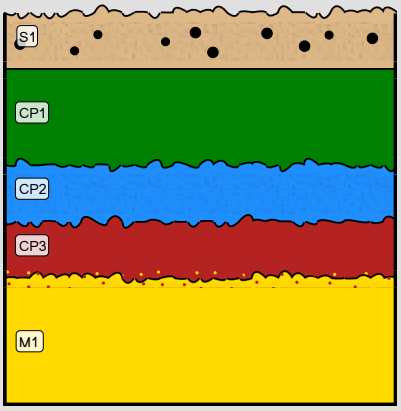
Fig. 4: Stratigraphic representation of the corrosion structure of the bracelet observed macroscopically under binocular microscope using the MiCorr application with reference to the whole Fig. 3. The characteristics of the strata are only accessible by clicking on the drawing that redirects you to the search tool by stratigraphy representation, Credit HE-Arc CR, N.Gutknecht.

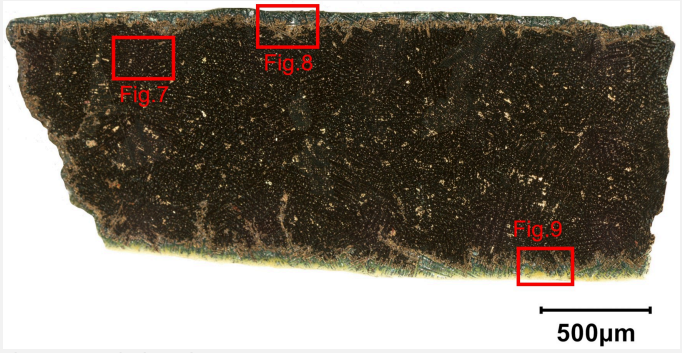
Fig. 5: Micrograph of the cross-section of the sample taken from the bracelet (Fig. 2) in dark field showing the location of Figs. 7 to 9,

Description of sample	The cross-section corresponds to a lateral cut (Fig. 2) and is representative of the entire thickness of the bracelet's body. A metallic core is present below the corrosion layers (Fig. 6).
Alloy	Bronze
Technology	As-cast
Lab number of sample	ébauche 38
Sample location	Archaeological Service of the Fribourg Canton, Fribourg
Responsible institution	Archaeological Service of the Fribourg Canton, Fribourg

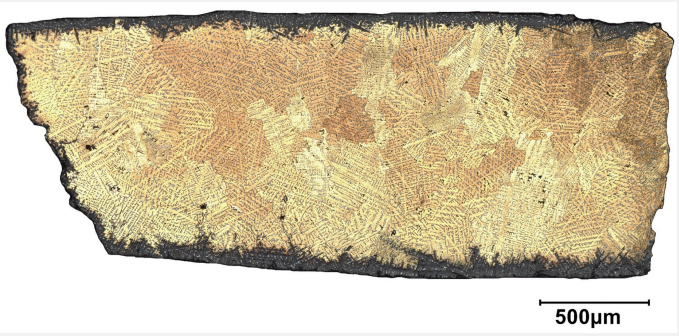
Table 3: Chemical composition of the alloy over a general area of analysis obtained by SEM-EDX.

EDX analysis of the residual metal on cross-section indicates that it is a high tin bronze (16% Sn) (Table 3).
The metal has a dendritic structure (Fig. 6). Boundaries are visible between the dendrites (Fig. 7). The α phase constitutes the dendrites, the α+δ phase (grey) is observed in interdendritic areas.
Small Pb inclusions (2-3 µm, Fig. 7) are homogeneously distributed on the whole surface of the sample.

Elements	mass %
Cu	82
Sn	16
Pb	0.5
Ni	<0.5
As	<0.5
Si	<0.5

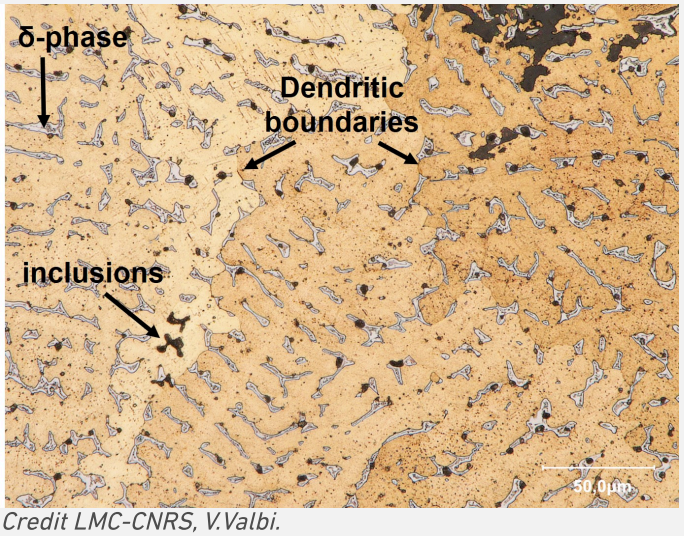
Fig. 6: Micrograph of the etched cross-section of the sample taken from the bracelet (Fig. 2) in bright field,

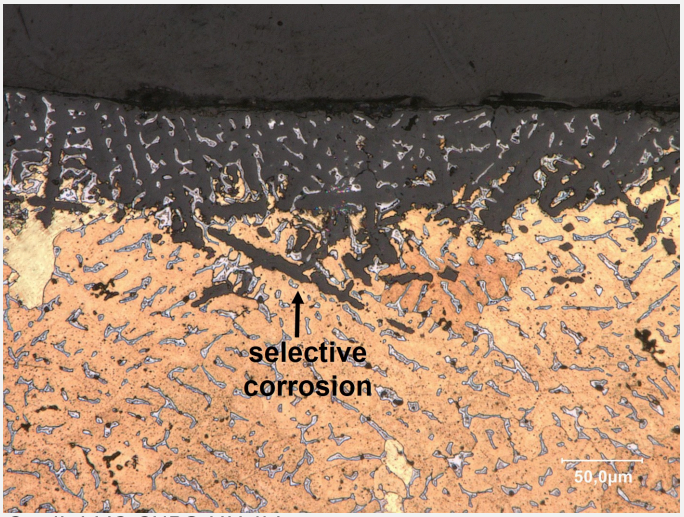
Fig. 7: Micrograph of the metal sample from Fig. 5 (detail), etched, bright field, dendritic structure. Presence of grey Sn-rich α+δ phase and black Pb inclusions,

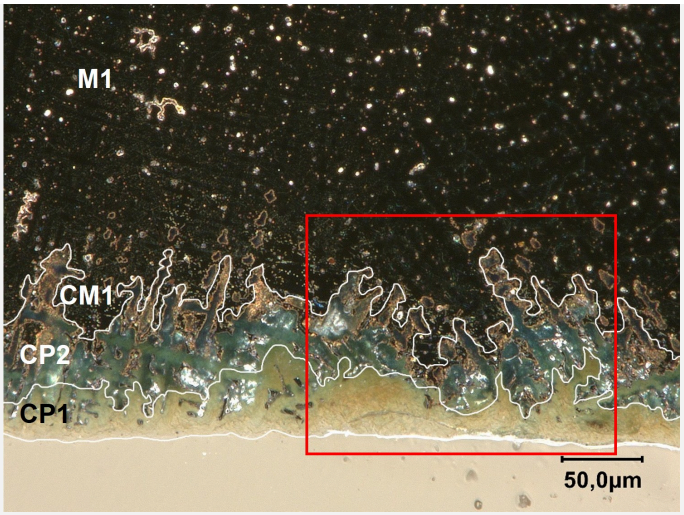
Selective corrosion of the α phase is locally observed following the dendritic microstructure (Fig. 8).

Fig. 8: Micrograph of the metal sample from Fig. 5 (detail), etched, bright field, showing the presence of selective corrosion,

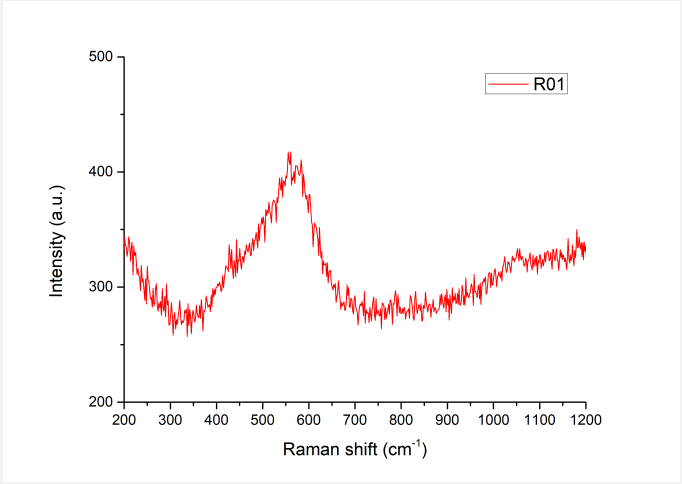
Analyses with µ-Raman were performed on the identified strata (Fig. 10). The R01 point of analysis was performed on the green layer and the spectrum obtained has a broad peak at 560 cm^{-1} that can be attributed to nanocrystals of cassiterite Sn_2O thanks to comparison with the work of Ospitali et al. 2012 (Fig. 11).

Fig. 10: SEM image, BSE-mode, and elemental chemical distribution of the selected area. The selected points for Raman analysis shown in Fig. 11 are indicated,

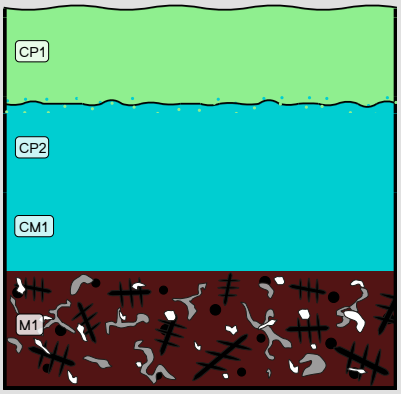
Fig. 12: Stratigraphic representation of the sample of the bracelet observed in cross-section under dark field using the MiCorr application. The characteristics of the strata are only accessible by clicking on the drawing that redirects you to the search tool by stratigraphy representation. This representation was build according to Fig. 9, Credit LMC-CNRS, V.Valbi.

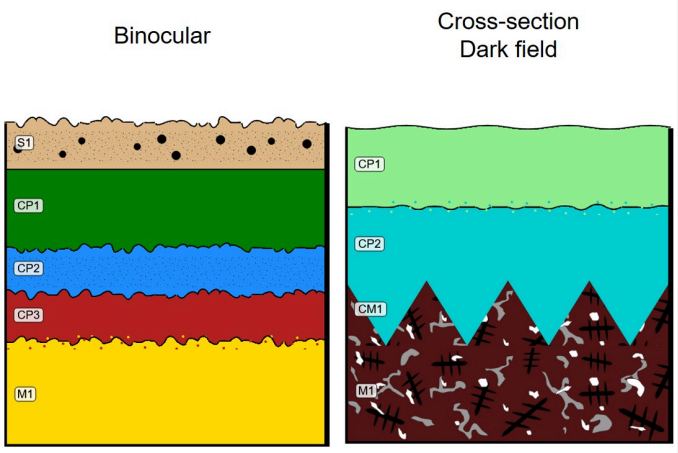
One S1 and three CPs were identified by binocular observation, while two CPs and a CM1 were observed in cross-section.

The CP1 and CP2 observed in binocular observation correspond to the CP1 and CP2 observed in cross-section. The internal CP3 layer identified by binocular observation was not observed in cross-section. This could be explained by a discontinuous CP3 strata on the object.

Fig. 13: Stratigraphic representation side by side of binocular view and cross-section (dark field),
