BRACELET BUS-NA 98 BZ 11 - BRONZE - IRON AGE - SWITZERLAND

Artefact name Bracelet bus-na 98 BZ 11

Authors Christian. Degrigny (HE-Arc CR, Neuchâtel, Neuchâtel, Switzerland) & Naima. Gutknecht (HE-Arc CR, Neuchâtel, Neuchâtel, Switzerland) & Valentina. Valbi (Laboratoire Métallurgie et Culture LMC-IRAMAT-CNRS-UTBM, Belfort, Franche-Comté, France)

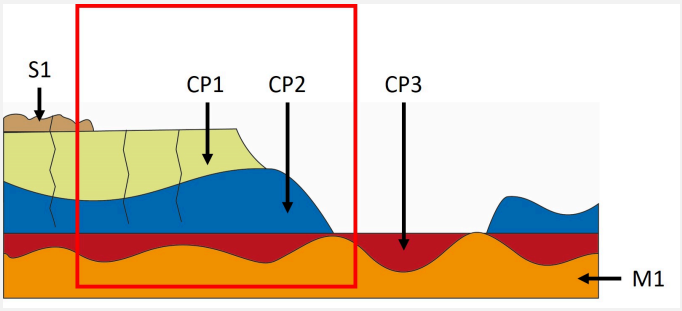
Fig. 4: Stratigraphic representation of the corrosion structure of the bracelet by macroscopic and binocular observation with indication of the corrosion structure used to build the MiCorr stratigraphy of Fig. 5 (red square),

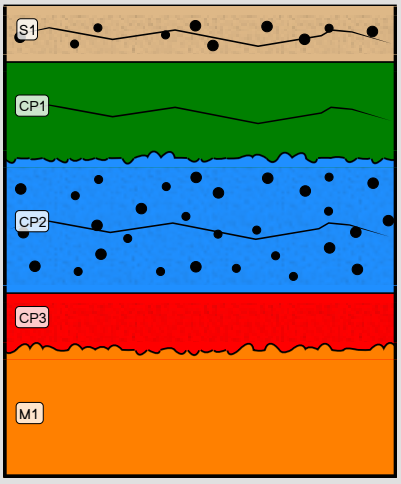
Fig. 5: Stratigraphic representation of the corrosion structure of the bracelet observed macroscopically under binocular microscope using the MiCorr application with reference to Fig. 4. The characteristics of the strata are only accessible by clicking on the drawing that redirects you to the search tool by stratigraphy representation, Credit HE-Arc CR, N.Gutknecht.

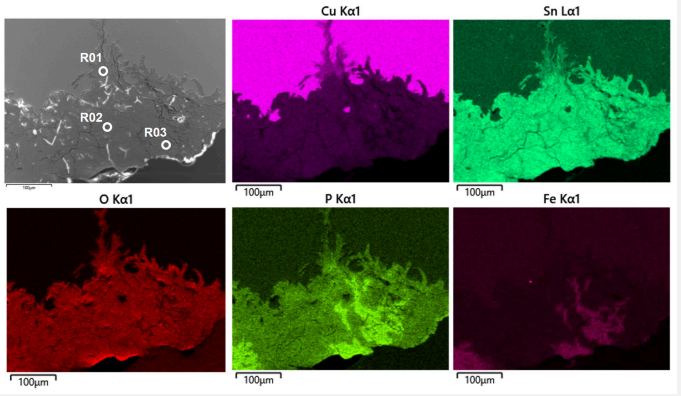
The EDX elemental analysis (Table 4) and mapping (Fig. 11) of the visually identified CPs by binocular and cross-sectional observations show that CP1 is Cu depleted, O, Sn and Pb enriched and polluted with Ca, Fe and P, while CP2 is also Cu depleted and O and Sn-rich but with fewer external polluting elements and CP3 is Cu rich. The results are in agreement with those of the preliminary XRF analysis (table 2), with the exception of aluminum and bismuth which

Fig. 11: SEM image, BSE-mode, and elemental chemical distribution of Fig.10. The selected points for Raman analysis shown in Fig. 12 are indicated,

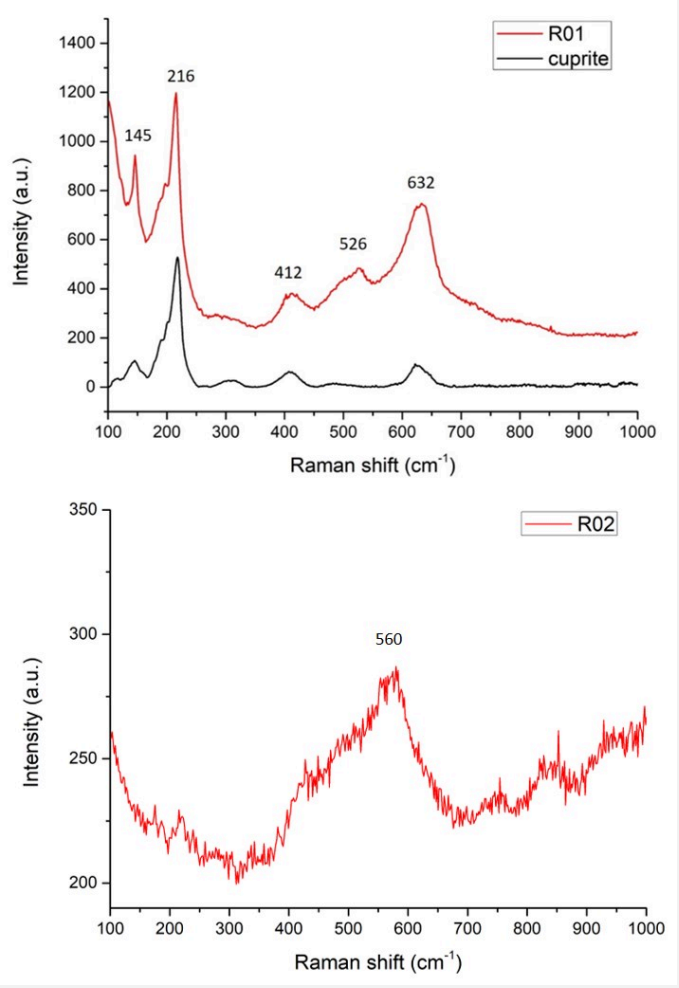
Analyses with µ-Raman were performed on the three identified strata (Fig. 11). The R01 (Fig. 12) point of analysis was performed on the red CP3 layer and the obtained spectrum presented the typical main peaks (145, 218, 632 cm^{-1}) of the Raman RUFF reference spectrum of cuprite Cu_2O (Lafuente et al. 2015). The R02 point of analysis was performed on the blue layer and the spectrum obtained has a broad peak at 560 cm^{-1} that can be attributed to nanocrystals of cassiterite Sn_2O thanks to comparison with the work of Ospitali et al. 2012. The R03 analysis point performed on the green/yellow external phase was too disturbed by fluorescence signal and an identification of the phase was impossible. The blue color of CP2 is probably caused by residual Cu ions, while the greenish/yellowish color of CP1 is given by the presence of Fe ions.

Fig. 12: Raman spectra of points R01 (together with the RRUFF reference RRUFFID=R140763 for cuprite) and R02 showed in Fig. 11,

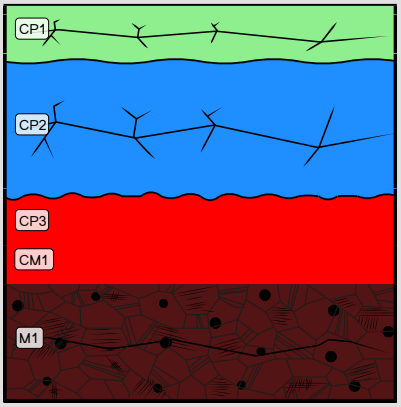
Fig. 13: Stratigraphic representation of the sample of bracelet observed in cross-section under dark field using the MiCorr application. The characteristics of the strata are only accessible by clicking on the drawing that redirects you to the search tool by stratigraphy representation. This representation was build according to Fig. 10, Credit LMC-CNRS, V.Valbi.
