TANG FRAGMENT OF A KNIFE HR-6246 - TIN BRONZE - LATE BRONZE AGE - SWITZERLAND

Artefact name	Tang fragment of a knife HR-6246
Authors	Marianne. Senn (Empa, Dübendorf, Zurich, Switzerland) & Christian. Degrigny (HE-Arc CR, Neuchâtel, Neuchâtel, Switzerland) & Naima. Gutknecht (HE-Arc CR, Neuchâtel, Neuchâtel, Switzerland) & Rémy. Léopold (HE-Arc CR, Neuchâtel, Neuchâtel, Switzerland)
Url	/artefacts/1038/

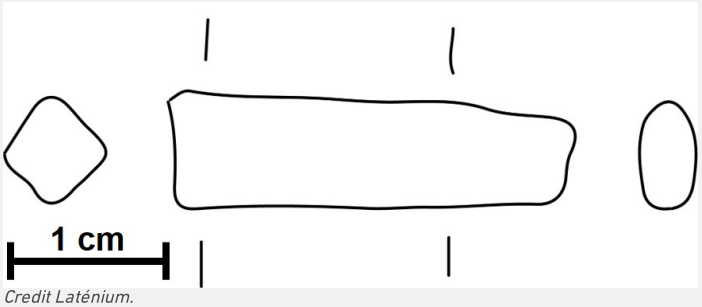
Fig. 1: Tang fragment of a knife (after Rychner-Faraggi 1983, plate 35.35),

Fig. 2: Shiny yellow and green-blue corrosion products on the surface of the tang fragment of a knife,

Description of the artefact	Tang fragment of a knife with shiny yellow and green-blue corrosion products (Figs. 1 & 2). Dimensions: L = 2.7cm; Ø = around 5mm; WT = 5.8g.
Type of artefact	Household implement
Origin	Hauterive - Champréveyres, Neuchâtel, Neuchâtel, Switzerland
Recovering date	Excavation 1983-1985, object from layer 1 (layer with material from Bronze Age till 20th cent.)
Chronology category	Late Bronze Age
chronology tpq	1050 B.C.
chronology taq	800 B.C.
Chronology comment	Hallstatt A/B

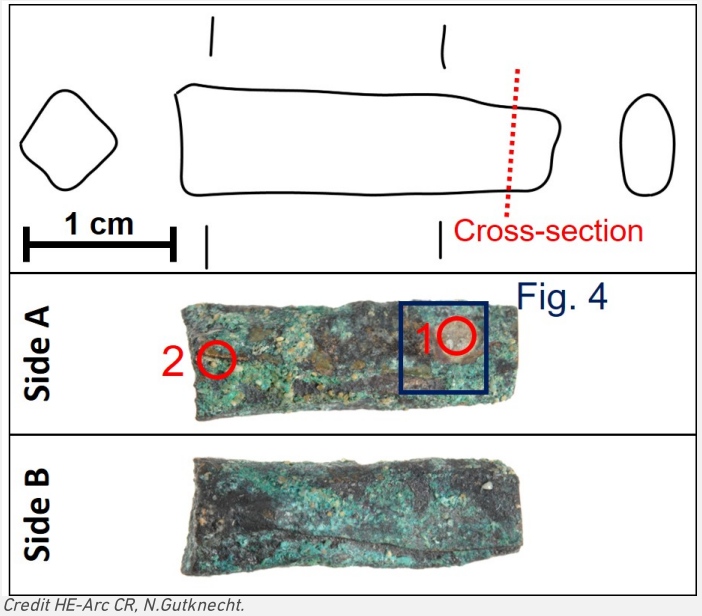
Fig. 3: Location of the cross-section before sampling and both sides of the fragment not sampled with location of the detail of Fig. 4 (blue square) and XRF analysis areas (red circles),

XRF analyses of the tang fragment were carried out on two representative areas (Fig. 3). Point 1 was done in a lacuna of the green-blue corrosion layer, while point 2 was performed on a black corrosion layer (CP4) where all strata (soil, corrosion products, and metal) are analyzed at the same time.

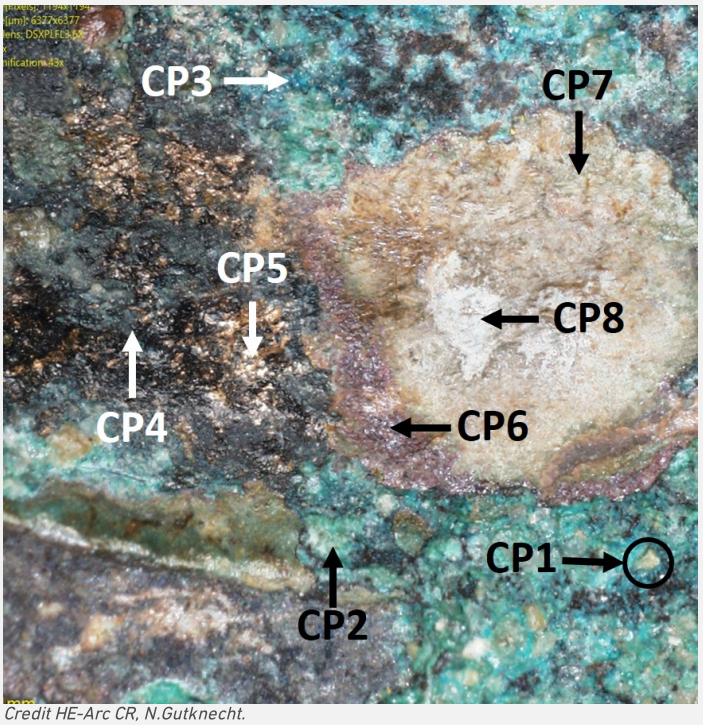
Fig. 4: Corrosion structure (detail) from Fig. 3 showing some of the documented strata,

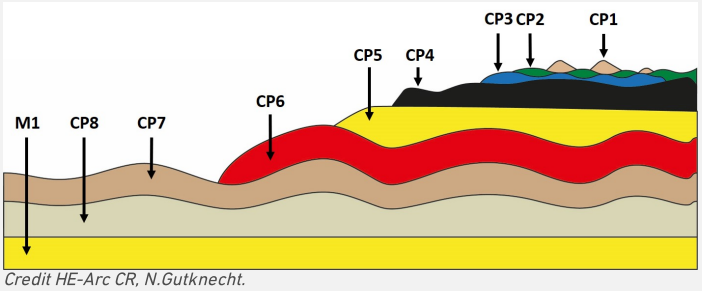
Fig. 5: Stratigraphic representation of the corrosion structure of the tang by macroscopic and binocular observation with reference to Fig. 4,

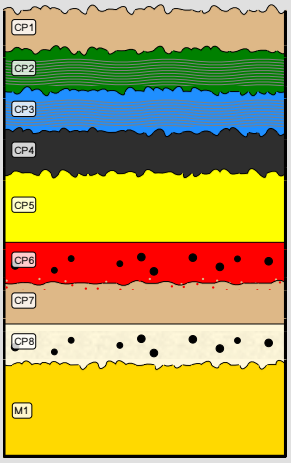
Fig. 6: Stratigraphic representation of the corrosion structure of the tang observed macroscopically under binocular microscope using the MiCorr application with reference to the whole Fig. 5. The characteristics of the strata, such as discontinuity, are accessible by clicking on the drawing that redirects you to the search tool by stratigraphy representation, Credit HE-Arc CR, N.Gutknecht,

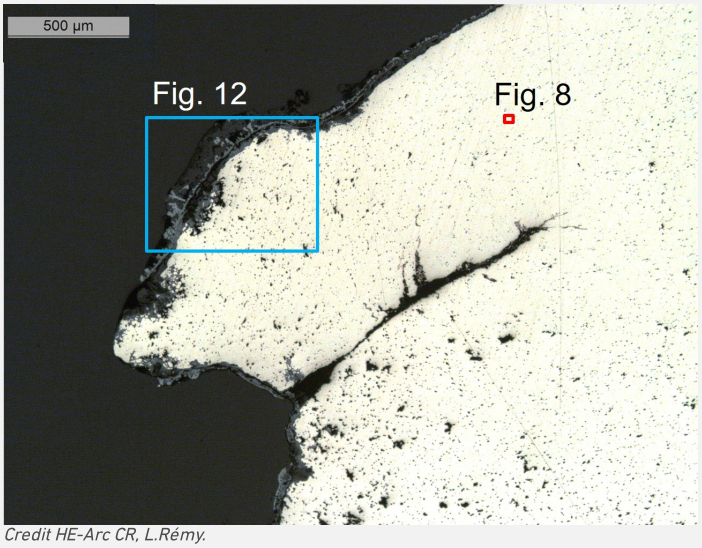
Fig. 7: Micrograph from an area of the cross-section of the sample taken from the tang fragment with location of Fig. 8 (red square) and Fig. 12 (blue square), unetched, bright field,

Description of sample	The cross-section corresponds to a lateral cut (Fig. 3). The surface is covered with a thick corrosion layer but part of it has gone (Fig. 7).
Alloy	Tin Bronze
Technology	Cold worked with partial annealing
Lab number of sample	MAH 87-197
Sample location	Musées d'art et d'histoire, Genève, Geneva
Responsible institution	Musées d'art et d'histoire, Genève, Geneva
Date and aim of sampling	1987, metallography and corrosion characterisation

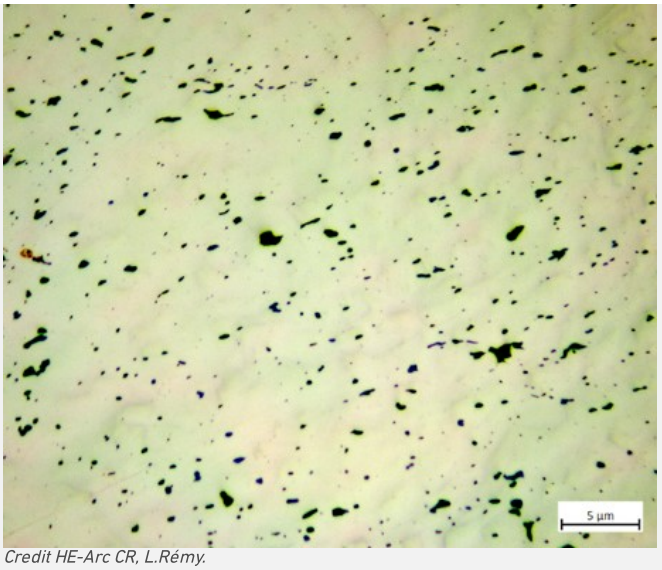
Fig. 8: Detail of the metal from Fig. 7, unetched, bright field,

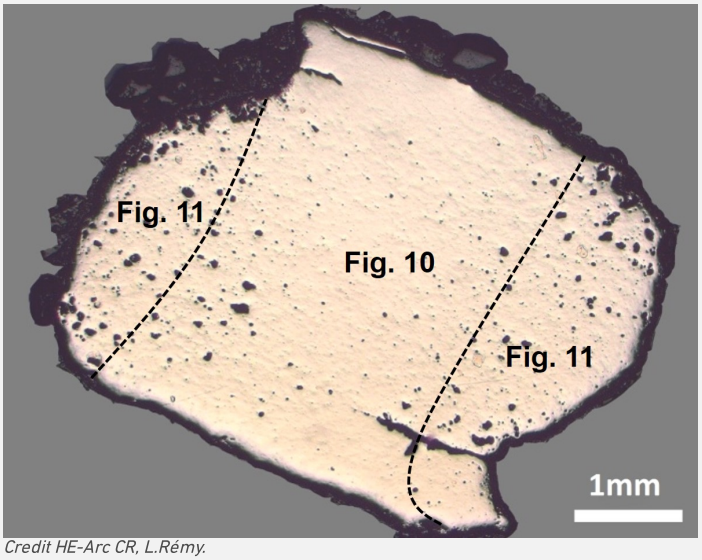
The remaining metal is a tin bronze (Table 3) with high porosity (Figs. 7-9) and large cracks both on the left and right edges of the sample (Fig. 9). The metal contains small, elongated copper sulphide (Table 4) and Pb inclusions. The etched metal shows three zones with a core where elongated grains and slip lines are visible indicating cold working without annealing (Figs. 9-10), while annealing appears on both external sides (Fig. 9-11). The average hardness of the metal is HV1 145, but significant variations are observed, depending on where the measurements are taken.

Fig. 9: Micrograph of the cross section of the tang of a knife with three distinct zones: metal core with elongated grains and slip lines (Fig. 10) and external sides with polygonal grains and twin lines (Fig. 11), unetched, bright field,

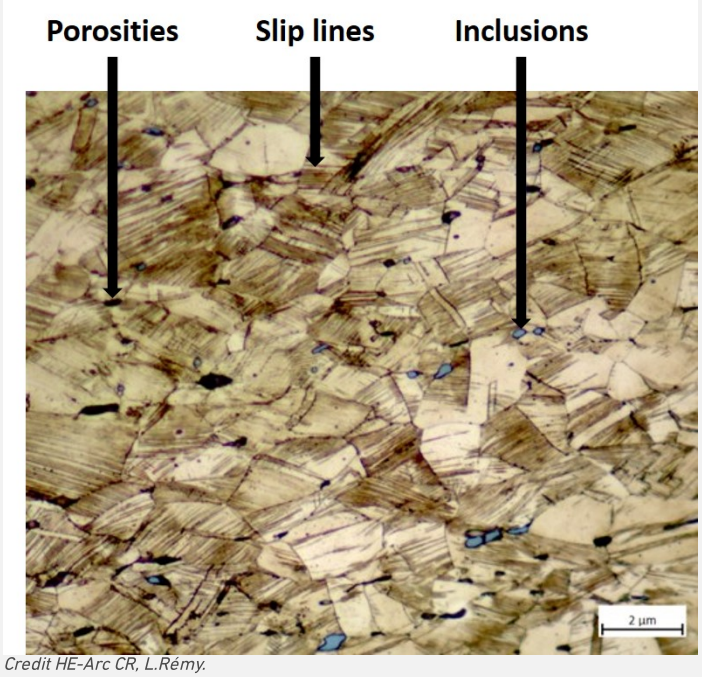
Fig. 10: Micrograph of the metal sample from Fig. 9 (detail), etched, bright field. Elongated grains with slip lines are observed, as well as grey copper sulphide inclusions and dark porosities,

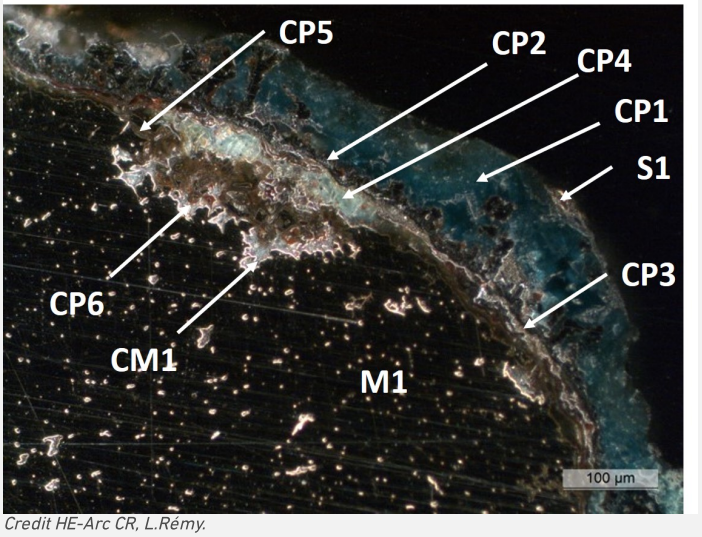
Fig. 13: Micrograph similar to Fig. 12, unetched, dark field and corresponding to the stratigraphy of Fig. 16,

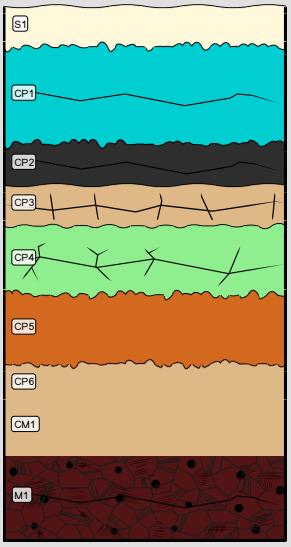
Fig. 16: Stratigraphic representation of the sample taken from the tang fragment in cross-section (dark field) using the MiCorr application. The characteristics of the strata are only accessible by clicking on the drawing that redirects you to the search tool by stratigraphy representation. This representation can be compared to Fig. 13, Credit HE-Arc CR, L.Rémy.

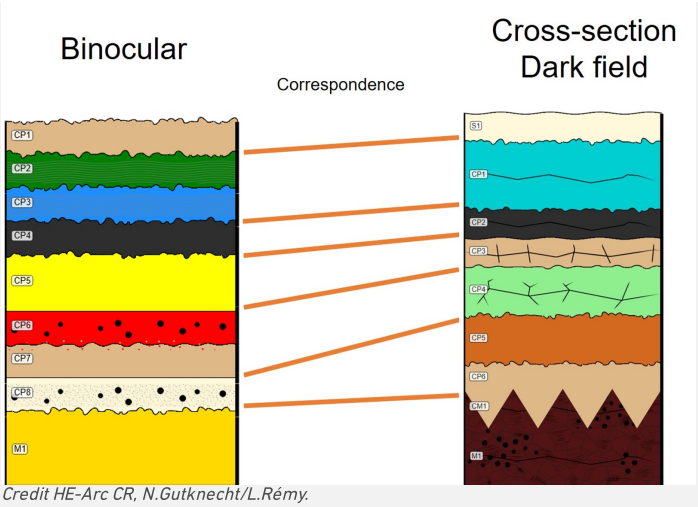
The following correspondence can be found: CP1 in binocular mode as sediment (S1) in cross-section mode. CP2 and CP3 in binocular mode are differentiated by their color. They match CP1 in cross-section mode. CP4 in binocular mode matches CP2 in cross-section mode. CP5 in binocular mode seems to match CP3 in cross-section mode. CP6 and CP7 in binocular mode match CP4 in cross-section mode. CP8 in binocular mode matches CP5, CP6 and CM1 in cross-section mode.

Fig. 17: Stratigraphic representation side by side of binocular view and cross-section (dark field),
