TANG FRAGMENT OF A KNIFE HR–6567 – LEADED BRONZE – LATE BRONZE AGE – SWITZERLAND

Artefact name	Tang fragment of a knife HR-6567
Authors	Marianne. Senn (Empa, Dübendorf, Zurich, Switzerland) & Christian. Degrigny (HE-Arc CR, Neuchâtel, Neuchâtel, Switzerland) & Naima. Gutknecht (HE-Arc CR, Neuchâtel, Neuchâtel, Switzerland) & Rémy. Léopold (HE-Arc CR, Neuchâtel, Neuchâtel, Switzerland)
Url	/artefacts/1039/

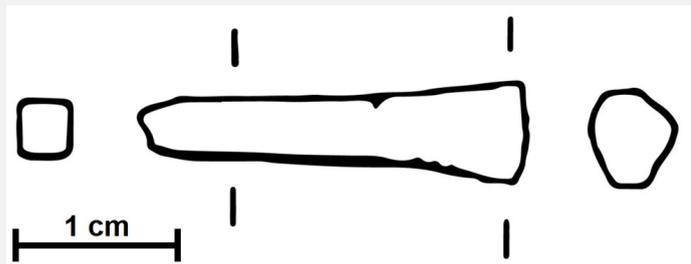
Fig. 1: Tang fragment of a knife (after Rychner-Faraggi 1983, plate 35.26),

Fig. 2: Dense and brown-yellow corrosion product (detail) of the tang fragment of a knife,

Description of the artefact	Tang fragment with shiny brown-yellow corrosion products still in place locally (Fig. 2). Dimensions: L = 2.9cm; Ømax. = 6.8mm; WT = 4.9g.
Type of artefact	Household implement
Origin	Hauterive - Champréveyres, Neuchâtel, Neuchâtel, Switzerland
Recovering date	Excavation in 1983-1985, layer 3
Chronology category	Late Bronze Age
chronology tpq	1054 B.C. ⌄
chronology taq	1000 B.C. ⌄
Chronology comment	Hallstatt B1 (1054/1037BC _ 1000BC)
Burial conditions / environment	Lake
Artefact location	Laténium, Neuchâtel, Neuchâtel
Owner	Laténium, Neuchâtel, Neuchâtel
Inv. number	HR 6567
Recorded conservation data	No conservation data available, but a coating and inventory number is visible on the surface.

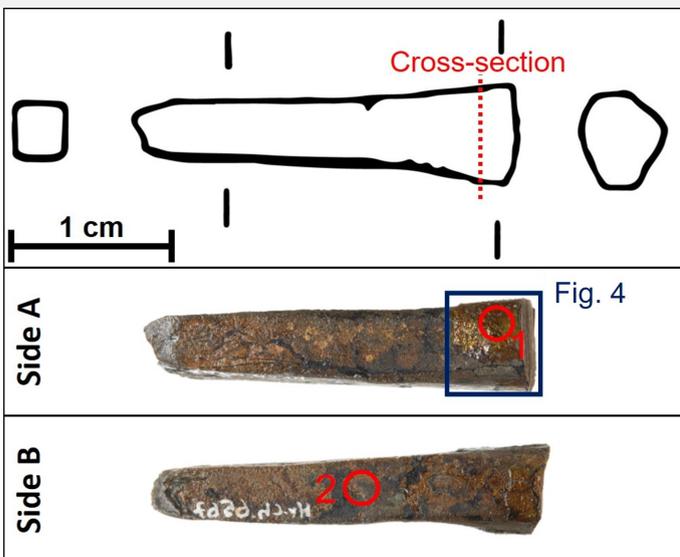
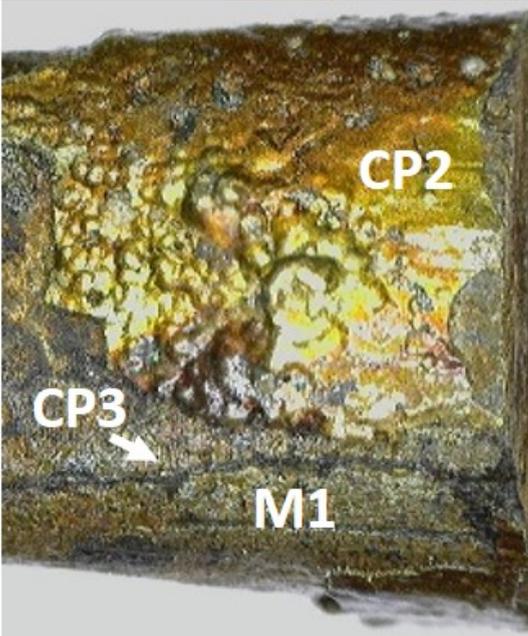
Fig. 3: Location of cross-section on drawing before sampling and both sides of fragment (after sampling) with location of the detail of Fig. 4 and XRF analysis areas (red circles),

Fig. 4: Corrosion structure (detail) from Fig. 3 showing some of the documented strata in Fig. 5,

XRF analyses of the tang fragment of a knife were carried out on two representative areas (Fig. 3). Point 1 was done on the dark yellow corrosion layer (CP2), while point 2 was performed on the remaining metal surface. For both points, soil, corrosion products and metal are analyzed at the same time.

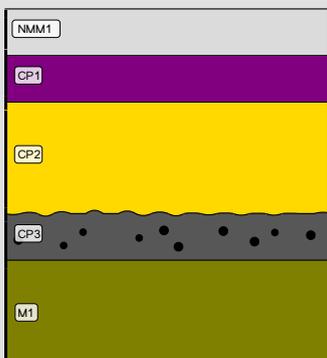
Fig. 6: Stratigraphic representation of the corrosion structure of the tang of a knife observed macroscopically under binocular microscope using the MiCorr application with reference to the whole Fig. 5. The characteristics of the strata, such as discontinuity, are accessible by clicking on the drawing that redirects you to the search tool by stratigraphy representation, Credit HE-Arc CR, N.Gutknecht.

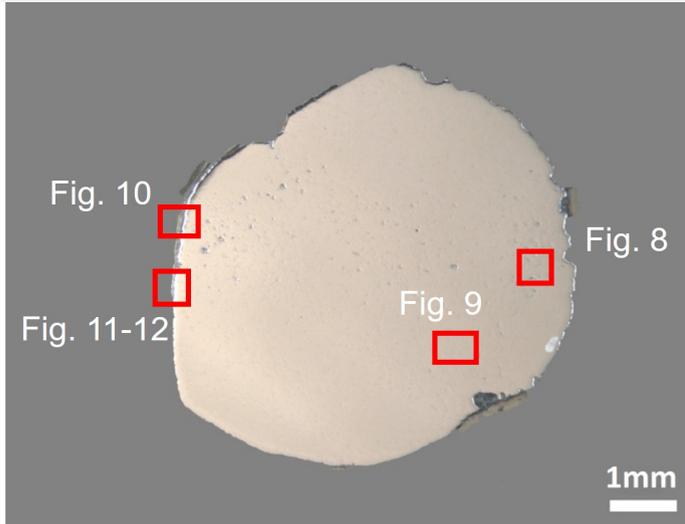
Fig. 7: Micrograph of the cross-section of the sample taken from the tang fragment of a knife showing the location of Figs. 8 to 12,

Description of sample	This cross-section shows a lateral cut through the tang (Fig. 3). Most of the corrosion structure is absent (Fig. 7).
Alloy	Leaded Bronze
Technology	Cold worked with partial annealing
Lab number of sample	MAH 87-196
Sample location	Musées d'art et d'histoire, Genève, Geneva
Responsible institution	Musées d'art et d'histoire, Genève, Geneva
Date and aim of sampling	1987, metallography and corrosion characterisation

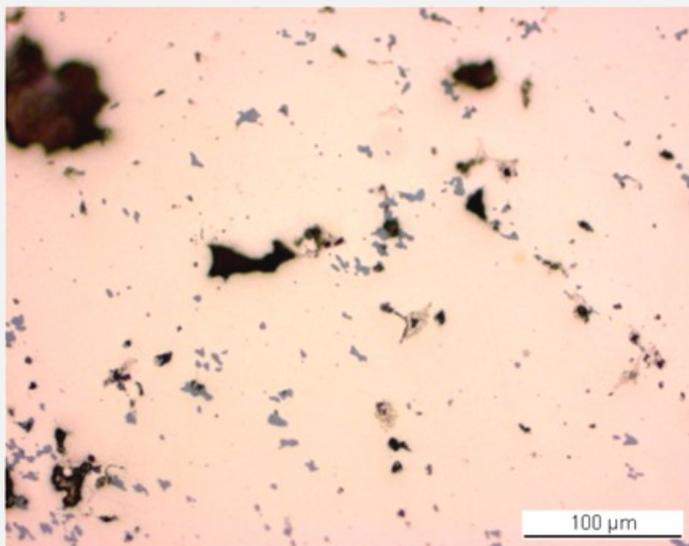
The remaining metal is a leaded bronze (Table 2) containing numerous copper sulphide and tiny Pb inclusions (Figs. 8-10, 12 and Table 4). The porosity within the metal is high, particularly along a band through the middle of the sample (Figs. 7 and 8). The etched structure of the leaded bronze shows small, regular polygonal grains, some with twinning (Fig. 9). Slip lines appear in grains close to the metal surface (Fig. 9). The average hardness of the metal is HV1 120.

Fig. 8: Micrograph of the metal sample from Fig. 7 (detail), unetched, bright field. In pink the metal, in black the porosity and in dark-grey copper sulphide inclusions,

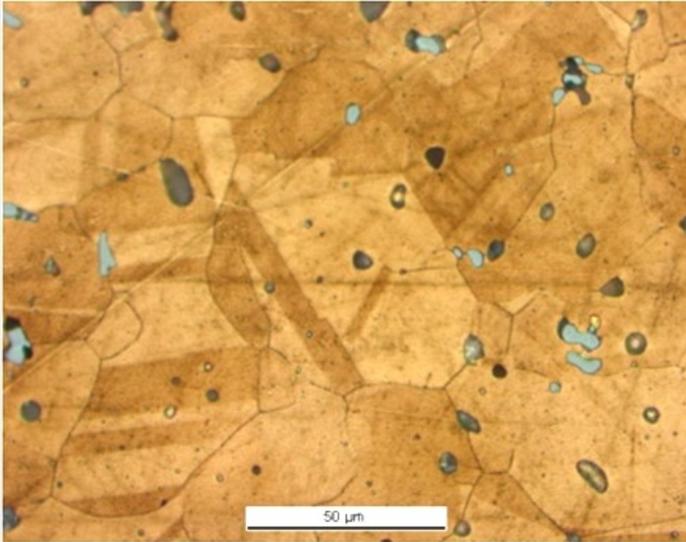
Fig. 9: Micrograph of the metal sample from Fig. 7 (detail), etched, bright field. Angular and twinned grains are revealed as well as copper sulphide inclusions in grey,

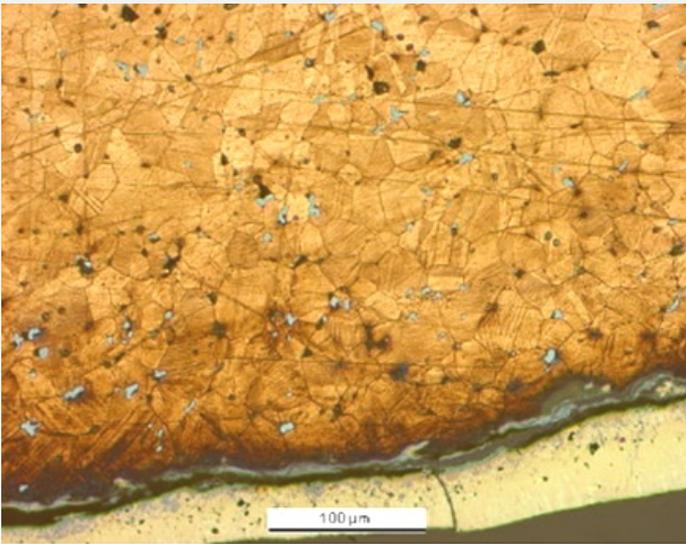
Fig. 10: Micrograph of the metal sample from Fig. 7, etched, bright field (rotated by 270°, detail). Angular grains with slip lines can be seen as well as copper sulphide inclusions in grey,

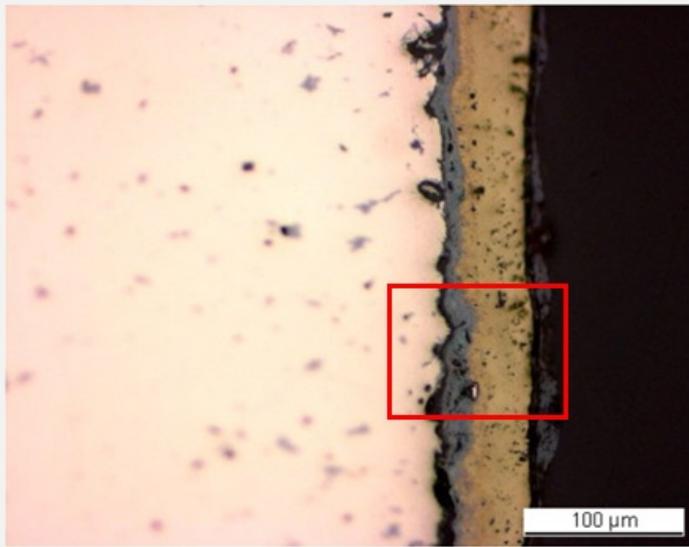
The metal has lost most of its original corrosion layer, the remainder having an average thickness between 60 and 190µm (Fig. 6). In some areas up to three corrosion strata are visible (Fig. 11). In polarised light (Fig. 12), the corrosion stratigraphy appears more clearly: it is composed of a dense black inner layer, an intermediate thick brown layer with bright spots (indicating porosity) and an outer red layer with white particles. The elemental chemical distribution of the SEM image reveals that the black inner layer (CP3) is Sn-rich, but contains Cu, O, Fe, Si, P, Pb, Ni, As, Ca and S (Table 5, Figs. 12-13). The brown layer (CP2) contains S, Fe and Cu and has a composition similar to chalcopyrite/$CuFeS_2$ (Table 5, Figs. 12-13). This was confirmed by past XRD analyses carried out by Schweizer (1994, museum report (1987)). The red layer (CP1) is an iron oxide (main elements Fe and O) and is contaminated with calcite/$CaCO_3$ particles (S1) (Table 5, Figs. 12-13).

Fig. 11: Micrograph of the metal sample from Fig. 7 (reversed picture, detail), unetched, bright field. From left to right: metal (in pink), inner light-grey layer, intermediate brown layer and top dark-grey layer. The area selected for elemental chemical distribution (Fig. 13) is marked by a red rectangle,

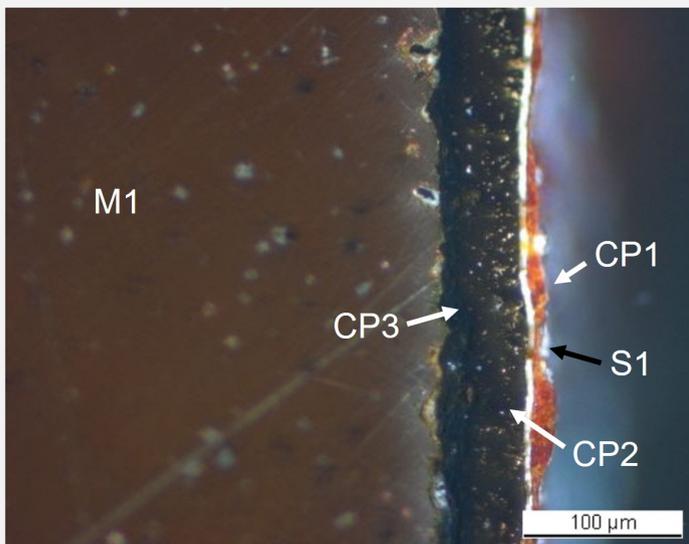
Fig. 12: Micrograph of the same area as Fig. 11 and corresponding to the stratigraphy of Fig. 14, polarized light. From left to right: metal (in brown) covered with a corrosion layer consisting of a black layer, an intermediate brown layer with bright spots, a crack (white line) and a red layer with white particles,

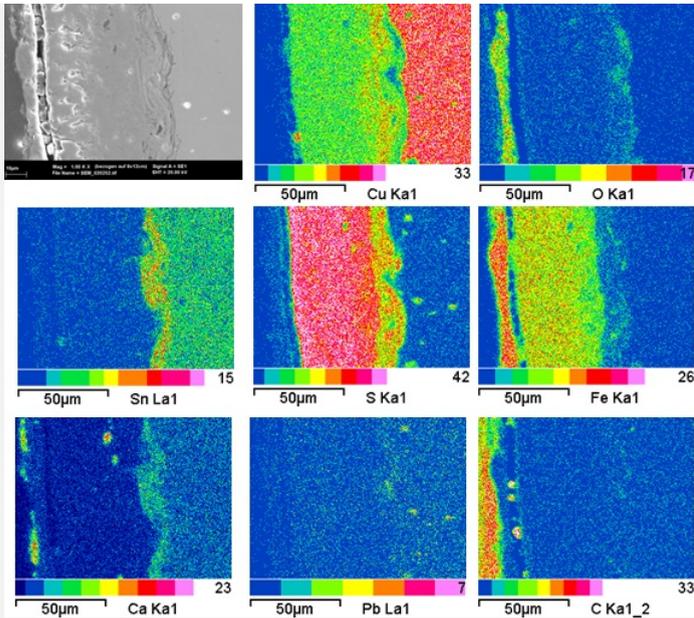
Fig. 13: SEM image, SE-mode, and elemental chemical distribution of the selected area of Fig. 11 (reversed picture). Method of examination: SEM/EDS, Laboratory of Analytical Chemistry, Empa,

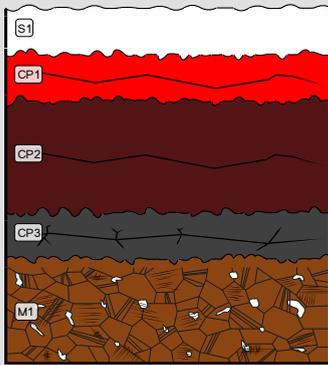
Fig. 14: Stratigraphic representation of the sample taken from the tang fragment of a knife in cross-section (dark field) using the MiCorr application. The characteristics of the strata are accessible by clicking on the drawing that redirects you to the search tool by stratigraphy representation. This representation can be compared to Fig. 12, Credit HE-Arc CR.

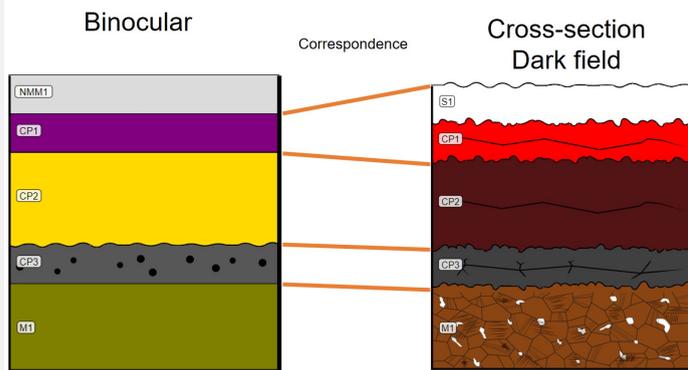
NMM1 in binocular mode is not observed in cross-section mode, as the cross-section does not show any coating.

CP1 in binocular mode is documented as sediment (S1) and CP1 in cross-section mode. But it is not clear if it matches the CP1 from cross-section, which is a Fe-rich layer, or if CP1 from binocular mode developed as an atmospheric corrosion after the excavation and is therefore not present on the embedded sample.

CP2 and CP3 in binocular mode match CP2 and CP3 in cross-section mode.

Fig. 15: Stratigraphic representation side by side of binocular view and cross-section (dark field),
