COATED LAMP POST(?) FRAGMENT - GREY CAST IRON - MODERN TIMES - SWITZERLAND

Artefact name	Coated lamp post(?) fragment
Authors	Christian. Degrigny (HE-Arc CR, Neuchâtel, Neuchâtel, Switzerland) & Mathea. Hovind (University of Oslo, Department of archaeology, conservation and history (IAKH-UiO), Oslo, Oslo, Norway)
Url	/artefacts/1049/

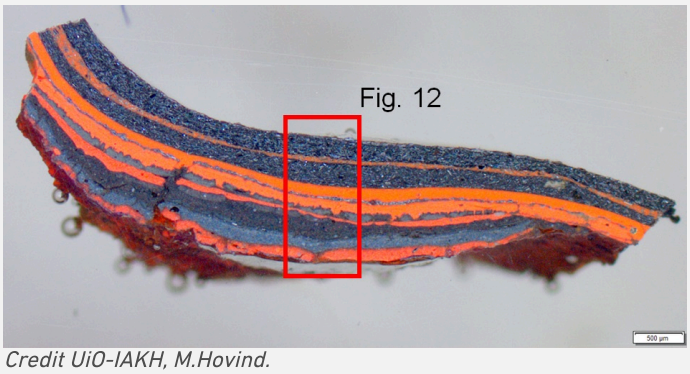
Fig. 4: Micrograph of the sample taken from the lamp post (?) fragment showing the locations of Figs. 6, 8 and 9. The coated surface (NMM) appears light grey,

Description of sample	The sample (Fig. 4) was cut out from one of the profiles of the lamp post (?) fragment (Fig. 2). Its vertical surface corresponds to the rear (non-painted) surface, while the top surface contains three layers of paint. The lower surface is where the sample was cut. The paint flake (Fig. 5) corresponds to the coating that covers the entire fragment. Its location in relation to the remaining artefact is not known, it is however considered to be representative of the overall surface of the object.
Alloy	Grey cast iron
Technology	As-cast
Lab number of sample	CCI2018 (Coated Cast Iron) and CCIP2018 (Coated Cast Iron Paint flake)
Sample location	HE-Arc CR, Neuchâtel, Neuchâtel
Responsible institution	HE-Arc CR, Neuchâtel, Neuchâtel
Date and aim of sampling	March 2018, study of corrosion stratigraphy and elementary analyses

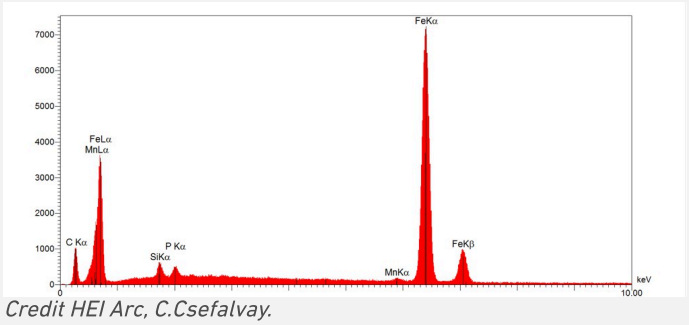
The metal is a grey cast iron with characteristic graphite flakes (Fig. 6). It contains C in addition to P, Mn and some Si (Fig. 7). Its matrix consists of a P-rich eutectoid and a dendritic phase; the latter containing a significant amount of C, but less P than the aforementioned eutectoid (Table 1).

Fig. 6: Micrograph of the metal sample from Fig. 4 (detail), unetched, bright field. The microstructure of the metal consists of graphite flakes in a matrix of dendrites (light grey) and an interdendritic eutectoid phase (light brown). The global analysis of the metal (Fig. 7) was carried out on a surface area of similar size,

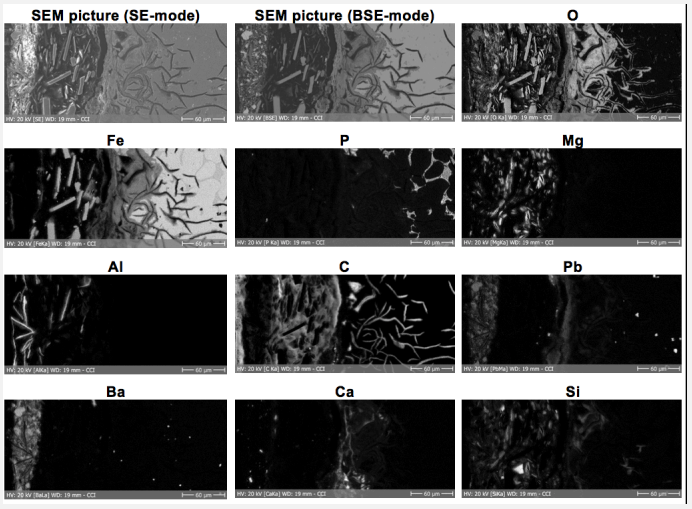
The metal is covered by a coating of alternating layers of paint (appearing light grey, black and bright orange under polarized light, NMM1-NMM3 in Fig. 8). Local analyses by SEM-EDS (Table 2) as well as elemental mapping (Fig. 10) reveal that the light grey layer (NMM1) contains a considerable amount of Ba in addition to S, Si and Al. The black layer (NMM2) contains Fe, Si, Mg and Al. The latter is visible as rectangular flakes (see NMM2 in Fig. 9). This layer could consist of Al flakes and FeO in an organic binder (C and O). The underlying, bright orange layer (NMM3) contains Fe and O in addition to a considerable amount of Pb, some Si, Zn and Ca. This layer is probably a preparatory paint consisting of red lead (Pb3O4) and Zn oxide (ZnO). C and O were detected in all layers and are probably components of the binder (Table 2 and Fig. 10).

The metal has developed a thin graphitized layer (CP1) as well as a corroded metal phase (CM1). The later is located just beneath NMM3 and appears dark grey under polarized light (Fig. 8). It consists mainly of Fe and O with Pb and Ca (Table 4, Fig. 10). Pb can probably be explained by the proximity to the Pb-rich paint layer NMM3 (Table 2). The presence of Ca is more interesting however, as it might originate from past exposure to the environment, implying that the paint was not applied immediately after fabrication. The composition of CP1 was not analyzed.

Fig. 10: SEM image and elemental chemical distribution of the selected area from Fig. 9 (rotated 270°). Method of analysis: SEM-EDS. Lab. of Electronic Microscopy and Microanalysis, Néode, HEI Arc,

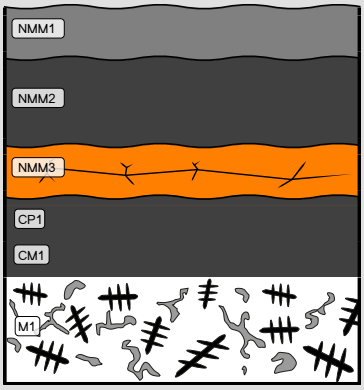
Fig. 11: Stratigraphic representation of the sample taken from the lamp post (?) fragment in cross-section (dark field) using the MiCorr application. The characteristics of the strata are only accessible by clicking on the drawing that redirects you to the search tool by stratigraphy representation. This representation can be compared to Fig. 8, Credit UiO-IAKH, M.Hovind.

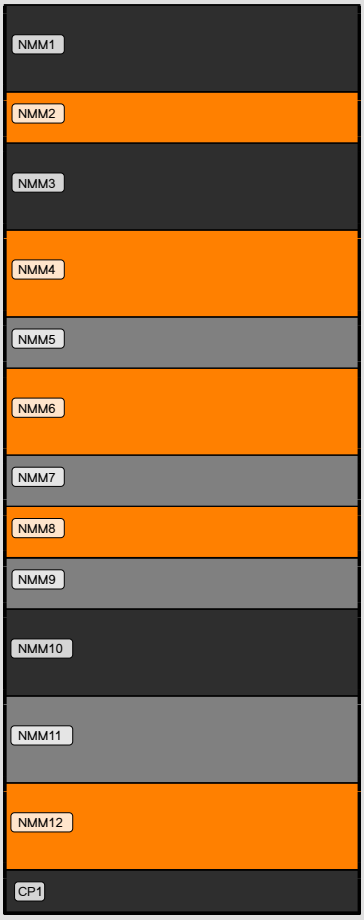
Fig. 12: Stratigraphic representation of paint layer in cross-section based on Fig. 5 using the MiCorr application. The characteristics of the strata are only accessible by clicking on the drawing that redirects you to the search tool by stratigraphy representation, Credit UiO-IAKH, M.Hovind.

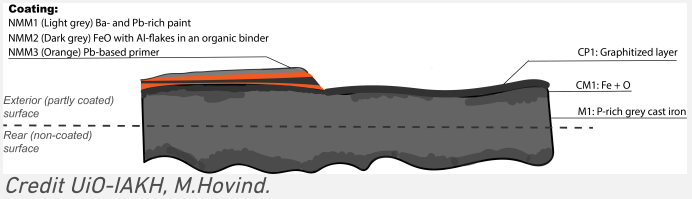
Fig. 13: Improved stratigraphic representation of the lamp post (?) fragment with results from analyses by SEM-EDS and visual microscopic observation. The colour of the metal was changed to grey as this was the colour of the metal when viewed in cross-section. NMM = non-metallic material, CP = corrosion product, CM = corroded metal, M = metal,

The lamp post (?) fragment is a grey cast iron with a microstructure consisting of graphite flakes and a P-rich eutectic phase. It is coated by several paint layers, up to 12 in total. What appears to be a Pb-based primer is located right next to the metal, followed by a black layer consisting of aluminium flakes and iron oxide in an organic binder and superimposed by a light grey, Ba- and Pb-rich paint layer. Inhibitive primers often contain red lead in linseed oil (Hare 2011:979). The uppermost layer is dark in colour and corresponds to the black paint layer previously mentioned.

It seems likely that the lamp post(?) fragment has been treated with a system of at least three different paints which have all been applied several times, hence the relatively thick coating. The efficiency of the paint system is proven by the fact that internal corrosion is much more prominent in areas that are not protected by paint system. Corrosion control by application of paint films is a well-known treatment of metals (Hare 2011:971, Selwyn 2004:109). The use of an anti-corrosion system consisting of several layers of paint with different colours is known to facilitate monitoring as a break in the coating will be readily visible. Additionally, the presence of more than one paint layer will minimize the risk for a hole in the coating and help avoid localized corrosion (Selwyn 2004:105).
