SICKLE AUV-313 - LATE BRONZE AGE - SWITZERLAND

Artefact name Sickle AUV-313

Authors Rémy. Léopold (HE-Arc CR, Neuchâtel, Neuchâtel, Switzerland)

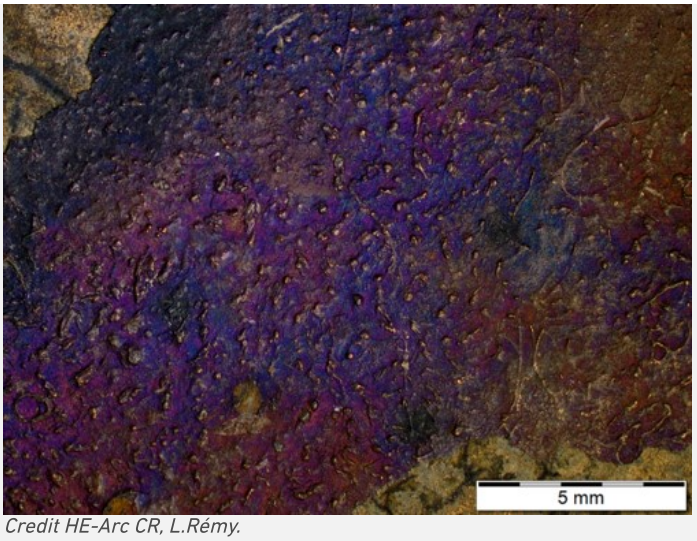
Fig. 3: Magenta-blue and brown-yellow corrosion products (detail) of the haft of the sickle,

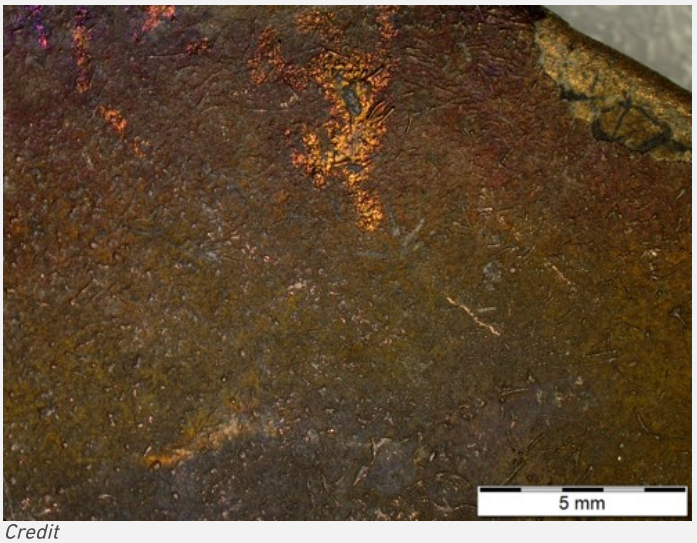
Fig. 4: Brown-yellow and dark-grey corrosion products (detail) of the middle of the sickle,

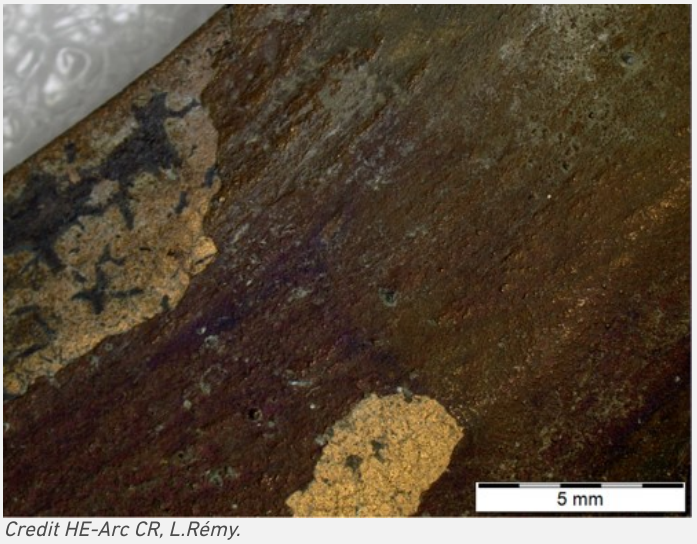
Fig. 5: Brown-yellow and dark-grey corrosion products as well as lacunas of the corrosion layers (detail) of the tip of the sickle,

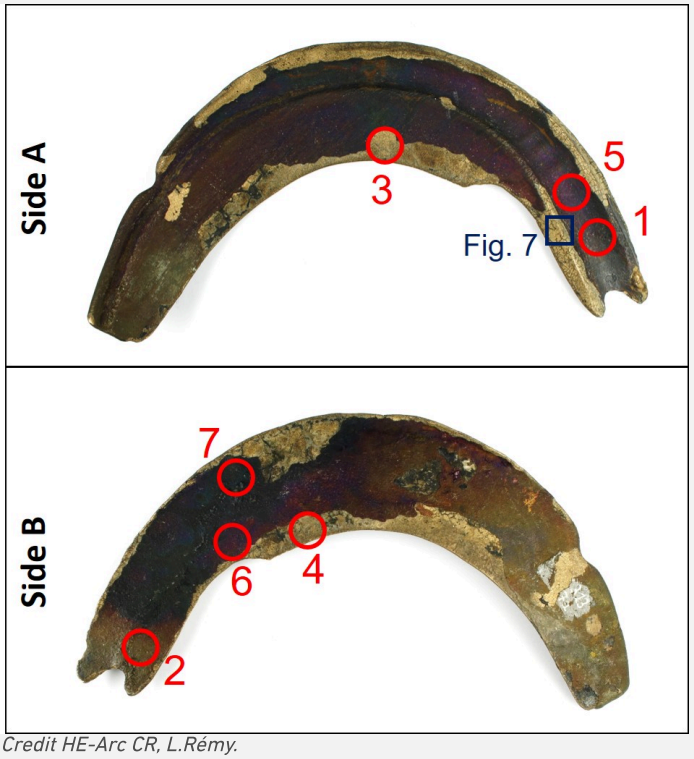
Fig. 6: Sides A and B (opposite sides) with indication of XRF analyses (red circles) and location of Fig. 7 (blue square),

The XRF analyses of the sickle were carried out on seven representative areas (Fig. 6). Points 1 and 2 were done in the brown corrosion layer of each side (CP1), points 3 and 4 on yellow areas covered with dark-grey corrosion layer (CP2 and CP3), points 5 and 6 on the magenta-blue corrosion layer (CP1), and point 7 on a black corrosion layer (CP1). All strata (soil, corrosion products, and metal) are analyzed at the same time.

Results of points 1, 2, 5, 6 and 7 are different and indicate the depletion in Cu and Sn and the enrichment in Fe and S.

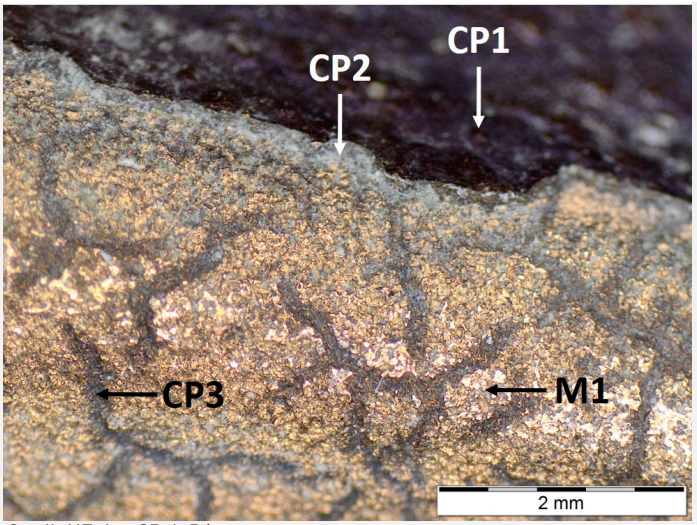
Fig. 7: Side view of a lacuna with the mention of the different strata,

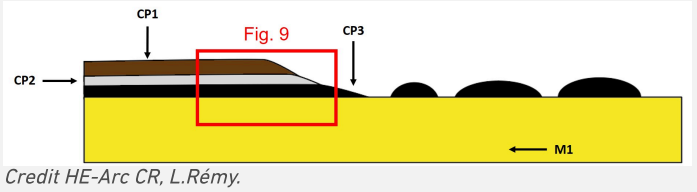
Fig. 8: Stratigraphic representation of the corrosion structure of the sickle by macroscopic and binocular observation with indication of the corrosion structure used to build the MiCorr stratigraphy of Fig. 9 (red square),

The appearance of CP1 and its composition (Cu, Fe, S) seem to indicate that it is either itaite or chalcopyrite.

The sickle is made from a tin bronze. The XRF analysis show that the brown, purple and black corrosion layers (CP1) have higher %Fe and %S and lower % Cu and %Sn than the layer closer to the metal. It would indicate that CP1 is made of copper iron sulfide like itaite (Cu5FeS6) or chalcopyrite (CuFeS2) as described by Rychner (1987). According to Schweizer's paper from 1994, it would mean that CP1 could be a lake patina which was generated on the metal by the presence of sulfate-reducing bacteria in the burial environment.
