SICKLE AUV-313 – LATE BRONZE AGE – SWITZERLAND

Artefact name	Sickle AUV-313
Authors	Rémy. Léopold (HE-Arc CR, Neuchâtel, Neuchâtel, Switzerland)
Url	/artefacts/1059/

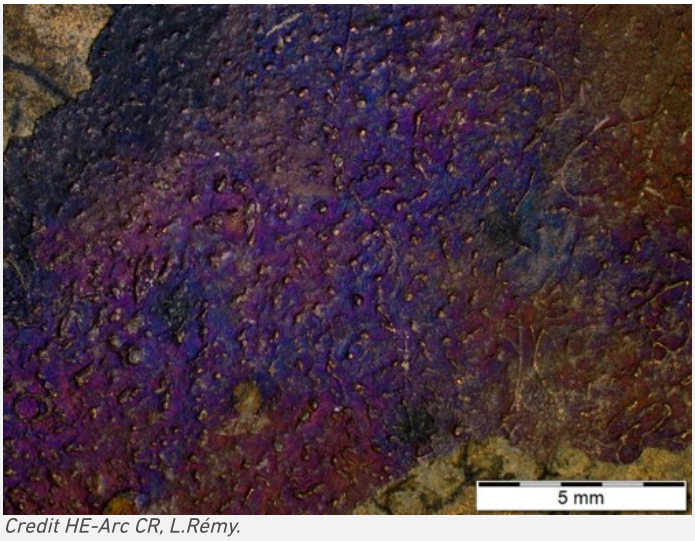
Fig. 3: Magenta-blue and brown-yellow corrosion products (detail) of the haft of the sickle,

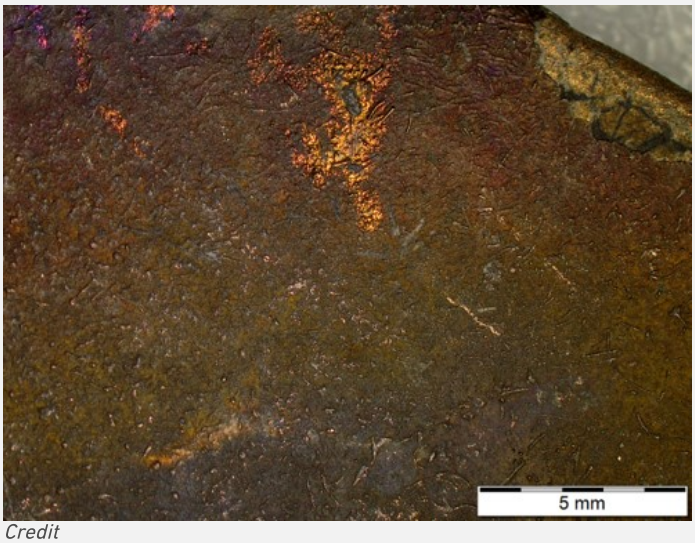
Fig. 4: Brown-yellow and dark-grey corrosion products (detail) of the middle of the sickle,

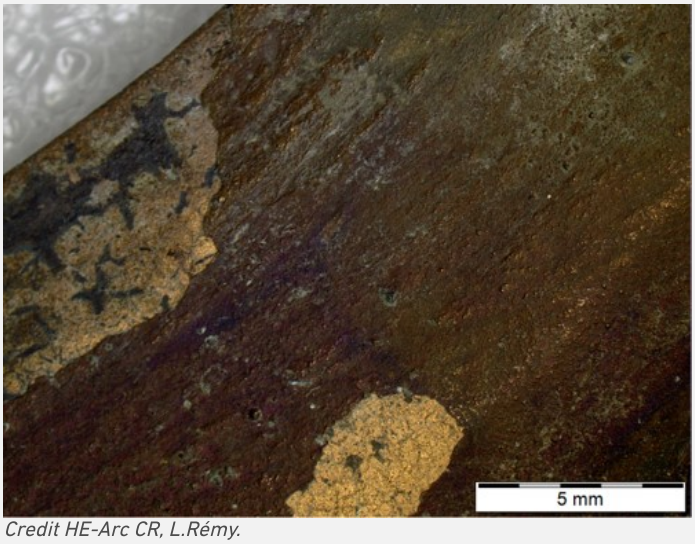
Fig. 5: Brown-yellow and dark-grey corrosion products as well as lacunas of the corrosion layers (detail) of the tip of the sickle,

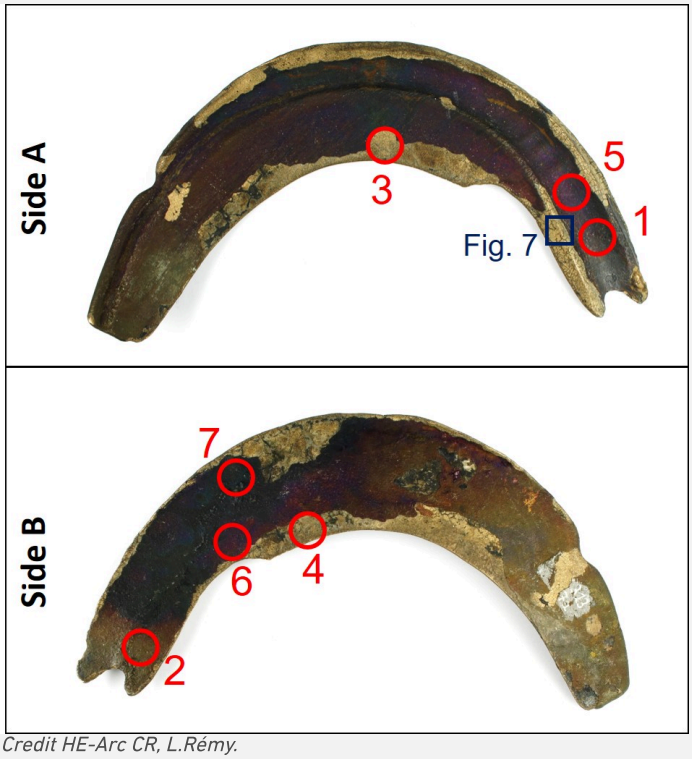
Fig. 6: Sides A and B (opposite sides) with indication of XRF analyses (red circles) and location of Fig. 7 (blue square),

The XRF analyses of the sickle were carried out on seven representative areas (Fig. 6). Points 1 and 2 were done in the brown corrosion layer of each side (CP1), points 3 and 4 on yellow areas covered with dark-grey corrosion layer (CP2 and CP3), points 5 and 6 on the magenta-blue corrosion layer (CP1), and point 7 on a black corrosion layer (CP1). All strata (soil, corrosion products, and metal) are analyzed at the same time.

Results of points 1, 2, 5, 6 and 7 are different and indicate the depletion in Cu and Sn and the enrichment in Fe and S.

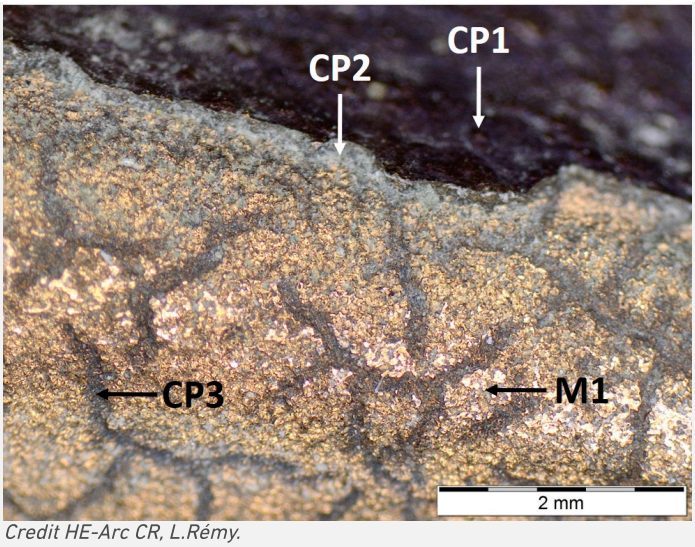
Fig. 7: Side view of a lacuna with the mention of the different strata,

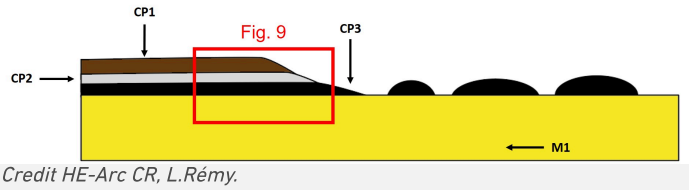
Fig. 8: Stratigraphic representation of the corrosion structure of the sickle by macroscopic and binocular observation with indication of the corrosion structure used to build the MiCorr stratigraphy of Fig. 9 (red square),
