SICKLE AUV-322 - LATE BRONZE AGE - SWITZERLAND

Artefact name Sickle AUV-322

Authors Rémy. Léopold (HE-Arc CR, Neuchâtel, Neuchâtel, Switzerland)

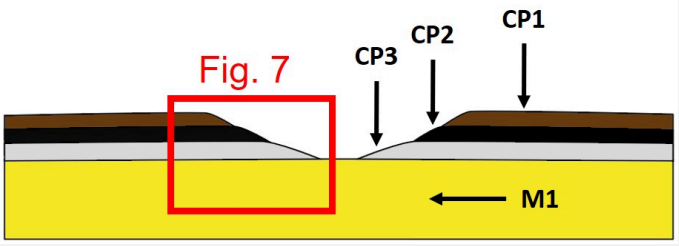
Strata	Type of stratum	Principal characteristics
CP1	Corrosion product	Brown, matte, thin, discontinuous, compact, powdery, very soft
CP2	Corrosion product	Black, matte, thin, discontinuous, compact, powdery, very soft
CP3	Corrosion product	Extra light grey, matte, thin, discontinuous, compact, powdery, hard
M1	Metal	Yellow, thick, metallic, continuous, compact, tough, very hard

Fig. 6: Stratigraphic representation of the corrosion structure of the sickle by macroscopic and binocular observation with indication of the corrosion structure used to build the MiCorr stratigraphy of Fig. 7 (red square),

The appearance of CP1 and CP2 and their composition (Cu, S) seem to indicate that they might be chalcocite or djurleite.

The sickle is made from a tin bronze. The XRF analysis shows that the black corrosion layer CP2 has higher %S and lower %Cu, it would indicate the presence of black copper sulfide such as chalcocite (Cu2S) and djurleite (Cu1.93S), as described by Rychner (1987).
