PIN HR-3071 – TIN BRONZE – LATE BRONZE AGE – SWITZERLAND

Artefact name	Pin HR-3071
Authors	Naima. Gutknecht (HE-Arc CR, Neuchâtel, Neuchâtel, Switzerland) & Rémy. Léopold (HE-Arc CR, Neuchâtel, Neuchâtel, Switzerland) & Domon Beuret. Emmanuelle (Laténium, Neuchâtel, Neuchâtel, Switzerland)
Url	/artefacts/1088/

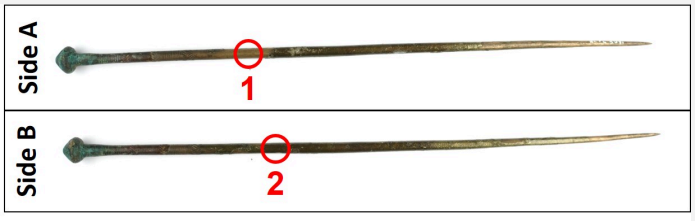
Fig. 4: Sides A and B (opposite sides) of the pin showing the XRF analysis areas (red circles),

XRF analysis was carried out on two representative areas of the surface (Fig. 4). Point 1 was performed on a lacuna of the olive green corrosion layer and point 2 on the olive green corrosion layer (CP4 of Fig. 5).

Results of point 2 are very different from those of point 1, they indicate the enrichment in Fe and in S and depletion in Cu.

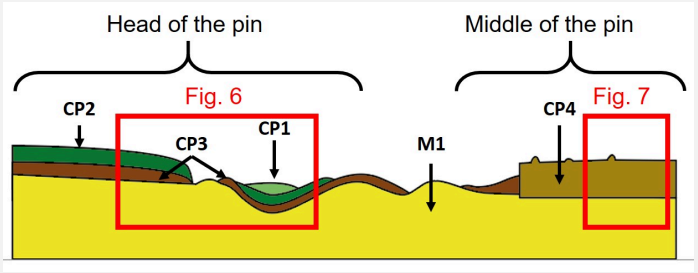
Fig. 5: Stratigraphic representation of the corrosion structure of the pin by macroscopic and binocular observation using the Micorr application with reference to Figs. 6 and 7,

Strata	Type of stratum	Principal characteristics
CP1	Corrosion product	Light green, thin, scattered, non compact, very soft

CP2	Corrosion product	Dark green, thin, scattered, compact, very soft
CP3	Corrosion product	Dark brown, medium, discontinuous, compact, hard
CP4	Corrosion product	Olive green, medium, discontinuous, compact, hard
M1	Metal	Yellow, metallic, compact, hard

CP4 (dense, smooth olive green stratum) is enriched with Fe and S and depleted in Cu. It seems to correspond to chalcopyrite (CuFeS2).
