PIN HR-3389 - TIN BRONZE - LATE BRONZE AGE - SWITZERLAND

Artefact name Pin HR-3389

Authors Naima. Gutknecht (HE-Arc CR, Neuchâtel, Neuchâtel, Switzerland) & Rémy. Léopold (HE-Arc CR, Neuchâtel, Neuchâtel, Switzerland) & Domon Beuret. Emmanuelle (Laténium, Neuchâtel, Neuchâtel, Switzerland)

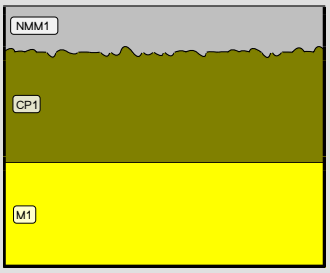
Strata	Type of stratum	Principal characteristics
NMM1	Non-metallic material	Transparent, thin, compact, only present in CP1
CP1	Corrosion product	Olive green, thick, discontinuous, compact, hard
CP2	Corrosion product	Black, veins shape, thin, discontinuous, compact, hard
CP3	Corrosion product	Dark brown, thin, continuous, compact, hard
M1	Metal	Dark yellow, thick, metallic, hard

Fig. 7: Stratigraphic representation of the corrosion structure of the pin observed macroscopically under binocular microscope using the MiCorr application with reference to Fig. 6. The characteristics of the strata, such as the discontinuity, are accessible by clicking on the drawing that redirects you to the search tool by stratigraphy representation, Credit HE-Arc CR, N.Gutknecht.
