PIN HR-18603 - TIN BRONZE - LATE BRONZE AGE - SWITZERLAND

Artefact name	Pin HR-18603
Authors	Naima. Gutknecht (HE-Arc CR, Neuchâtel, Neuchâtel, Switzerland) & Rémy. Léopold (HE-Arc CR, Neuchâtel, Neuchâtel, Switzerland) & Domon Beuret. Emmanuelle (Laténium, Neuchâtel, Neuchâtel, Switzerland)
Url	/artefacts/1091/

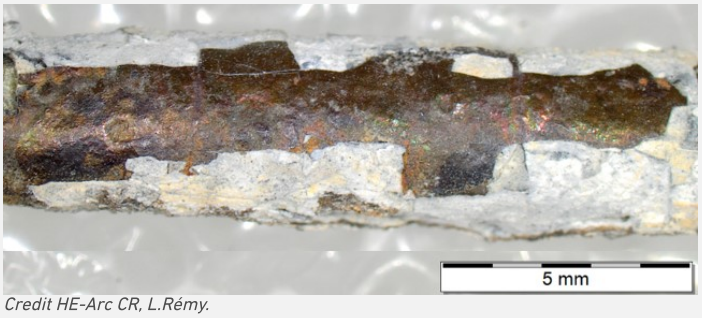
Fig. 1: Pin with decorated head (ring) and round section,

Fig. 2: White corrosion products (detail) on the head of the pin,

Fig. 3: White and brown corrosion products (detail) on an area in the middle of the pin,

Fig. 4: White and brown corrosion products (detail) on an area in the middle of the pin,

Fig. 5: Brown and green corrosion products (detail) on an area in the middle of the pin,

Description of the artefact	Pin with green-blue and brown shiny corrosion products (Figs. 1-5) and recently developed white corrosion products (see complementary information below). Dimensions: L = 10.5cm; WT = 6.6g.
Type of artefact	Jewellery
Origin	Hauterive - Champréveyres, Neuchâtel, Neuchâtel, Switzerland
Recovering date	Excavation 1983-1985, object from layer 1
Chronology category	Late Bronze Age
chronology tpq	1050 B.C.
chronology taq	800 B.C.
Chronology comment	
Burial conditions / environment	Lake
Artefact location	Laténium, Neuchâtel, Neuchâtel
Owner	Laténium, Neuchâtel, Neuchâtel
Inv. number	HR-18603
Recorded conservation data	The object has been kept in wooden storage, no intervention documented.

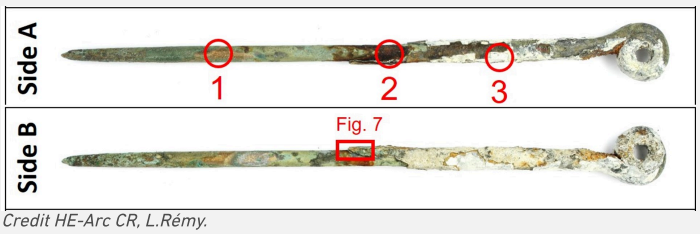
Fig. 6: Sides A and B (opposite sides) of the pin showing the XRF analysis areas (red circles) and the location of Fig. 7 (red square),

The XRF analysis of the pin was carried out on three representative areas of the surface (Fig. 6). Point 1 corresponds to the bright yellow surface and appears to be an area where the corrosion layers have dissociated to reveal the metal, point 2 corresponds to the dark brown surface (CP2), and point 3 to the white corrosion product (CP3).

The metal is presumably a tin bronze alloy with traces of As. The others elements detected are: S, Si, Fe, Zn, Al.

Results of point 2 indicate an enrichment in Fe and a depletion in Cu and in S in CP2.

Results of point 3 (CP3) are very different to those of points 1 and 2, they indicate the enrichment in Fe and in S and the depletion in Cu and in Sn.

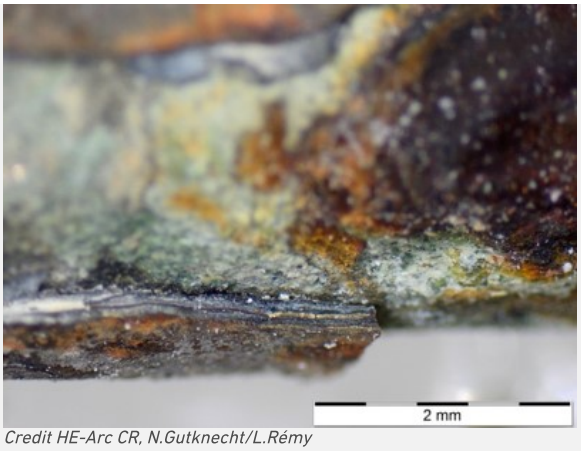
Fig. 7: Detail of the pin with view of the layers used for the description of the corrosion structure in Fig. 8.

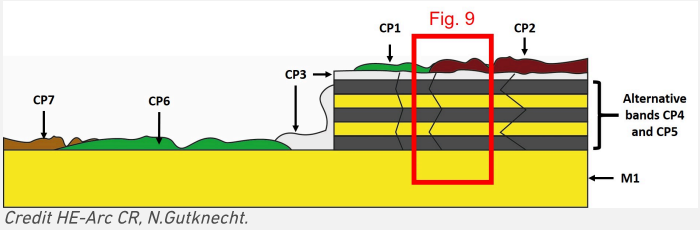
Strata	Type of stratum	Principal characteristics
CP1	Corrosion product	Dark green, thin, scattered, non compact, very soft
CP2	Corrosion product	Dark brown, thin, scattered, compact, hard
CP3	Corrosion product	Extra light grey, medium thickness, scattered, non compact, very soft
CP4	Corrosion product	Yellow, medium thickness, discontinuous, compact, hard
CP5	Corrosion product	Dark grey, medium thickness, discontinuous, non compact, very soft
CP6	Corrosion product	Dark green, thin, scattered, non compact, very soft
CP7	Corrosion product	Brown, thin, scattered, non compact, very soft
M1	Metal	Yellow, thick, metallic, soft

Fig. 8: Stratigraphic representation of the corrosion structure of the pin by macroscopic and binocular observation with reference to Fig. 9,

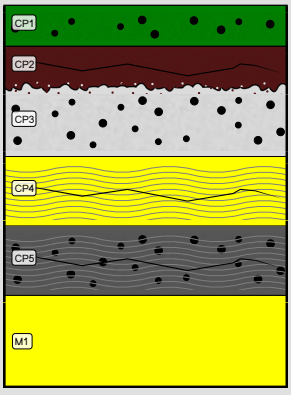
Fig. 9: Stratigraphic representation of the corrosion structure of the head of the pin observed macroscopically under binocular microscope using the MiCorr application with reference to Fig. 8. The characteristics of the strata, such as the discontinuity, are accessible by clicking on the drawing that redirects you to the search tool by stratigraphy representation, Credit HE-Arc CR, N.Gutknecht.

In the article "Bronze objects from Lake sites: from patina to bibliography. In: Ancient and historic metals, conservation and scientific research" (Schweizer 1994), the corrosion products of the pin 18603 (LAB MAH 86-77) are identified as copper iron sulfide (chalcopyrite) and as copper sulfate (antlerite). The first one is brown-yellow (probably CP2) and the other one is green (probably CP1).

The pin is made from a tin bronze. The corrosion products of the pin 18603 (LAB MAH 86-77) originally formed were identified as copper iron sulfide (chalcopyrite) typical of lake patina and copper sulfate (antlerite).
The white corrosion (CP3) seems to have developed after excavation (to be completed).
