BRACELET LNR. 30557 - CU ALLOY - BRONZE AGE - SWITZERLAND

Artefact name	Bracelet Lnr. 30557
Authors	Sabine. Brechbühl (archaeological service canton Bern, Bern, Bern, Switzerland) & Naima. Gutknecht (HE-Arc CR, Neuchâtel, Neuchâtel, Switzerland)
Url	/artefacts/1104/

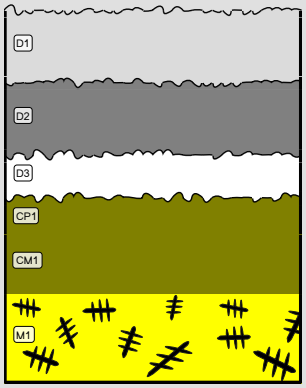
Fig. 5: Stratigraphic representation of the corrosion structure of the bracelet observed macroscopically under binocular microscope using the MiCorr application with reference to the whole Fig. 4. The characteristics of the strata are only accessible by clicking on the drawing that redirects you to the search tool by stratigraphy representation, Credit HE-Arc CR, N.Gutknecht.

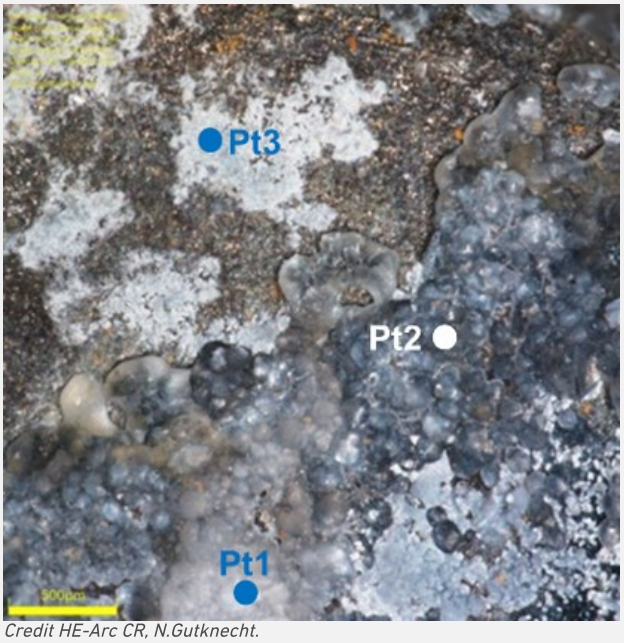
Raman spectroscopy was performed on different surface deposits (D1, D2 and D3). The hypothesis was that it could be a development of corrosion products since it was only observed after drying and storage. Nevertheless, the Raman spectra of the three crystal types (D1/Pt1, D2/Pt2 and D3/Pt3) correspond well to the reference spectra of calcite (Fig. 7). It appears to be a deposit from the burial environment (lake) with different levels of crystallisation.

Fig. 6: Location of the Raman analysis,

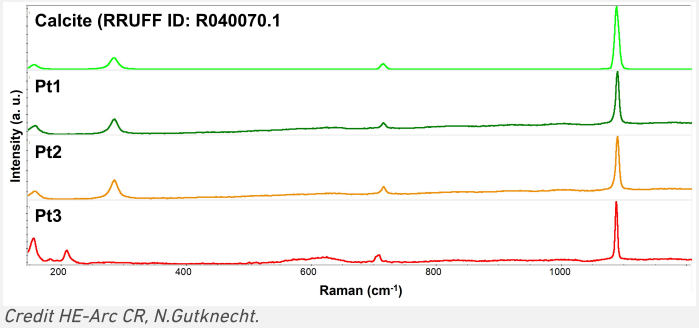
Fig. 7: Raman spectra reference for calcite (RRUFF ID=R040070.1) and points 1, 2 and 3 located in Fig. 6,

The bracelet is a tin bronze probably with some lead. It appears to be covered with copper oxide (cuprite) and various types of crystals attributed to calcite from the lake burial condition.
