# BRACELET BUS-NA 98 BZ 67 - BRONZE - IRON AGE - SWITZERLAND

**Artefact name** Bracelet bus-na 98 BZ 67

**Authors** Naima. Gutknecht (HE-Arc CR, Neuchâtel, Neuchâtel, Switzerland) & Valentina. Valbi (Laboratoire Métallurgie et Culture LMC-IRAMAT-CNRS-UTBM, Belfort, Franche-Comté, France)

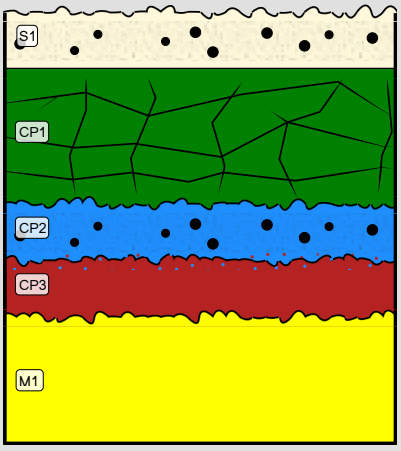
The transition between CP3 and the metal M1 is irregular. CP1 shows a network of cracks on the whole stratum.

Fig. 4: Stratigraphic representation of the corrosion structure of the bracelet observed macroscopically under binocular microscope using the MiCorr application with reference to the whole Fig. 3. The characteristics of the strata are only accessible by clicking on the drawing that redirects you to the search tool by stratigraphy representation, Credit HE-Arc CR, N.Gutknecht.

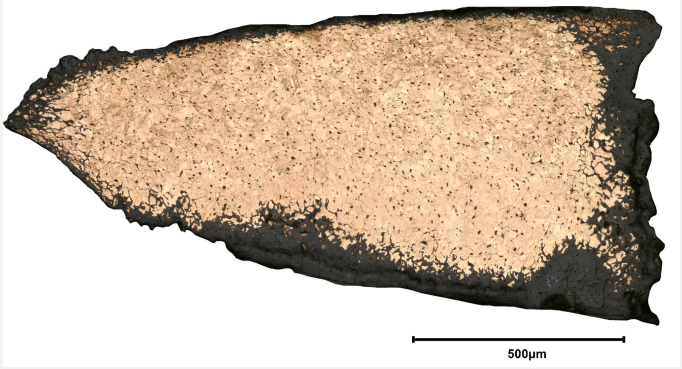
and 8) caused by cold mechanical working of the metal after annealing. Numerous lead inclusions (Figs. 7 and 10) of dimension of around 10 µm are homogeneously distributed on the whole surface of the sample. Intergranular corrosion is observed (Figs. 6 and 8).

Fig. 6: Micrograph of the etched cross-section of the sample taken from the bracelet (Fig. 2) in bright field,

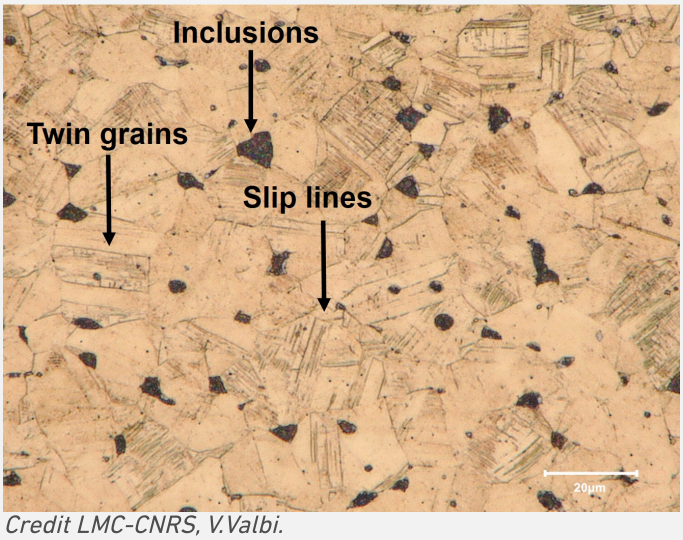
The metal has a grain structure (Fig. 7) with several twinned grains (Figs. 7 and 8), indicating that the object underwent an annealing procedure. On the whole sample, it is possible to observe the presence of slip lines (Figs. 7

Fig. 7: Micrograph of the metal sample from Fig. 5 (detail), etched, bright field. Elongated grains with slip lines are observed, as well as grey lead inclusions,

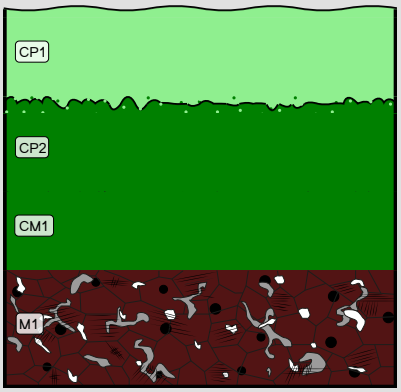
The observation of the sample in cross section in dark field (Figs. 5 and 9) allowed to identify an external continuous light green stratum (CP1), a dark green stratum (CP2) and a corroded metal stratum (CM1).

The EDX elemental analysis (Table 4) and mapping (Fig. 10) of the visually identified CPs by binocular and cross-sectional observations show that CP1 is Cu depleted, O and Sn enriched and polluted with Ca, Si and P from the soil, while CP2 is also Cu depleted and O and Sn rich but with less external polluting elements. These results are in agreement with the preliminary XRF analysis that already showed an enrichment in O and Sn and a depletion in Cu from the surface. No enrichment in Pb was though observed in cross-section.

Fig. 12: Stratigraphic representation of the sample observed in cross-section under dark field using the MiCorr application. The characteristics of the strata are only accessible by clicking on the drawing that redirects you to the search tool by stratigraphy representation. This representation was build according to Fig. 9, Credit LMC-CNRS, V.Valbi.
