VOTIVE FIGURE OF A BAT IVB4168 – GILDED BRASS – MODERN TIMES

Artefact name	Votive figure of a bat IVb4168
Authors	Christian. Degrigny (HE-Arc CR, Neuchâtel, Neuchâtel, Switzerland) & Naima. Gutknecht (HE-Arc CR, Neuchâtel, Neuchâtel, Switzerland) & Valentin. Boissonnas (HE-Arc CR, Neuchâtel, Neuchâtel, Switzerland)
Url	/artefacts/1112/

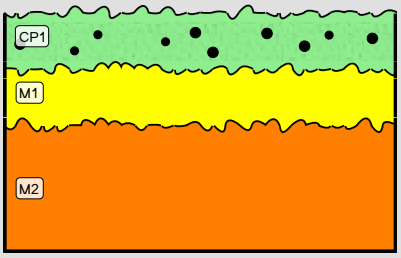
Fig. 4: Location of the areas 1 and 2 used to build the MiCorr stratigraphies of Figs. 5 and 6,

Fig 5: Stratigraphic representation of the corrosion structure of area 1 (Fig. 4) observed macroscopically under binocular microscope using the MiCorr application. The characteristics of the strata are only accessible by clicking on the drawing that redirects you to the search tool by stratigraphy representation, Credit HE-Arc CR, N.Gutknecht.

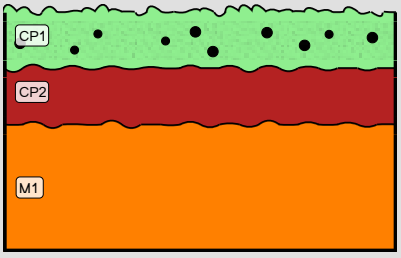
Fig. 6: Stratigraphic representation of the corrosion structure of area 2 (Fig. 4) observed macroscopically under binocular microscope using the MiCorr application. M1 is M2 in Fig. 5. The characteristics of the strata are only accessible by clicking on the drawing that redirects you to the search tool by stratigraphy representation, Credit HE-Arc CR, N.Gutknecht.

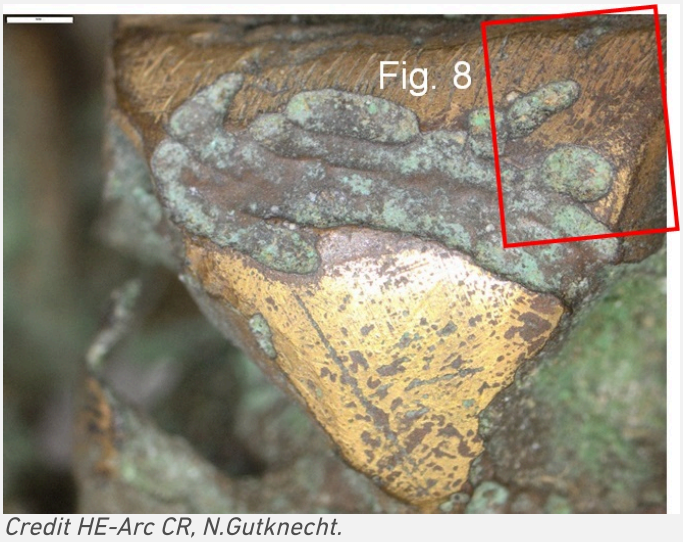
The metal seems to have been heavily attacked (acid dissolution). There are several perforations on the lower part of the object, and where the gold layer is absent the surface is unevenly pitted by corrosion (Figs. 1, 2 and 7). The submetallic core is not visible from the surface.
There are two corrosion products (Figs. 7 and 8). The red one (CP2) has a submetallic brightness and is opaque, non-magnetic, compact, hard and adherent. It is very thin (less than a few microns thick) and only appears where the gold layer has been lost. The EDX spectrum (Fig. 9) shows that it is a Cu- and O rich product, probably cuprite (Cu2O).
The light green to white corrosion product (CP1) has a waxy consistency and is thin, translucent, non-magnetic, powdery and very soft. It is very loosely bound. It is distributed on the whole object (front and back) as disparate clumps. It is mainly located on the cavities and irregularities of the surface. FTIR analyses (ATR mode) of both green and white areas of CP1 have similar spectra and were identified as copper nitrate (Fig. 10).

Fig. 7: Binocular image of the nose of the bat showing detail of Fig. 8,
