SICKLE AUV-310 - LATE BRONZE AGE - SWITZERLAND

Artefact name Sickle AUV-310

Authors Rémy. Léopold (HE-Arc CR, Neuchâtel, Neuchâtel, Switzerland)

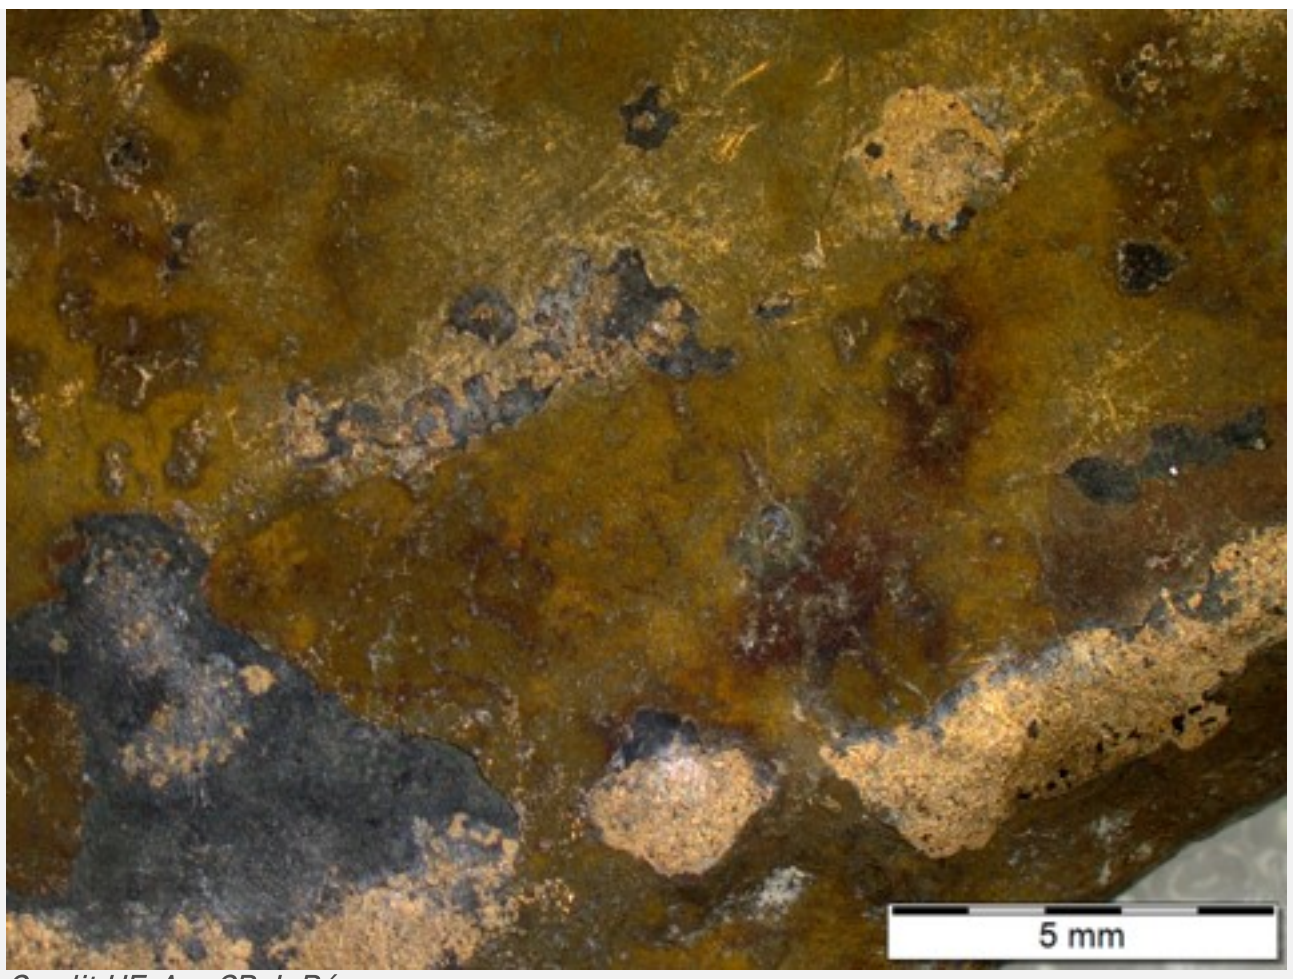
Fig. 3: Brown-yellow and dark-grey corrosion products and lacunas (detail) on the middle of the sickle,

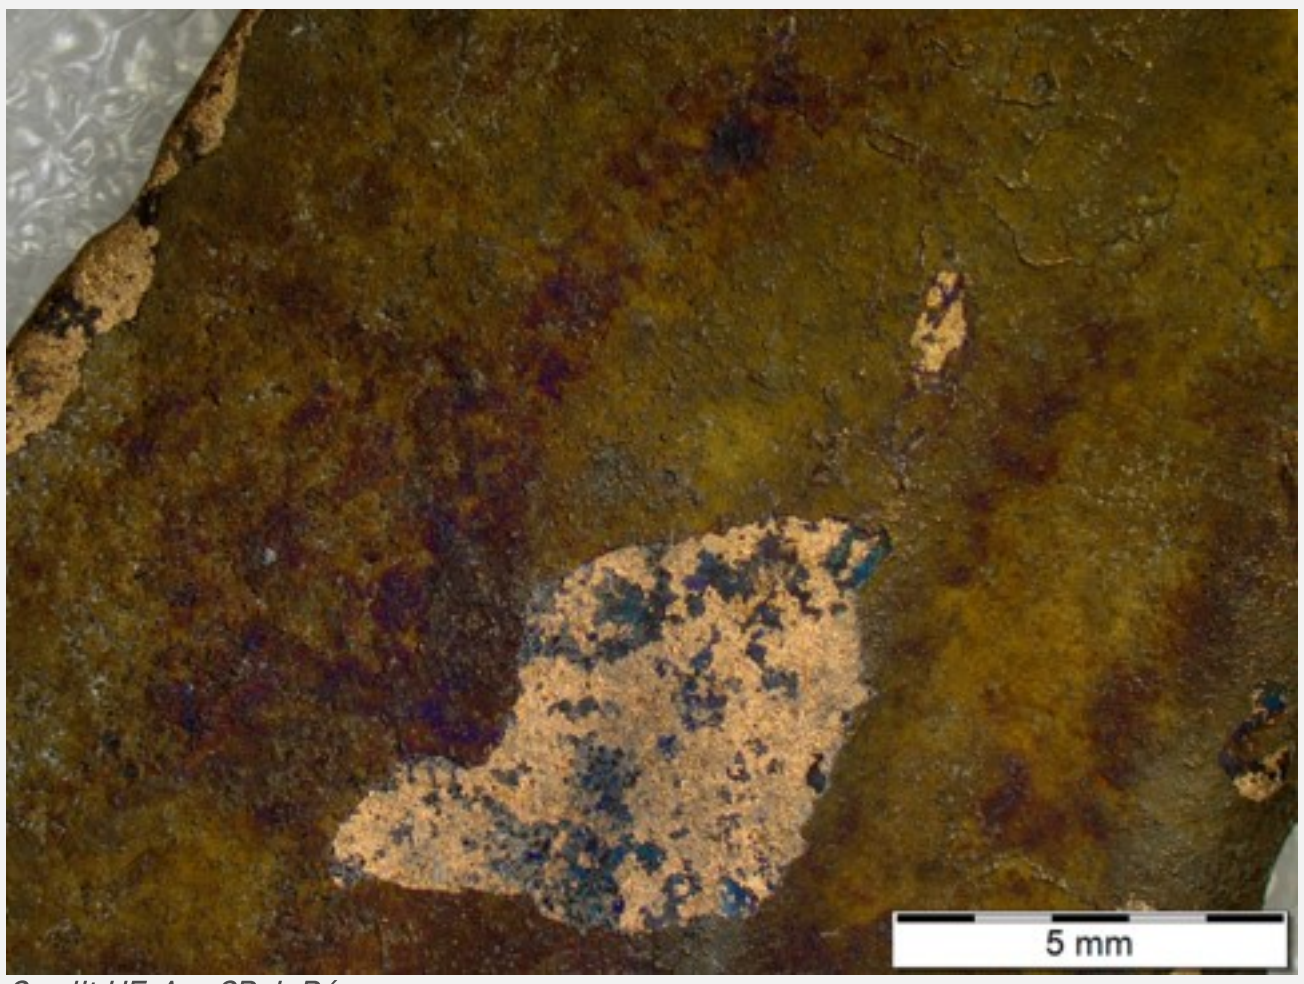
Fig. 4: Brown-yellow and dark-grey corrosion products and lacunas (detail) of an area close to the tip of the sickle,

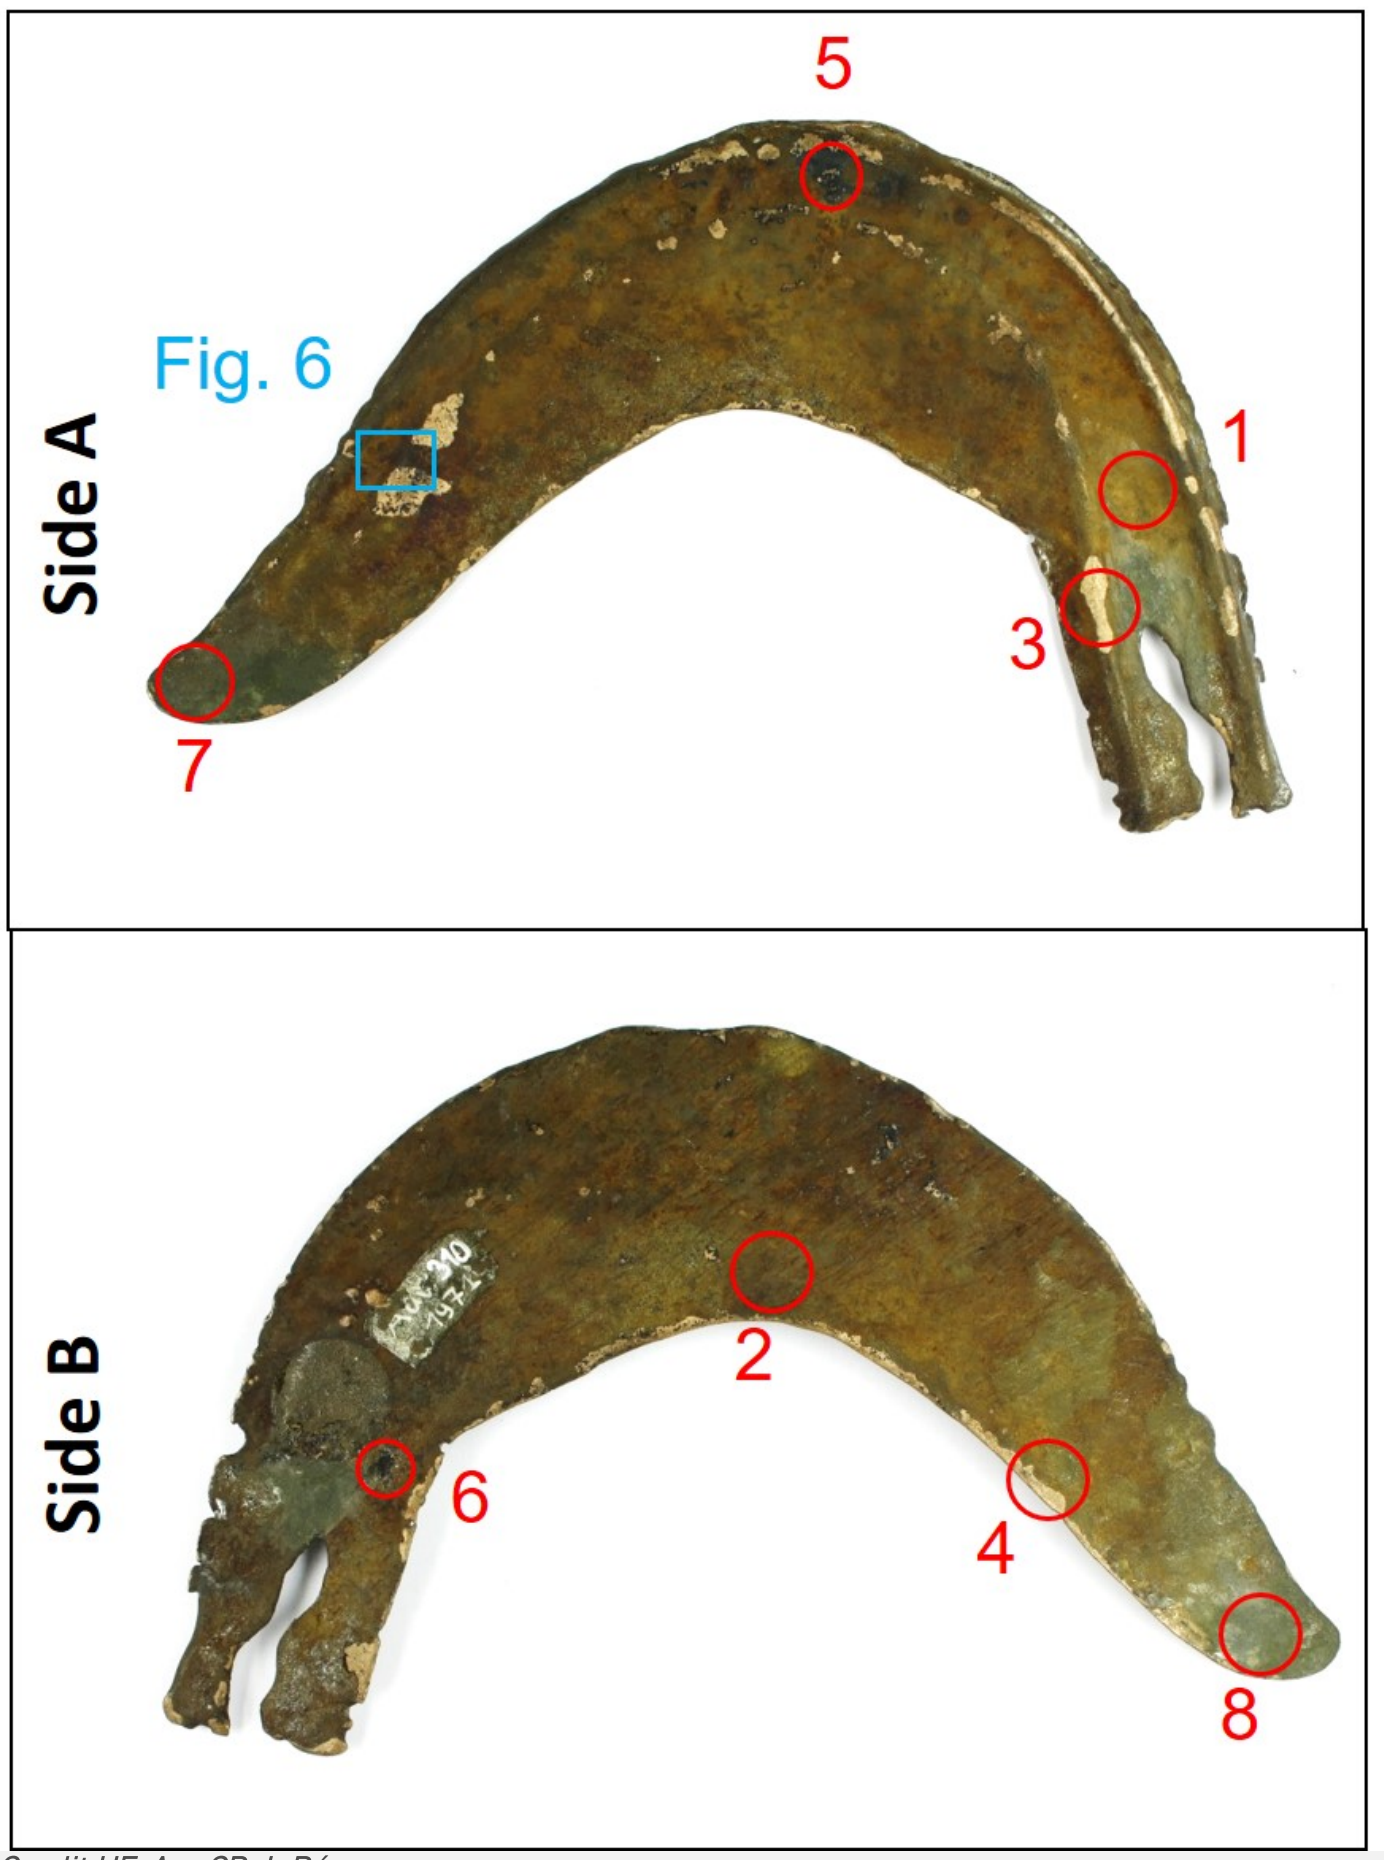
Fig. 5: Both sides (opposed) of the sickle with location of XRF analysis areas (red circles) and location of Fig. 6 (blue square),

XRF analyses of the sickle were carried out on eight representative areas (Fig. 5). Points 1 and 2 were done on the brown corrosion layer of each side (CP1), points 3 and 4 on the yellow areas covered with black and grey corrosion products (CP2 and CP3) of each side, and points 5 and 6 on the black corrosion layer of each side (CP2), and points 7 and 8 on the grey corrosion layer of each side (CP3). All strata (soil, corrosion products, and metal) are analyzed at the same time.

Results of points 1 and 2 are very similar, CP1 is rich in Fe and S, but delepled in Cu and Sn.

The results of points 3 and 4 are similarly very close, but different from those of points 1 and 2: we are closer to the residual metal but it is still covered with corrosion products containing Fe and S.

Results of point 5 indicate that again we are close to the metal surface with even less Fe and S.

Results of points 6 and 7 are very similar and are closer to the results of points 1 and 2.

Results of point 8 are closer to those of points 1 and 2 but with less S.

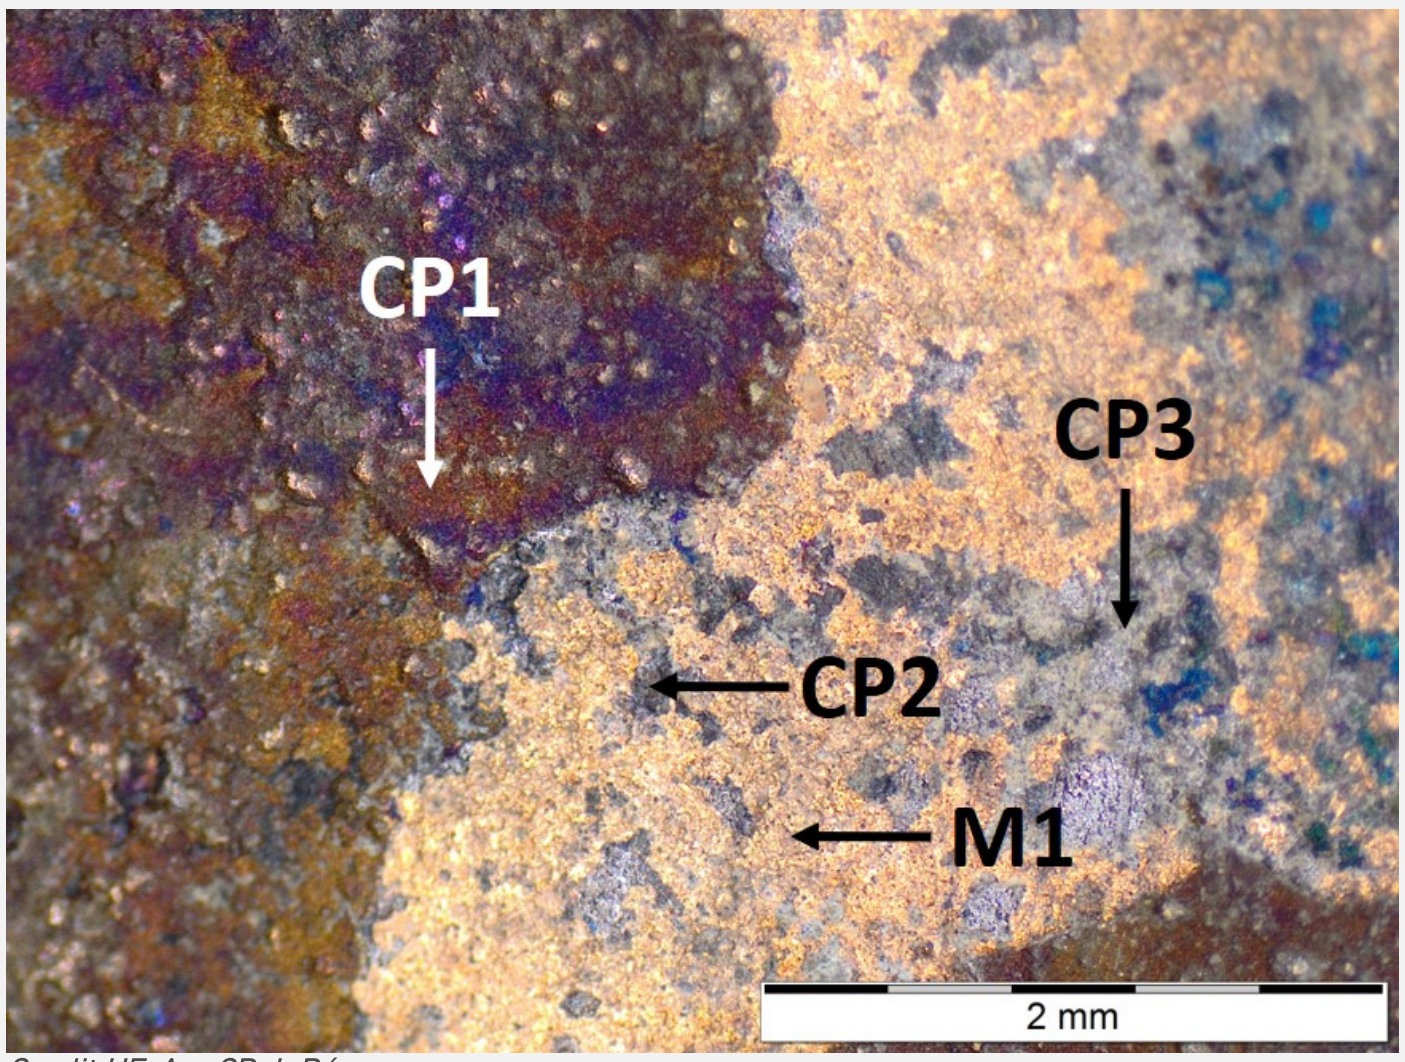
Fig. 6: Corrosion structure (detail) from Fig. 5 showing some of the documented strata in Fig. 7,

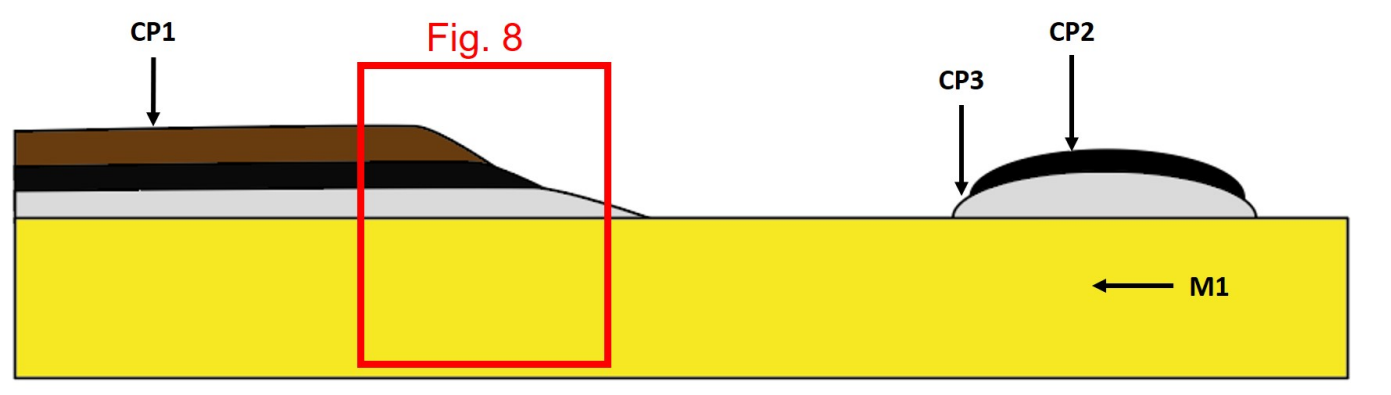
Fig. 7: Stratigraphic representation of the corrosion structure of the sickle by macroscopic and binocular observation with indication of the corrosion structure used to build the MiCorr stratigraphy of Fig. 8 (red square),

The appearance of CP1 and its composition (Cu, Fe, S) seem to indicate that it is either itaite or chalcopyrite.

The sickle is made from a tin bronze. The XRF analysis shows that the brown corrosion layer (CP1) have higher %Fe and %S and lower % Cu while CP2 is richer in %S than Fe. It would indicate that CP1 is made of copper iron sulfide like chalcopyrite (CuFeS2) as described by Rychner (1987). According to Schweizer's paper from 1994, it would mean that CP1 could be a lake patina which was generated on the metal by the presence of sulfate-reducing bacteria in the burial environment.
