BUGATTI 37 CYLINDER HEAD GASKET 0416 – AL ALLOY – MODERN TIMES – FRANCE

Artefact name Bugatti 37 cylinder head gasket 0416

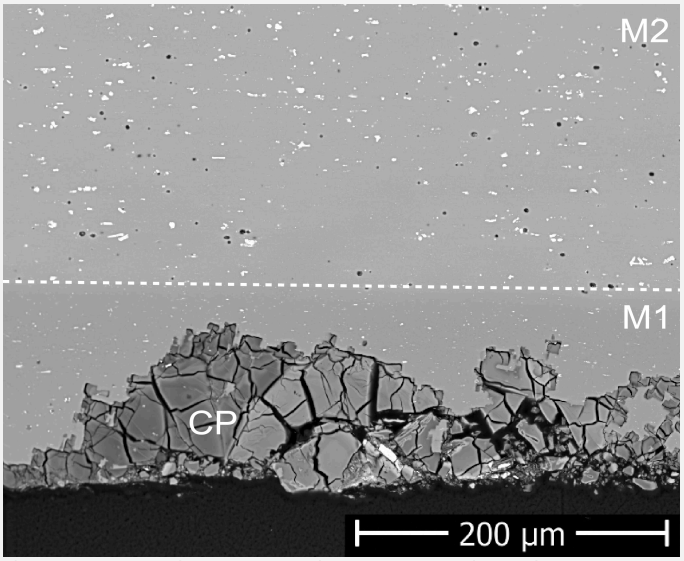
Fig. 6: Micrograph of the cross-section of the gasket, zone 1, shown on Fig. 5 unetched, dark field, showing the location of the EDS elemental chemical distribution of Fig. 10 to 13 (in blue) and of the SEM image of Fig. 7 (in red),

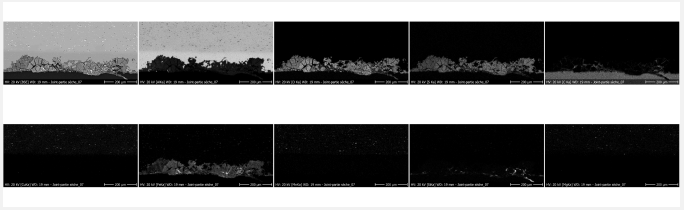
Fig. 13: SEM image and elemental chemical distribution of the area of Fig. 10. Method of analysis: SEM-EDS. Lab. of Electronic Microscopy and Microanalysis, Néode, HEI Arc.

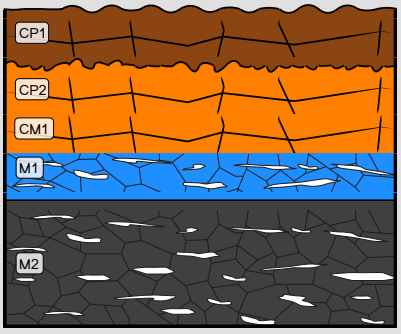
Fig. 14: Stratigraphic representation of the gasket (zone 1) in cross-section (dark field), using the MiCorr application. The characteristics of the strata are only accessible by clicking on the drawing that redirects you to the search tool by stratigraphy representation. This representation can be compared to Fig. 7, Credit HE-Arc CR, E.Granget.

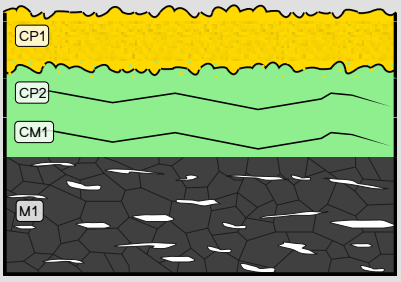
Fig. 15: Stratigraphic representation of the gasket (zone 2) in cross-section (dark field), using the MiCorr application. The characteristics of the strata are only accessible by clicking on the drawing that redirects you to the search tool by stratigraphy representation. This representation can be compared to Fig. 9, Credit HE-Arc CR, E.Granget.

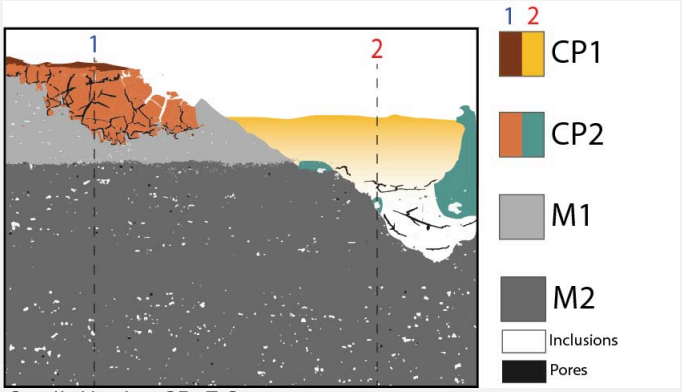
No analyses could be carried out on the top thicker part of CP1.

Fig. 16: Improved stratigraphic representation of the 2 corrosion structures of the Bugatti cylinder head gasket. CP1 could not be analysed,

The side of the gasket facing the cylinder block has a different corrosion pattern depending on whether the area is immersed or not. The surface in contact with the cylinder block shows a priori corrosion consisting of highly cracked aluminium sulphate (network). The surface immersed in the coolant is heavily corroded. The colaminated Al sheet has been completely consumed, and the corrosion progresses through the support metal, retaining inclusions of the alloy in its products. This layer is very brittle and tends to delaminate.

All the corrosion products are contaminated with iron oxides, probably from the block. The immersed part is covered with a thick crust of what is believed to be a mixture of ferrous and aluminium-based products.
