RING SMRA 16-17285-01 - CU ALLOY - ROMAN TIMES - SWITZERLAND

Artefact name Ring SMRA 16-17285-01

Authors Christian. Degrigny (HE-Arc CR, Neuchâtel, Neuchâtel, Switzerland) & Naima. Gutknecht (HE-Arc CR, Neuchâtel, Neuchâtel, Switzerland) & Valentina. Valbi (Laboratoire Métallurgie et Culture LMC-IRAMAT-CNRS-UTBM, Belfort, Franche-Comté, France)

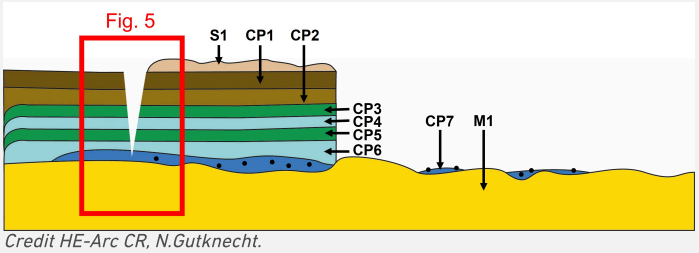
The schematic representation below gives an overview of the corrosion structure encountered on the ring from a first visual macroscopic observation.
There are cracks through CP1 to CP6 that generate the flaking of the layers.

Fig. 4: Stratigraphic representation of the corrosion structure of the ring by macroscopic and binocular observation with indication of the corrosion structure used to build the MiCorr stratigraphy of Fig. 5 (red rectangular),

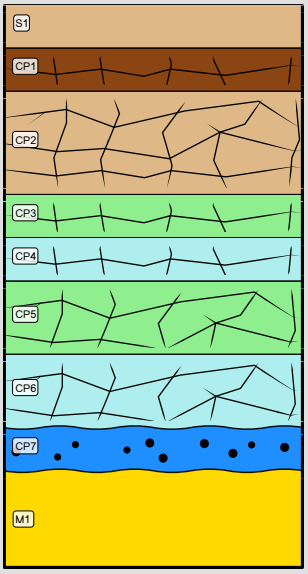
Fig. 5: Stratigraphic representation of the corrosion structure of the ring observed macroscopically under binocular using the MiCorr application with reference to Fig. 4. The characteristics of the strata, such a discontinuity, are accessible by clicking on the drawing that redirects you to the search tool by stratigraphy representation, Credit HE-Arc CR, N.Gutknecht.

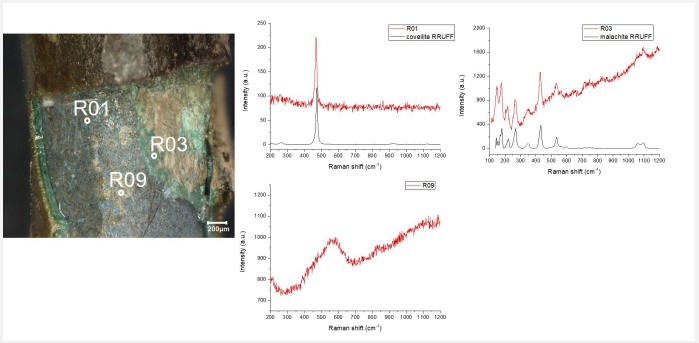
It was not possible to sample this artefact. Therefore, µ-Raman point analyses were performed on the surface of the object in an area where different strata of corrosion products were exposed, as shown in Fig. 6 in a micrograph taken by optical microscopy. The surface of the object appears brown (CP1). It covers a green stratum (CP5) and a blue/golden one (CP7 and M1) with black spots in it. The R01 analysis point was performed on one of the blackpots observed in the blue stratum and can be identified as covellite (CuS) by comparison with a reference spectrum. Point analyses performed on the blue (CP7) and golden stratum showed a spectrum with a large peak at around 560 cm-1 (R09) that can be identified as nanocassiterite (SnO2) by comparison with the work of Ospitali et al. 2012. The R03 point analysis was performed on the green stratum (CP5) and is identified as malachite (Cu2(CO3)(OH)2) by comparison with a reference spectrum.

Fig. 6: Raman points of analysis on the surface of the object and Raman spectra obtained for R01(together with the covellite reference spectrum RRUFFID=R060306), R03 (together with the malachite reference spectrum RRUFFID=R050508) and R09,

The ring is a tin bronze probably with some lead. The identification of nanocassiterite as the most internal CP shows a phenomenon of decuprification typical of bronze corrosion, accompanied by the formation of copper hydroxycarbonate as a more external CP. The dark inclusions observed in the CP7 and identified as covellite are likely to be residuals of copper sulfide inclusions from the metal microstructure.
