BRACELET BUS-NA 98 BZ 23 - BRONZE - IRON AGE - SWITZERLAND

Artefact name Bracelet bus-na 98 BZ 23

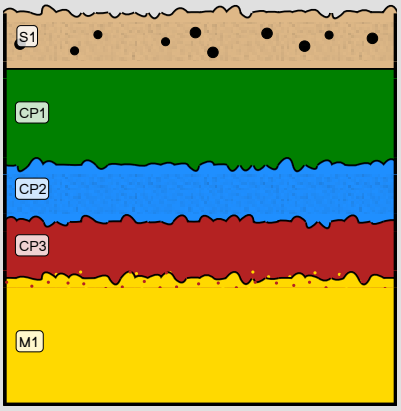
The transition between CP3 and the metal M1 is irregular and rough.

Fig. 3: Stratigraphic representation of the corrosion structure of the bracelet by macroscopic and binocular observation,

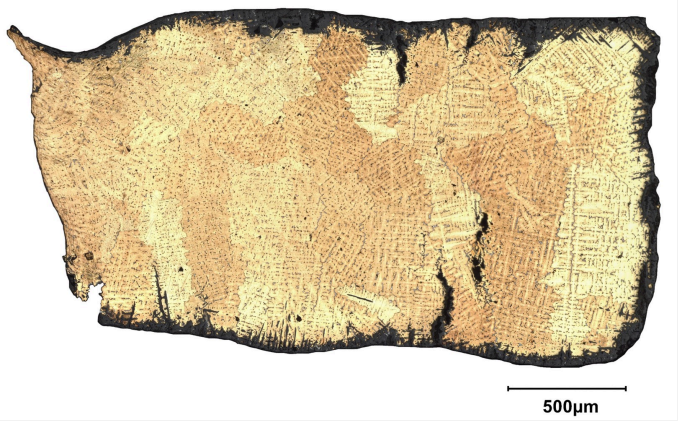
Elements	wt%
Cu	84
Sn	13
Pb	1
Ni	<0.5
As	<0.5
Si	<0.5
S	<0.5
Si	<0.5

Table 3: Chemical composition (wt%) of the alloy over a general area of analysis obtained by SEM-EDX, LMC-IRAMAT-CNRS-UTBM.

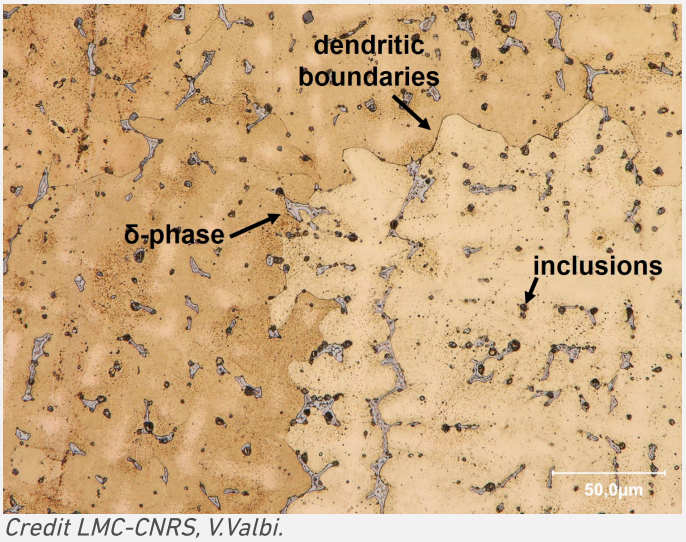
The metal has a dendritic structure (Fig. 6). Different dendritic grains are observed (with boundaries visible on Fig. 7).
The α phase constitutes the dendrites, the α+δ phase (grey) is observed in interdendritic areas.

Fig. 6: Micrograph of the etched cross-section of the sample taken from the bracelet (Fig. 2) in bright field,

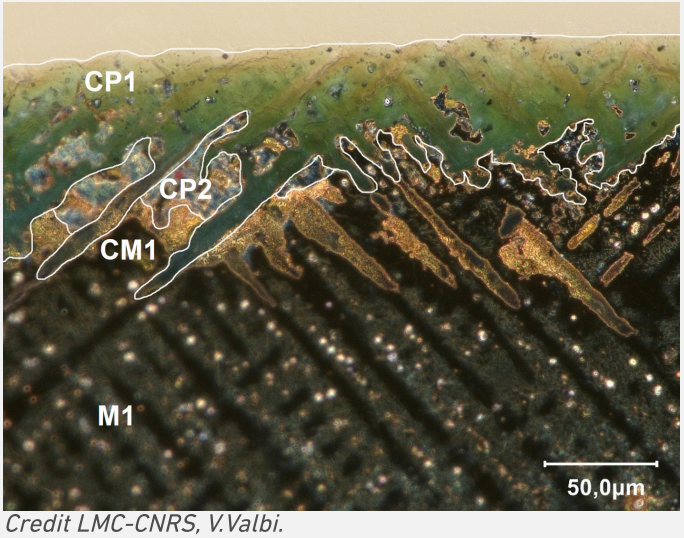
Selective corrosion of the α phase is locally observed following the dendritic microstructure (Fig. 8).

Fig. 8: Micrograph of the metal sample from Fig. 5 (detail), etched, bright field, showing the presence of selective corrosion,

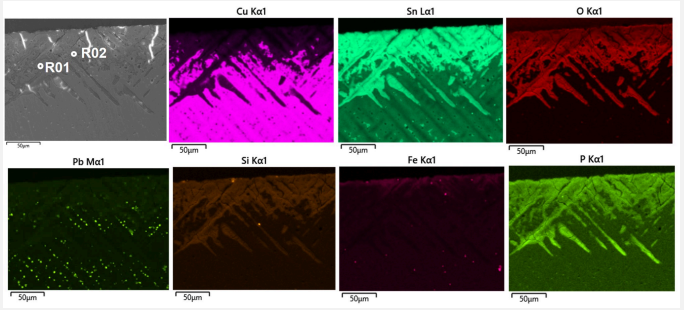
The observation of the sample in cross-section in dark field (Figs. 5 and 9) allowed to identify an external continuous green stratum (CP1), a red discontinuous thin stratum (CP2) and a corroded metal area (CM1) with an interface following the metal dendritic structure. The EDX elemental analysis (Table 4) and mapping (Fig. 10) of the visually identified CPs show that CP1 is Cu depleted, O and Sn enriched and polluted with Si, Ca, Fe and P. No EDX analysis is available for CP2. These results are in agreement with the preliminary XRF analysis.

Fig. 9: Micrograph of the corrosion structure from Fig. 5 (detail): green external CP1, red/gold CP2 following the dendritic structure,

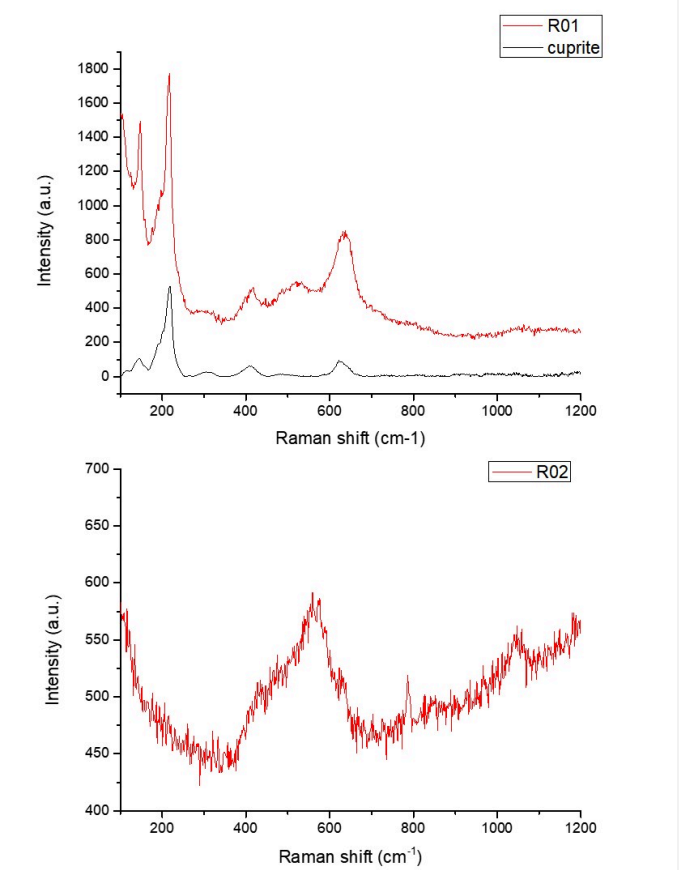
Analyses with µ-Raman were performed on the identified strata (Fig. 11). The R01 point of analysis was performed on the discontinuous CP2 layer and the obtained spectrum presented the typical main peaks (145, 218, 632 cm^{-1}) of the

Raman RUFF reference spectrum of cuprite Cu_2O (Lafuente et al. 2015). The R02 point of analysis was performed on the green layer and the spectrum obtained has a broad peak at 560 cm^{-1}) that can be attributed to nanocrystals of cassiterite Sn_2O thanks to comparison with the work of Ospitali et al. 2012.

Fig. 11: Raman spectra of points R01 (together with the RRUFF reference RRUFFID=R140763 for cuprite) and R02 showed in Fig. 10,

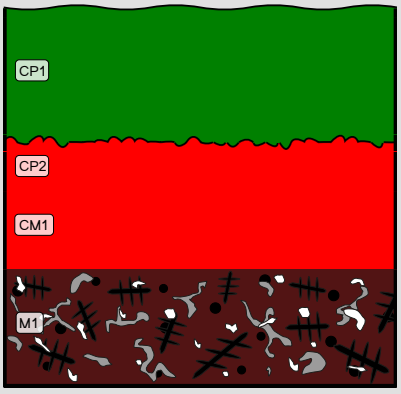
Fig. 12: Stratigraphic representation of the sample of the bracelet observed in cross-section under dark field using the MiCorr application. The characteristics of the strata are only accessible by clicking on the drawing that redirects you to the search tool by stratigraphy representation. This representation was build according to Fig. 9, Credit LMC-CNRS, V.Valbi.

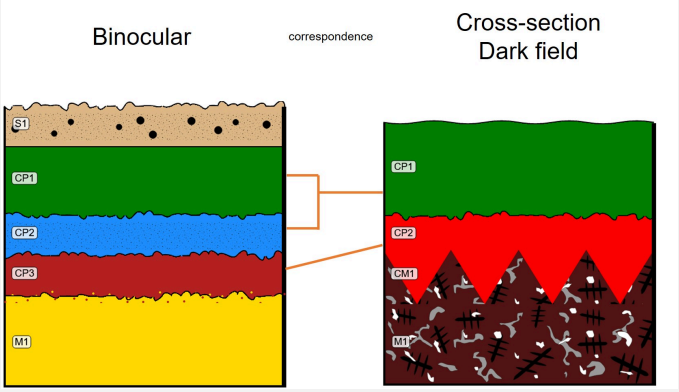
One S and three CPs were identified by binocular observation, while two CPs and a CM were observed in cross-section. It is reasonable to say that the CP1 and CP2 observed in binocular observation correspond to the CP1 observed in cross-section. In fact, in cross-section it is also possible to observe a different shade of green (yellowish) on the outer part of the CP1 that can justify the documentation of two different strata by the conservator. However the difference in color does not correspond in this case to a significant chemical difference, so it was identified as only one stratum in CS. The CP3 layer identified by binocular observation corresponds to the CP2 identified as cuprite in cross-section.

The outer sediment layer (S1), easily identified under binocular, was not visible in the cross-section. On the contrary, the presence of a CM1 stratum was only revealed through cross-section observation. Moreover, information obtained under binocular examination such as brightness, compactness, cohesion, and adherence are not accessible during cross-sectional observation. Conversely, the physico-chemical characteristics obtained by cross-section examination are not easily accessible during the binocular examination. The differences observed underline the necessity and complementarity of these two approaches.

Fig. 13: Stratigraphic representation side by side of binocular view and cross-section (dark field),
