BRACELET BUS-NA 98 BZ 38 - BRONZE - IRON AGE - SWITZERLAND

Artefact name Bracelet bus-na 98 BZ 38

Authors Christian. Degrigny (HE-Arc CR, Neuchâtel, Neuchâtel, Switzerland) & Naima. Gutknecht (HE-Arc CR, Neuchâtel, Neuchâtel, Switzerland) & Valentina. Valbi (Laboratoire Métallurgie et Culture LMC-IRAMAT-CNRS-UTBM, Belfort, Franche-Comté, France)

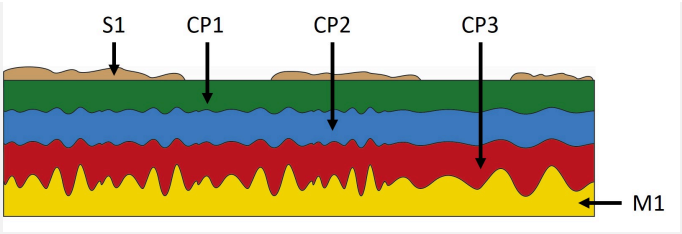
Strata	Type of stratum	Principal characteristics
S1	Soil	light brown, thin, non-compact, powdery
CP1	Corroded product	dark green, medium, continuous, compact, soft
CP2	Corroded product	blue, thin, continuous, compact, very soft
CP3	Corroded product	red, thin, continuous, compact, hard
M1	Metal	dark yellow, metallic, hard

The transition between CP3 and the metal M1 is irregular.

Fig. 3: Stratigraphic representation of the corrosion structure of the bracelet by macroscopic and binocular observation,

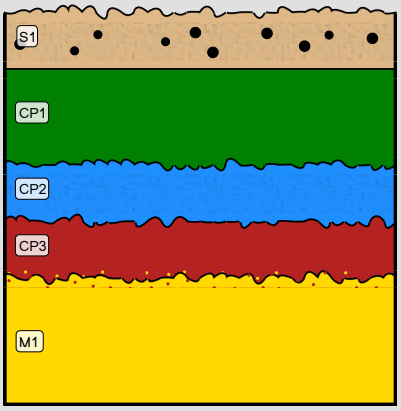
Fig. 4: Stratigraphic representation of the corrosion structure of the bracelet observed macroscopically under binocular microscope using the MiCorr application with reference to the whole Fig. 3. The characteristics of the strata are only accessible by clicking on the drawing that redirects you to the search tool by stratigraphy representation, Credit HE-Arc CR, N.Gutknecht.

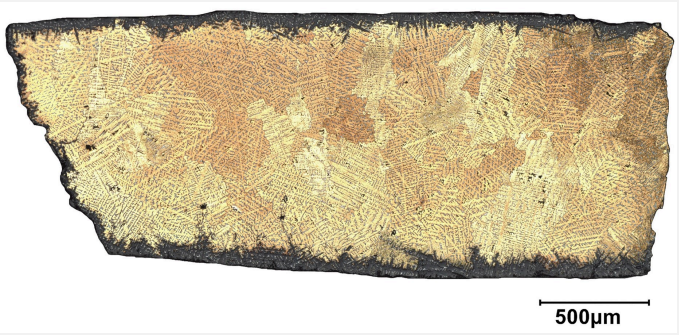
EDX analysis of the residual metal on cross-section indicates that it is a high tin bronze (16 wt% Sn) (Table 3).
The metal has a dendritic structure (Fig. 6). Boundaries are visible between the dendrites (Fig. 7). The α phase constitutes the dendrites, the α+δ phase (grey) is observed in interdendritic areas.
Small Pb inclusions (2-3 µm, Fig. 7) are homogeneously distributed on the whole surface of the sample.

Fig. 6: Micrograph of the etched cross-section of the sample taken from the bracelet (Fig. 2) in bright field,

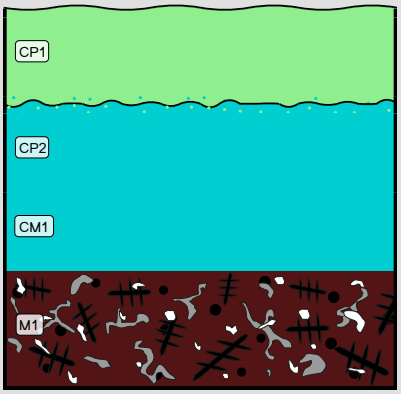
Fig. 12: Stratigraphic representation of the sample of the bracelet observed in cross-section under dark field using the MiCorr application. The characteristics of the strata are only accessible by clicking on the drawing that redirects you to the search tool by stratigraphy representation. This representation was build according to Fig. 9, Credit LMC-CNRS, V.Valbi.

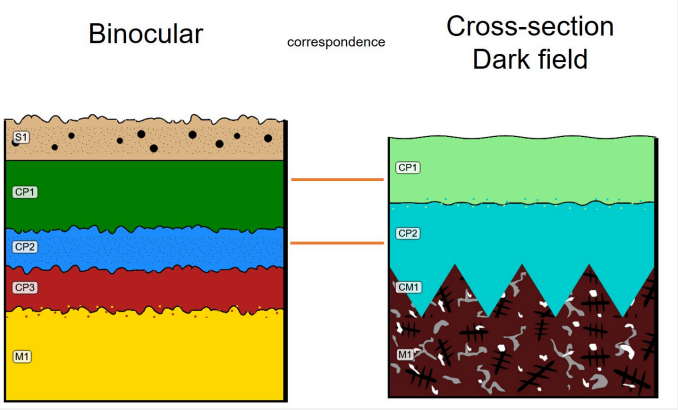
One S1 and three CPs were identified by binocular observation, while two CPs and a CM1 were observed in cross-section.

The CP1 and CP2 observed in binocular observation correspond to the CP1 and CP2 observed in cross-section. The internal CP3 layer identified by binocular observation was not observed in cross-section. This could be explained by a discontinuous CP3 strata on the object.

The outer sediment layer (S1), easily identified under binocular, was not visible in the cross-section. On the contrary, the presence of a CM1 stratum was only revealed through cross-section observation. Moreover, information obtained under binocular examination such as brightness, compactness, cohesion, and adherence are not accessible during cross-sectional observation. Conversely, the physico-chemical characteristics obtained by cross-section examination are not easily accessible during the binocular examination. The differences observed underline the necessity and complementarity of these two approaches.

Fig. 13: Stratigraphic representation side by side of binocular view and cross-section (dark field),
