BRACELET BUS-NA 98 BZ 38 - BRONZE - IRON AGE - SWITZERLAND

Artefact name Bracelet bus-na 98 BZ 38

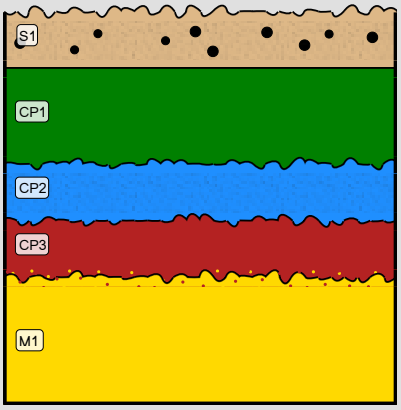
Fig. 4: Stratigraphic representation of the corrosion structure of the bracelet observed macroscopically under binocular microscope using the MiCorr application with reference to the whole Fig. 3. The characteristics of the strata are only accessible by clicking on the drawing that redirects you to the search tool by stratigraphy representation, Credit HE-Arc CR, N.Gutknecht.

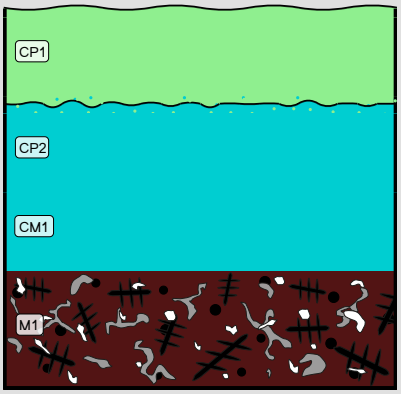
Fig. 12: Stratigraphic representation of the sample of the bracelet observed in cross-section under dark field using the MiCorr application. The characteristics of the strata are only accessible by clicking on the drawing that redirects you to the search tool by stratigraphy representation. This representation was build according to Fig. 9, Credit LMC-CNRS, V.Valbi.
