COIN CDN 2012-1-55 - CU ALLOY - LATE ROMAN TIMES - SWITZERLAND

Artefact name Coin CdN 2012-1-55

Authors Naima. Gutknecht (HE-Arc CR, Neuchâtel, Neuchâtel, Switzerland) & Valentina. Valbi (Laboratoire Métallurgie et Culture (LMC), Belfort, Franche-Comté, France) & Rey-Bellet. Bernadette (Musée d'art et d'histoire, Genève, Genève, Geneva, Switzerland)

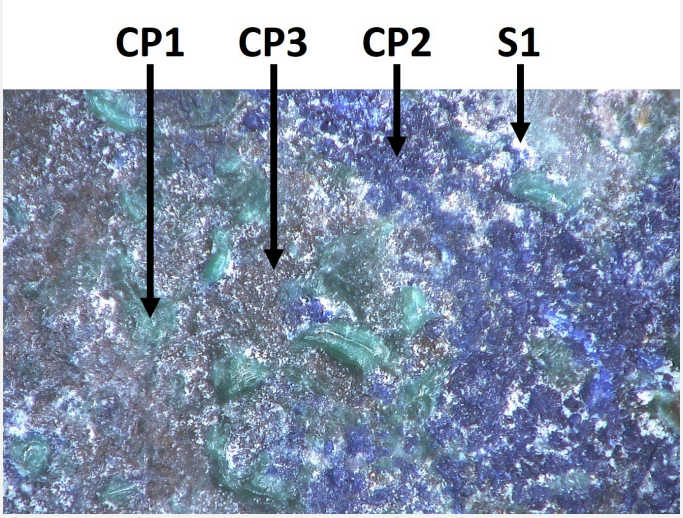
Fig. 2: Location of the detail (Fig. 3) and of the sampling for cross-section,

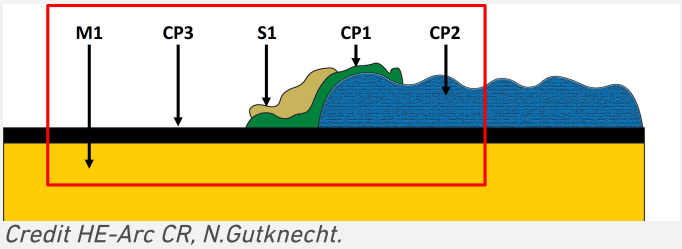
Table 1: Description of the principal characteristics of the strata as observed under binocular and described according to Bertholon's method.

Strata	Type of stratum	Principal characteristics
S1	Soil	Cluster, light grey, thin, scattered, non-compact, soft
CP1	Corrosion product	Cluster, dark green, medium, scattered, compact, very soft
CP2	Corrosion product	Cluster, blue, medium, scattered, compact, very soft
CP3	Corrosion product	Layer, black, thin, continuous, compact, soft
M1	Metal	Dark yellow, metallic, soft

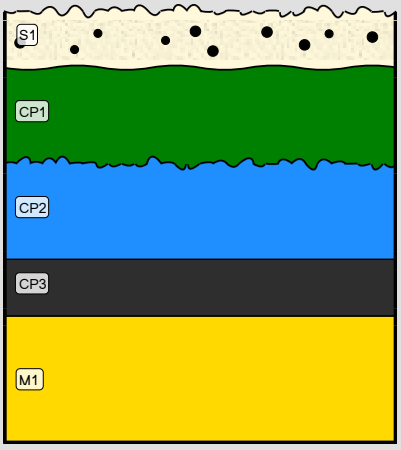
Fig. 5: Stratigraphic representation of the corrosion structure of the coin observed macroscopically under binocular microscope using the MiCorr application. The characteristics of the strata are only accessible by clicking on the drawing that redirects you to the search tool by stratigraphy representation, Credit MAHG, B.Rey-Bellet/HE-Arc CR, N.Gutknecht.

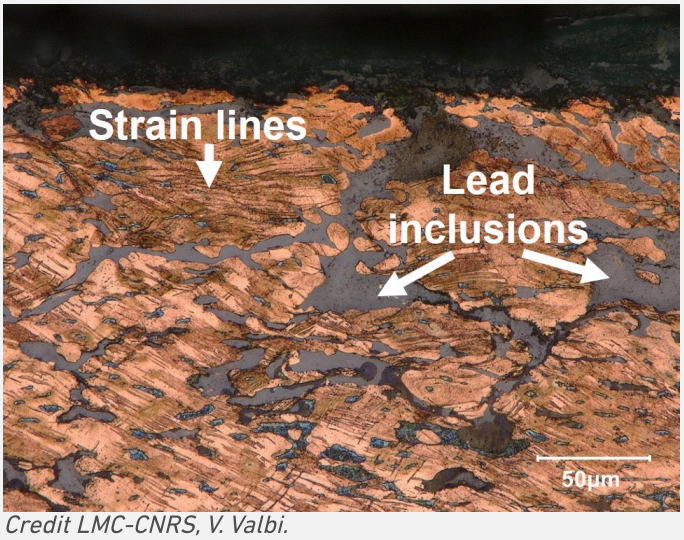
The sample presents on its whole thickness big Pb inclusions (50-100 µm, Figs. 7 and 8) homogeneously distributed. The metal has a polygonal grain structure (Figs. 8-9) with locally elongated grains and slip lines revealing that the object underwent cold working. Several longitudinal cracks are observed and are filled with corrosion products (Fig. 9).

Fig. 7: Micrograph (similar to Fig. 6) of the cross-section of the sample taken from the coin (Fig. 2) in bright field after chemical etching,

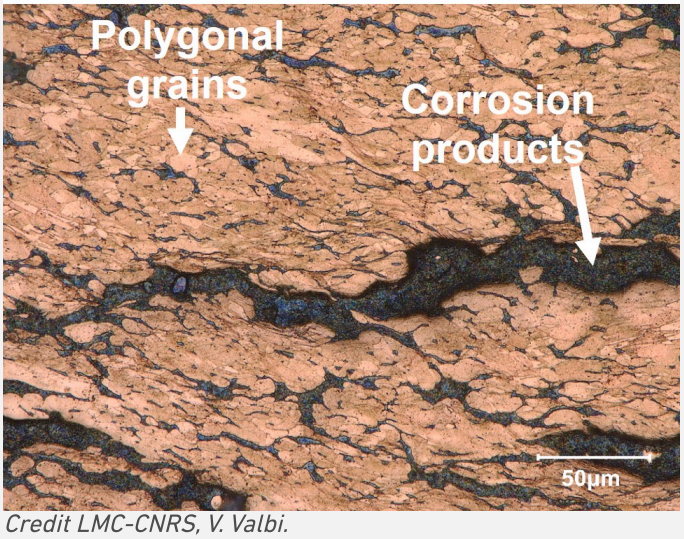
Fig. 8: Micrograph of the metal sample from Fig. 7 (detail), etched, bright field. Elongated grains with slip lines are observed, as well as grey lead inclusions,

The coin is composed of a Cu-Pb-Sn ternary bronze alloy with high Pb percentages (29 wt%). Pb is not soluble in the bronze metallic structure and large lead inclusions are observed throughout the whole metal thickness. The metallic microstructure reveals that the object underwent cold working. The whole object is fragilised by the presence of longitudinal cracks filled with corrosion products.

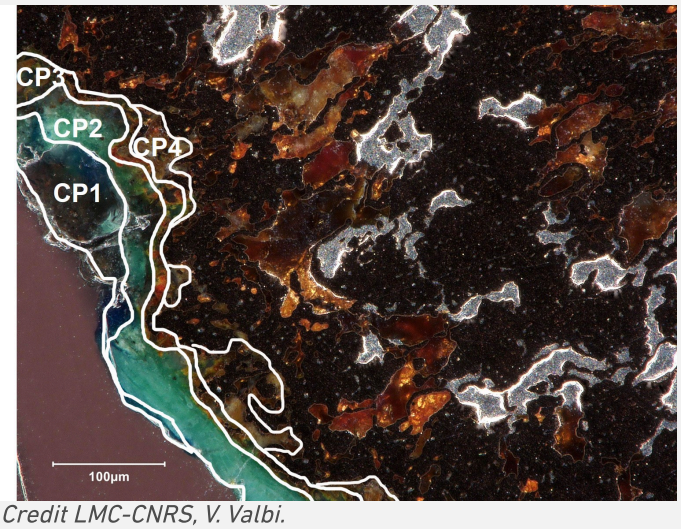
The observation of the sample in cross-section in dark field mode shows the presence of an external blue CP1 layer with sand inclusions, on top of a green CP2 layer, then a red thin internal CP3 layer and an orange CP4 also present in the inclusions inside the corroded metal (Fig. 10).

Fig. 10: Micrograph of the sample from Fig. 6 (detail), unetched, dark field with location of CP strata,

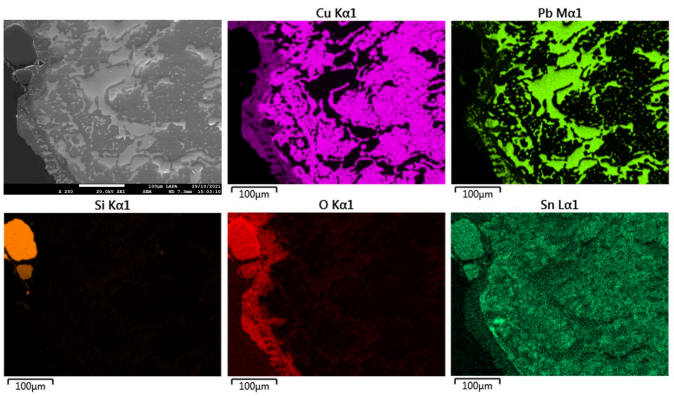
The EDX elemental analysis (Table 4, Fig.11) of the visually identified CPs by cross-sectional observation shows that the external CP1 and CP2 are Cu-based products with only few amounts of lead (3 wt %), while the orange CP4 is a lead-based compound.

Fig. 11: SEM image, BSE-mode, and elemental chemical distribution of Fig. 10,

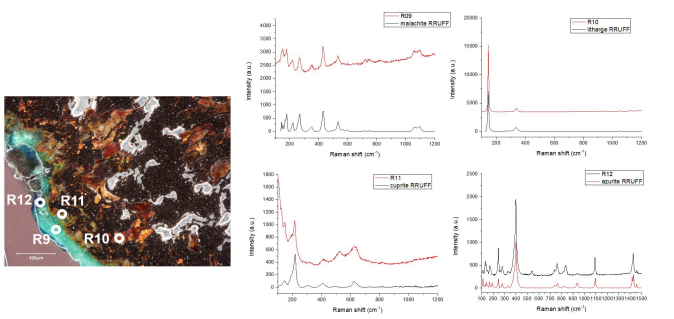
µ-Raman analyses were performed on the identified strata when possible (Fig. 12). The R12 point of analysis was performed on the blue CP1 layer and the corresponding spectrum presented the typical main peaks of azurite ($Cu_3(CO_3)_2(OH)_2$), The R9 point of analysis in the green CP2 layer shows the typical peaks of malachite ($Cu_2(CO_3)(OH)_2$). The R11 point of analysis was performed on the red thin CP3 layer and shows the main peaks of cuprite (Cu_2O), while the R10 point of analysis was performed on the internal orange corrosion products and showed the typical peaks of litharge (PbO).

Fig. 12: Raman points of analysis and corresponding spectra overlapped with reference spectra for malachite RRUFFID=R050508, litharge RRUFFID=R060959, cuprite RRUFFID=R140763, azurite RRUFFID=R050497,

The external corrosion products are composed of Cu-based hydroxycarbonate (azurite and malachite) formed by redeposition of copper with the carbonate ions from the burial environment. Cuprite (Cu_2O) is also identified at the metal interface and is the first corrosion product usually formed on bronzes, while litharge (PbO) is observed in the corroded metal stratum, replacing the lead inclusions selectively attacked.

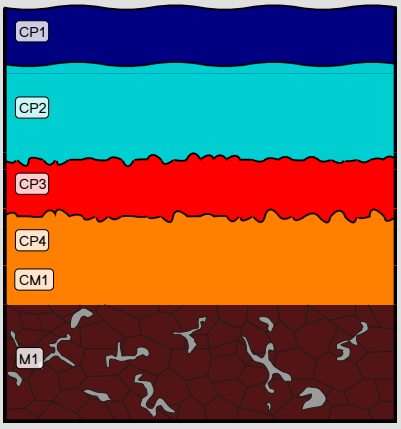
Fig. 13: Stratigraphic representation of the sample of the coin BL55 observed in cross-section under dark field using the MiCorr application. The characteristics of the strata are only accessible by clicking on the drawing that redirects you to the search tool by stratigraphy representation. This representation was build according to Fig. 10, Credit LMC-CNRS, V.Valbi

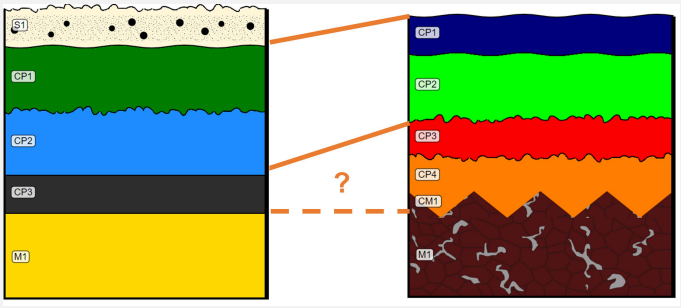
The stratigraphies obtained by binocular and cross-section observation show a few differences that can be attributed to the different scales of observation. In fact, under binocular it is possible to differentiate strata according to texture and light colour changes that do not always correspond to changes in chemical composition, thus leading to a regrouping of several strata into one according to the cross-section observation and physicochemical characterization.

The strata S1 observed in binocular is lacking in cross-section observation, probably due to a different observation location. The CP1 and CP2 layers observed by binocular probably correspond to the CP1 and CP2 observed in cross-section, but with the green and the blue layer inversed. The blue CP2 layer observed in binocular mode could correspond to the blue CP1 observed in cross-section and the green CP1 in binocular to the green CP2 in CS. This could be explained as well by the different locations of the observations carried out. Finally, the red cuprite CP3 and the orange litharge CP4 observed in cross-section as well as the corroded metal strata CM1 observed in cross-section were not clearly identified by binocular observation. Still, they could be linked to the black CP3 layers that can not be linked with certainty to any strata in cross-section, but probably a regrouping of CP3, CP4 and CM1. The binocular view rarely allows documenting CM strata, as the transition between layers is difficult to assess.

Fig. 14: Stratigraphic representation side by side of binocular view and cross-section (dark field),
