BUST OF AN APPLIQUE 2005.054.F00265.1 - QUARTERNARY BRONZE ALLOY - ROMAN TIMES - SWITZERLAND

Artefact name Bust of an applique 2005.054.F00265.1

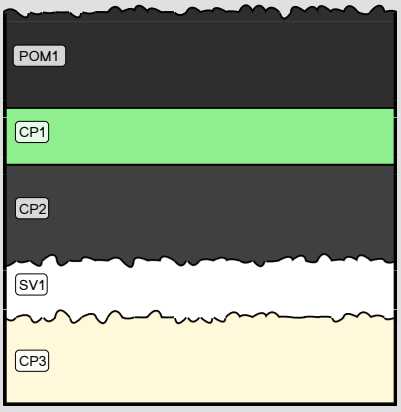
Fig. 6: Stratigraphic representation of the corrosion structure of the bust observed macroscopically under binocular microscope using the MiCorr application. The characteristics of the strata are only accessible by clicking on the drawing that redirects you to the search tool by stratigraphy representation. This representation can be compared to Fig. 5, Credit HE-Arc CR, C.Degrigny.

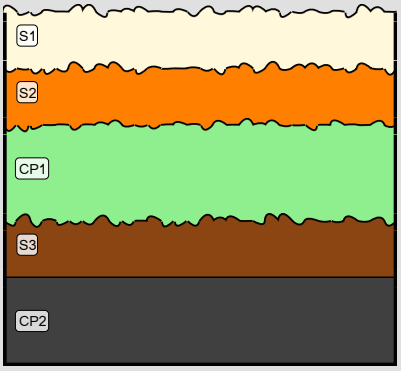
Fig. 7: Stratigraphic representation of the corrosion structure of the bust observed macroscopically under binocular microscope using the MiCorr application. The characteristics of the strata are only accessible by clicking on the drawing that redirects you to the search tool by stratigraphy representation. This representation can be compared to Fig. 5, Credit HE-Arc CR, C.Degrigny.
