AIRCRAFT FRONT FASTENING PLATE VHS-497 (2) - AL CU SN ZN SI ALLOY - MODERN TIMES

Artefact name	Aircraft front fastening plate VHS-497 (2)
Authors	Marianne. Senn (Empa, Dübendorf, Zurich, Switzerland) & Christian. Degrigny (HE-Arc CR, Neuchâtel, Neuchâtel, Switzerland)
Url	/artefacts/1213/

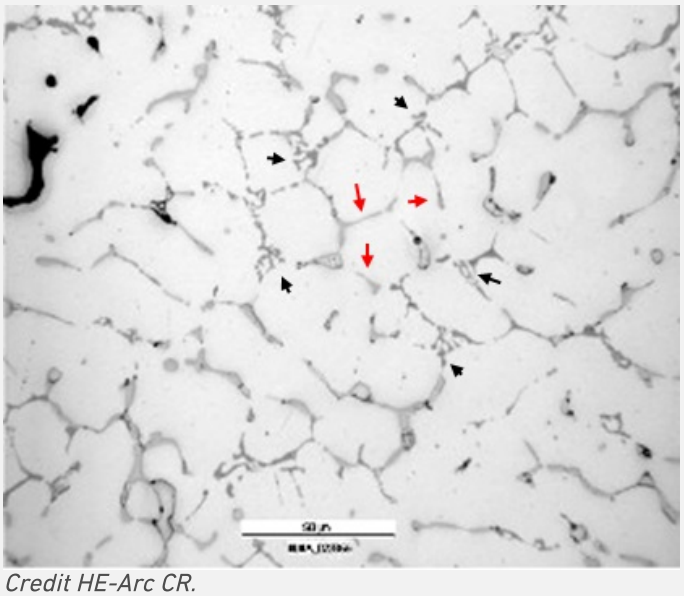
The metal is an aluminium alloy containing Cu, Sn, Zn and Si (Table 1). The unetched metal shows an as-cast structure consisting of the aluminium matrix with Sn (not soluble in Al) inclusions (Figs. 4 and 5), intermetallic compounds such as Al_2Cu (Fig. 4, red arrows) and clusters of Al,Fe,Cu & Si phases (Fig. 4, black arrows). There are porosities in the metal (Figs. 3 and 5). The average hardness of the metal is HV1 80.

Table 1: Chemical composition (mass %) of the metal and inclusions (from Fig. 5). Method of analysis: SEM/EDS, Laboratory of Analytical Chemistry, Empa.

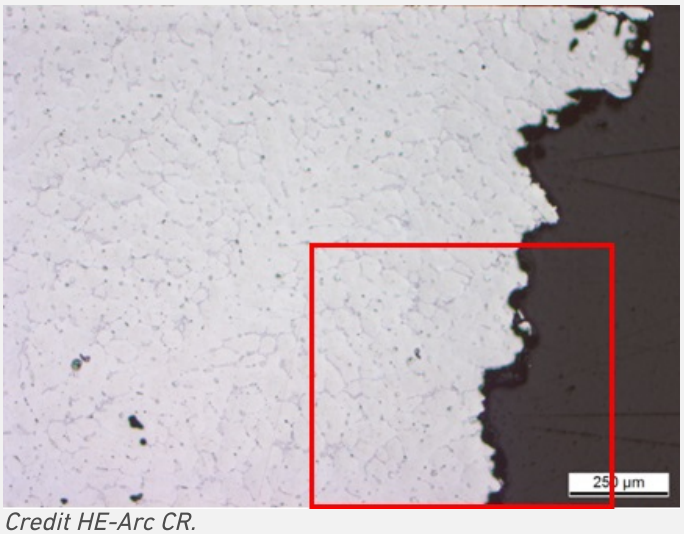
No corrosion layer can be seen on the metal surface (Figs. 3 and 6). Under polarized light small white and brown particles are visible on the broken edge (D1, Fig. 7). Their analysis reveals the presence of silica particles surrounded by dirt (Table 2 and Fig. 8). The metal surface is covered by a thin oxygen bearing skin (CP1, Fig. 8).

Table 2: Chemical composition (mass %) of the adhering particles to the metal surface (from Fig. 8). Method of analysis: SEM/EDS, Laboratory of Analytical Chemistry, Empa.

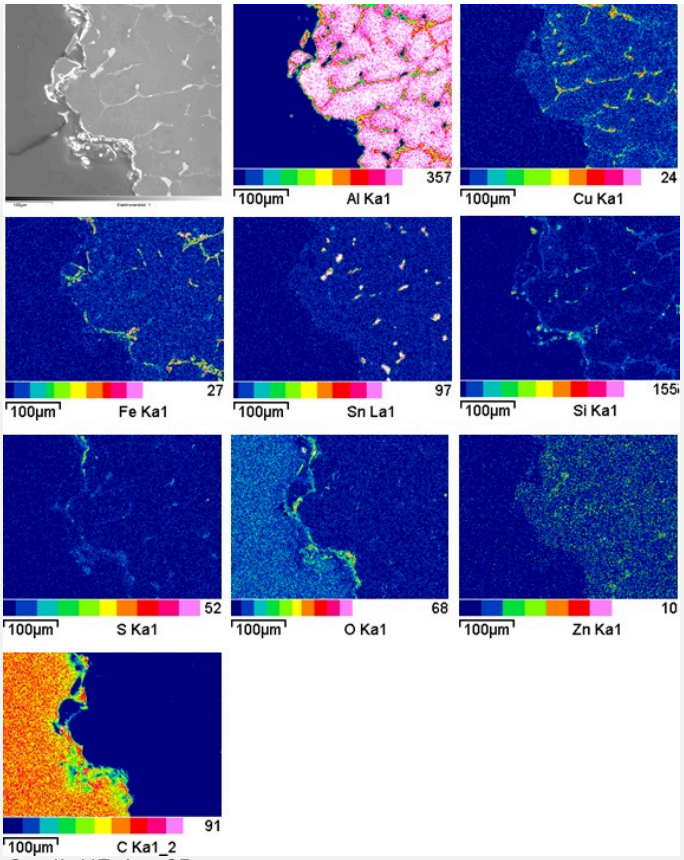
Fig. 8: SEM image, BSE-mode, and elemental chemical distribution of the selected area from Fig. 7 (reversed picture, detail). Method of examination: SEM/EDS, Laboratory of Analytical Chemistry, Empa,

This front fastening plate of Dufaux IV plane is made in cast Al-Cu-Sn-Zn-Si, an alloy rather common at the beginning of the 20th century. No corrosion layer has been found on the metal surface except adherent silica-rich particles and the thin oxidised skin typical of Al alloys. The presence of these materials can be explained by the regular maintenance of the metal, probably using silicon carbide abrasive paper.

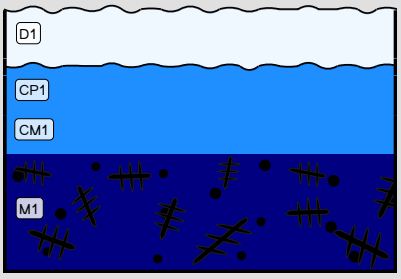
Fig. 9: Stratigraphic representation of the sample taken from the front fastening plate in cross-section (dark field) using the MiCorr application. The characteristics of the strata are only accessible by clicking on the drawing that redirects you to the search tool by stratigraphy representation. This representation can be compared to Fig. 7, Credit HE-Arc CR.
