DEFORMED FRAGMENT OF METAL SHEET WT10-M305 - TIN BRONZE - IRON AGE - SWITZERLAND

Artefact name	Deformed fragment of metal sheet WT10-M305
Authors	Marianne. Senn (EMPA, Dübendorf, Zurich, Switzerland) & Christian. Degrigny (HE-Arc CR, Neuchâtel, Neuchâtel, Switzerland)
Url	/artefacts/1216/

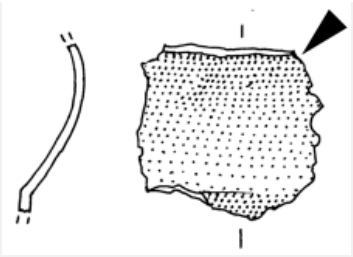
Fig. 1: Deformed fragment of metal sheet (section and front side) (after Department of Prehistory, University of Zurich),

Description of the artefact	Deformed fragment of metal sheet with a dark green and grey powdery surface (patina) that might have been caused by exposure to high temperatures (Fig. 1). A green layer appears below the dark surface. Dimensions: L = 2.4cm; W = 2.3cm; WT = 4.8g.
Type of artefact	Metal sheet
Origin	Ritual place Wartau Ochsenberg, Sankt Gallen, Saint Gallen, Switzerland
Recovering date	Excavation in 1991
Chronology category	Iron Age
chronology tpq	500 B.C.
chronology taq	401 B.C.
Chronology comment	5th Century BC
Burial conditions / environment	Soil
Artefact location	Kantonsarchäologie, Sankt Gallen, Saint Gallen
Owner	Kantonsarchäologie, Sankt Gallen, Saint Gallen
Inv. number	WT10-M305
Recorded conservation data	Not conserved

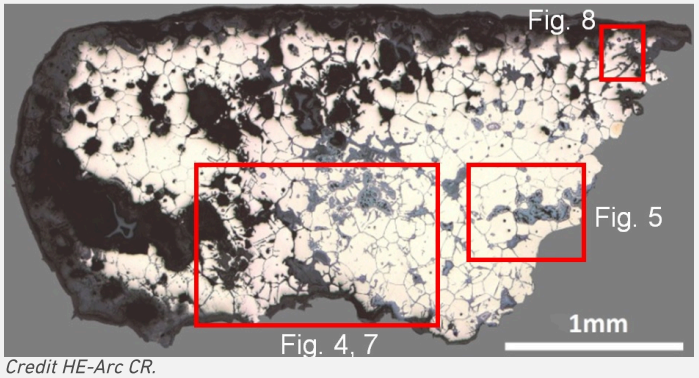
Fig. 3: Micrograph of the cross-section of the sample (Fig. 2) taken from the deformed fragment of metal sheet with dark green / grey patina showing the location of Figs. 4, 5, 7 and 8, unetched, bright field,

Description of sample	The sample is a section from the top right corner of the sheet (Fig. 2). Its dimensions are: L = 2.5mm and W = 2.3mm. The metal is surrounded on three sides by corrosion products. Intergranular corrosion has developed throughout the metal section (Fig. 3).
Alloy	Tin Bronze
Technology	Secondary recrystallization (produced by burning) after cold working
Lab number of sample	MAH 92-5-2-003
Sample location	Musées d'art et d'histoire, Genève, Geneva
Responsible institution	Musées d'art et d'histoire, Genève, Geneva
Date and aim of sampling	1992, examination of the corrosion layer

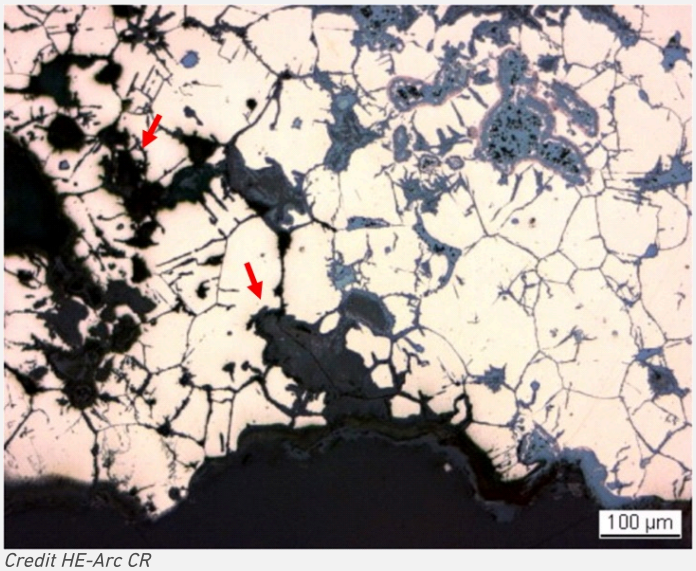
The remaining metal is a porous (red arrows on Fig. 4) tin bronze (Table 1). Five analyses were carried out. S was detected in the non-corroded part of the metal (2 measurements) while P was present only in the corroded metal (3 measurements). As no major difference in the composition was observed (comparison of relative standard deviation, RSD) all analyses were used to calculate the median value. Inter- and transgranular corrosion has developed so extensively that all grain boundaries and twin lines are outlined (Fig. 4). After etching, the metal shows annealed polygonal grains with a few twins and slip lines below the surface (Fig. 5). The slip lines are restricted to the right side of the sample where the metal is best preserved (Fig. 4). The grain size varies between 50 and 170µm, due to an excessively long or hot annealing procedure leading to a grain coarsening. Small copper sulphide inclusions appear in blue (Fig. 4). The average hardness of the metal is HV1 90.

Fig. 4: Micrograph of the metal sample from Fig. 3 (detail), unetched, bright field. Extensive inter- and transgranular corrosion has developed within the metal. Possible large pores are visible (arrows) inside the remaining metal,

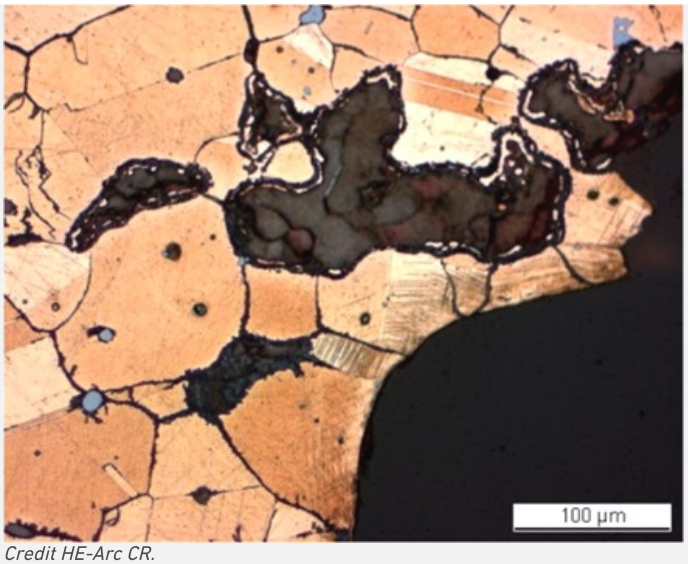
Fig. 5: Micrograph of the metal sample from Fig. 3 (detail), etched, bright field. We observe pink-orange polygonal grains with twins and slip lines as well as copper sulphide inclusions (in blue),

Microstructure	Large polygonal grains with few twins + strain lines
First metal element	Cu
Other metal elements	As, Sn

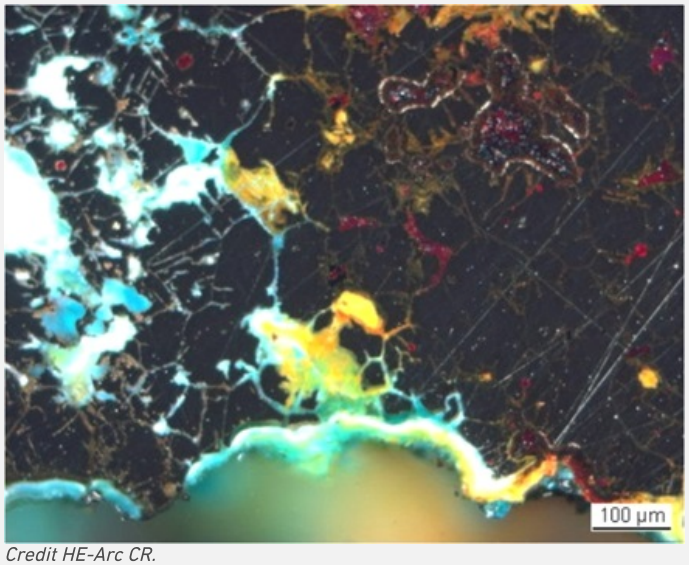
The corrosion crust varies in thickness between 60 and 150µm (Fig. 3). In bright field, it appears dark-grey (Fig. 4) and consists of two layers (CP1 and CP2). The inner layer is dark-grey and dense while the thin outer layer is slightly lighter coloured. Within the metal, the corrosion products are light-grey (CP3, Fig. 4). Under polarized light, the corrosion layer turns blue-green with dark-blue areas (Figs. 6 and 7) whereas corrosion products inside the metal are either light-blue or red-orange (Figs. 6 and 7). The red corrosion products (CP3) have the composition of cuprite/Cu2O while the orange compounds (also CP3) are enriched in Sn (Table 2). The blue-green corrosion products (CP2) both within the remaining metal and on the surface are even richer in Sn and O, and contain some P (Table 2 and Fig. 8). The thin, irregular dark-grey surface layer (CP1) is enriched in P, Fe, Si and Al (Table 2 and Fig. 8). XRD analyses of powdery particles sampled from the thin, dark surface corrosion layer (CP1) indicate the presence of tenorite/CuO and cassiterite/SnO2 (Museum report 1992). The Raman spectra of this layer (Fig. 9) confirmed the presence of tenorite.

Fig. 6: Micrograph of the cross-section of the metal sample (same as Fig. 3) and corresponding to the stratigraphy of Fig. 10, polarised light, showing the location of Fig. 7,

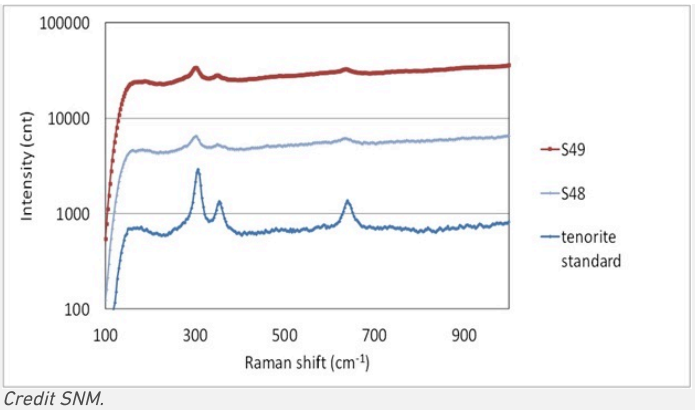
Fig. 9: Raman spectra of the outer dark corrosion layer (S48 and S49) compared to a tenorite standard spectrum. Settings: laser wavelength 532nm, acquisition time 20s for S48 and 100s for S49, one accumulation, filter D1 (7.5-8mW), hole 500, slit 80, grating 600. Method of analysis: Raman spectroscopy, Lab of Swiss National Museum, Affoltern a. Albis ZH,

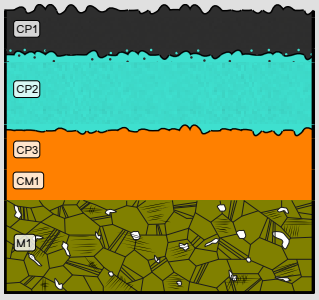
Fig. 10: Stratigraphic representation of the sample taken from the deformed fragment of metal sheet with dark green / grey patina in cross-section (dark field) using the MiCorr application. The characteristics of the strata are only accessible by clicking on the drawing that redirects you to the search tool by stratigraphy representation. This representation can be compared to Fig. 6, Credit HE-Arc CR.
