SACRIFICIAL ANODE VHS-8339 - ZN ALLOY - MODERN TIMES

Artefact name	Sacrificial anode VHS-8339
Authors	Marianne. Senn (Empa, Dübendorf, Zurich, Switzerland) & Christian. Degrigny (HE-Arc CR, Neuchâtel, Neuchâtel, Switzerland)
Url	/artefacts/1218/

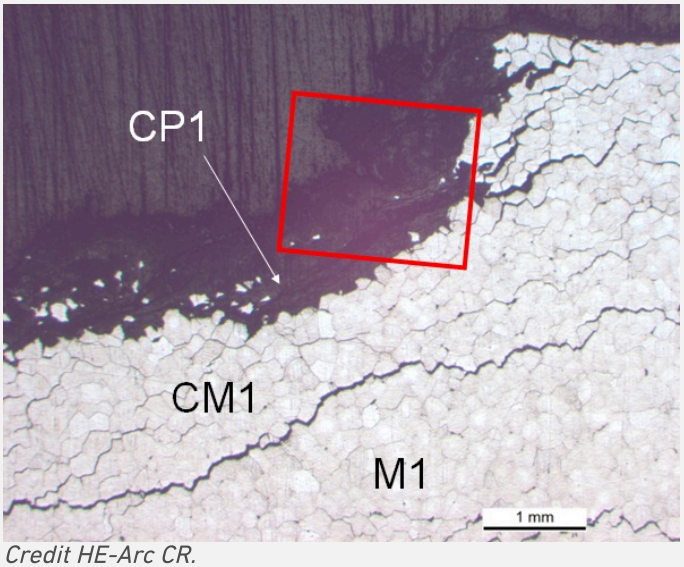
The remaining metal is an almost pure zinc alloy (Table 1). The oxygen content is not from the original alloy, but is due to secondary corrosion. The metal grains are visible without etching and present a polygonal structure (Figs. 4 and 5). The structure is recrystallised after annealing. The recrystallization of zinc alloys begins at room temperature.

Elements	Zn	Al	O	Total
Metal	95	1	2	98

Table 1: Chemical composition (mass %) of the metal. Method of analysis: SEM/EDS, Lab Analytical Chemistry, Empa.

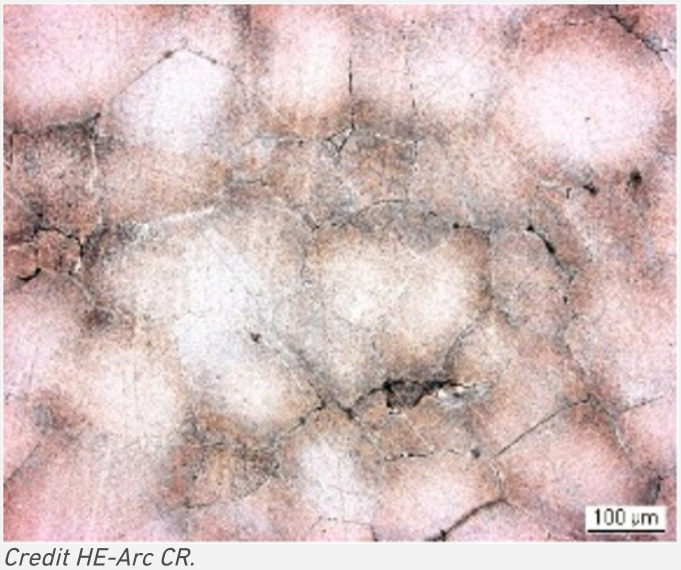
Fig. 4: Micrograph of the metal sample from Fig. 3 (reversed picture, detail), unetched, bright field. Extensive intergranular corrosion is visible.The rectangle marks Fig. 6,

Extensive intergranular corrosion / cracking has developed in the metal structure (Figs. 4, 5). The metal is covered by a corrosion crust that is hardly visible in bright field and which contains remnant metal (Fig. 4). On most of the sample the corrosion crust is uniform. In areas we see cracks (Fig. 6) appearing as brown lines separating the corrosion crust (Fig. 7). In bright field the corrosion crust appears grey containing dark-grey zones (Fig. 6). Under polarized light, the corrosion crust appears white with darker parts including remnant metal (Fig. 7). It contains Zn and O as well as S along some cracks (Table 2 and Fig. 8).

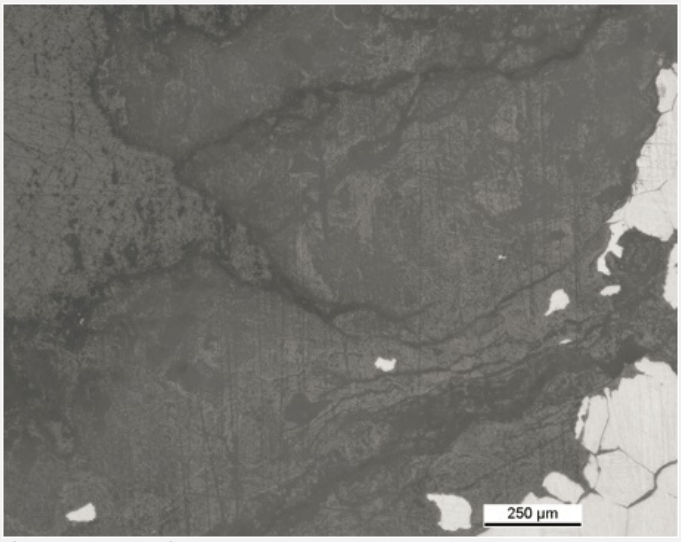
Elements	O	Al	Zn	Total
Light-grey corrosion part	23	<	77	98
Dark grey corrosion part	38	<1	68	107

Table 2. Chemical composition (mass %, <: below the detection limit) of the corrosion layer from Figs. 6 and 8. Method of analysis: SEM/EDS, Laboratory of Analytical Chemistry, Empa.

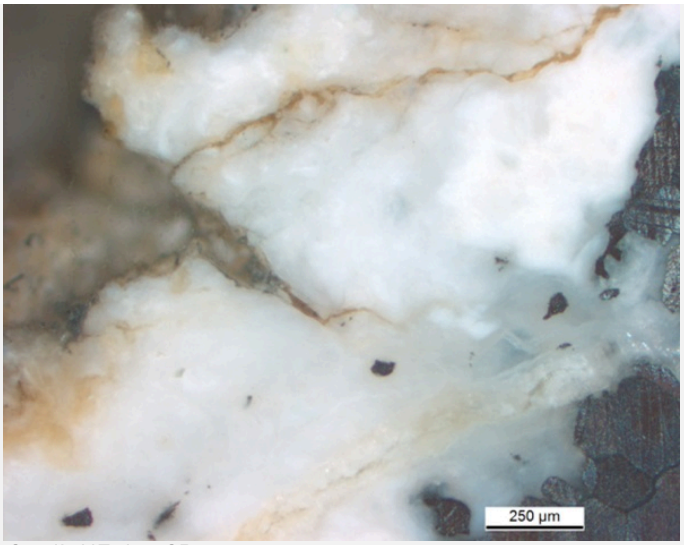
Fig. 6: Micrograph showing the metal - corrosion products interface from Fig. 5 (detail), unetched, bright field,

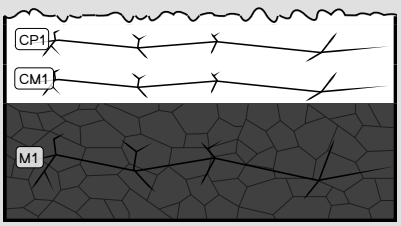
Fig. 9: Stratigraphic representation of the fragment sampled from the sacrificial anode in cross-section (dark field) using the MiCorr application. The characteristics of the strata are only accessible by clicking on the drawing that redirects you to the search tool by stratigraphy representation. This representation can be compared to Fig. 5, Credit HE-Arc CR.
