BLADE FRAGMENT OF A WINGED AXE FK43 – TIN BRONZE – MIDDLE BRONZE AGE – SWITZERLAND

Artefact name	Blade fragment of a winged axe FK43
Authors	Marianne. Senn (Empa, Dübendorf, Zurich, Switzerland) & Christian. Degrigny (HE-Arc CR, Neuchâtel, Neuchâtel, Switzerland)
Url	/artefacts/1223/

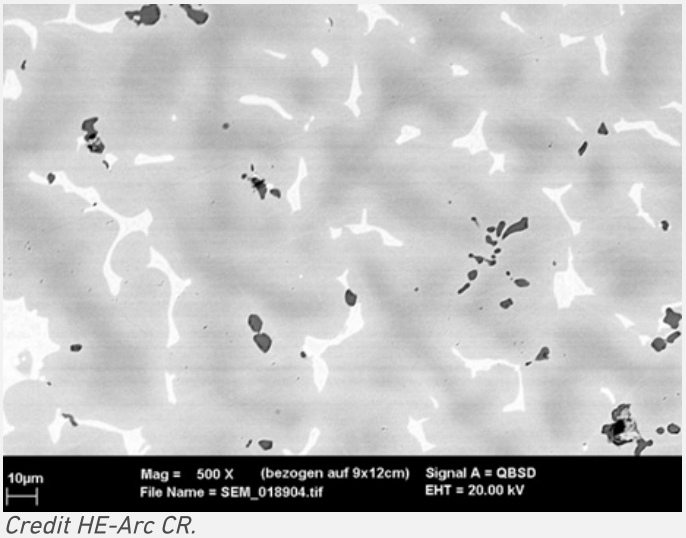
The remaining metal is a tin bronze containing some As (Table 1) with high porosity and grey copper sulphide inclusions (Figs. 4 and 5, Table 2). The etched metal has the typical dendritic structure of a cast tin bronze with an average hardness of HV1 135 (Fig. 6). The cored dendritic structure is surrounded by an alpha-delta eutectoid. The core of the dendrites is rich in Cu whereas the outer layers are rich in Sn.

Table 2: Chemical composition (mass %) of the dark-grey inclusions seen in Fig. 4. Method of analysis: SEM/EDS, Laboratory of Analytical Chemistry, Empa.

Fig. 4: SEM image of the metal sample from Fig. 3 (detail), BSE-mode. The cored alpha phase of the dendrites appears in grey, becoming lighter towards the periphery (more Sn). The alpha-delta eutectoid appears in white and the copper sulphide inclusions in dark-grey,

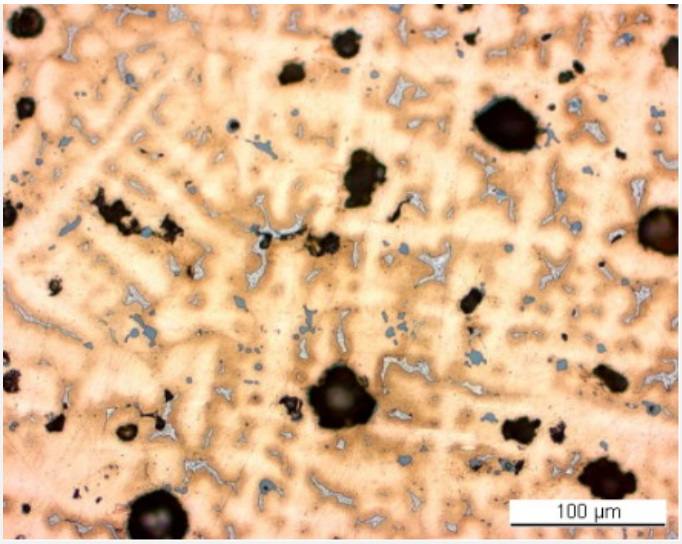
Fig. 5: Micrograph of the metal sample from Fig. 3, etched, bright field. We observe the eutectoid phase in light grey and copper sulphide inclusions in dark-grey,

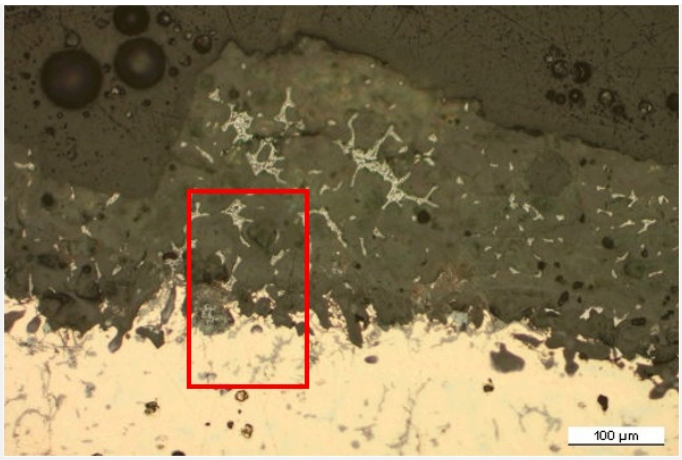
A dark green corrosion crust with a thickness between 100 and 320µm covers the entire surface of the blade fragment (Fig. 6). It retains a metallic ghost structure (Sn-rich eutectoid alpha + delta phase). Under polarized light localized orange and red corrosion products can be seen at the metal - corrosion crust interface (Fig. 7). Interdendritic corrosion and corroded slip lines can be seen in the metal structure and near fissures (Fig. 8). Elemental mapping (Fig. 9) shows that the green layer is Sn-rich (CP1, probably cassiterite, SnO_2) and depleted of Cu, whereas the orange and red corrosion aggregates are depleted of Sn and rich in Cu (Fig. 9, Table 3). Their Raman spectra indicate that they are mainly composed of cuprite (Fig. 10). The overall corrosion crust contains O, Si, C and Fe from the environment, while S is concentrated around the cuprite particles (Fig. 9).

Fig. 6: Micrograph of the metal sample from Fig. 3 (rotated 180°), unetched, bright field. A metallic ghost structure is preserved in the corrosion crust. The area selected for elemental chemical distribution (Fig. 9) is marked by a red rectangle,

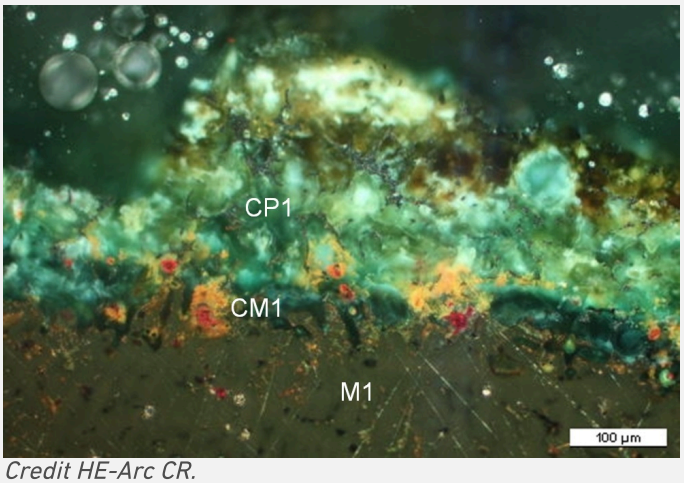
Fig. 7: Micrograph similar to Fig. 6 and corresponding to the stratigraphy of Fig. 11, polarised light. At the metal - green corrosion crust interface red and orange corrosion products can be seen,

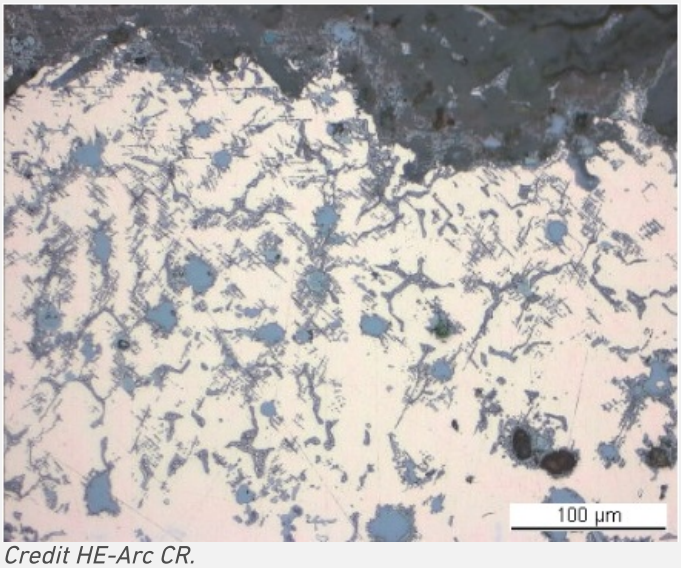
Fig. 8: Micrograph of the metal sample from Fig. 3 (detail), unetched, bright field. Metal with slip lines outlined by the corrosion,

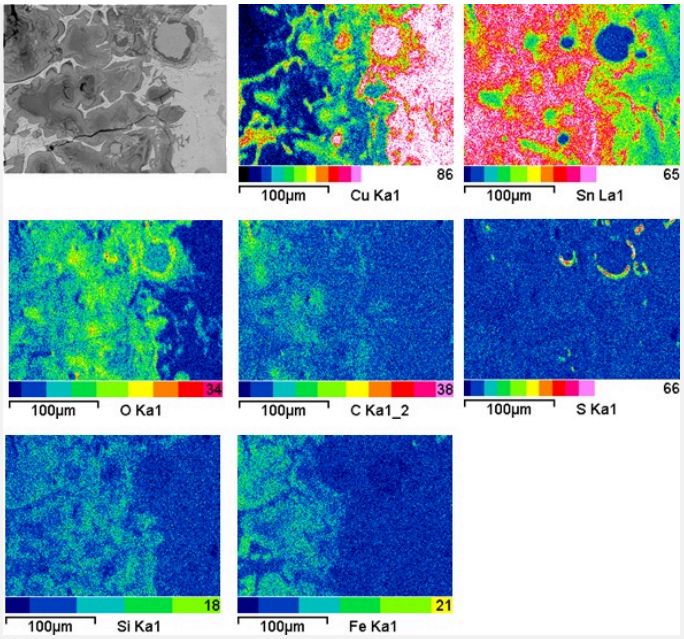
Table 3: Chemical composition (mass %, <: below the detection limit) of the corrosion crust from Fig. 9. Method of analysis: SEM/EDS, Laboratory of Analytical Chemistry, Empa.

Fig. 9: SEM image, SE-mode, and elemental chemical distribution of the selected area of Fig. 6 (reversed picture rotated by 270°). Method of examination: SEM/EDS, Laboratory of Analytical Chemistry, Empa,

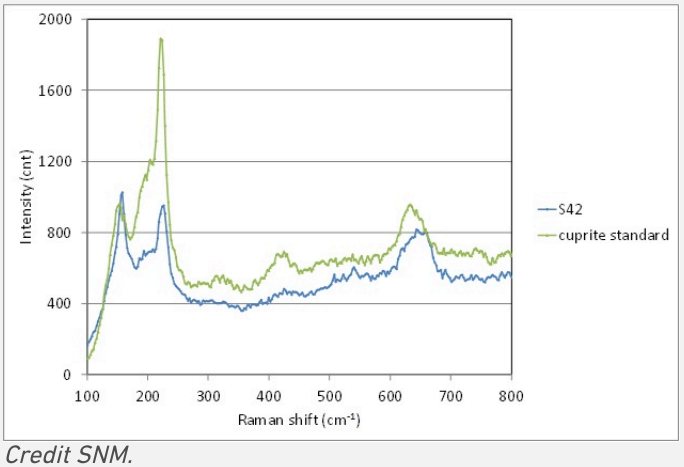
Fig. 10: Raman spectrum of a red-orange corrosion particle (S42) of Fig. 7 compared to the cuprite standard spectrum. Settings: laser wavelength 532nm, acquisition time 10s, one accumulation, filter D2 (0.75-0.8mW), hole 500, slit 80, grating 600. Method of analysis: Raman spectroscopy, Lab of Swiss National Museum, Affoltern a. Albis ZH,

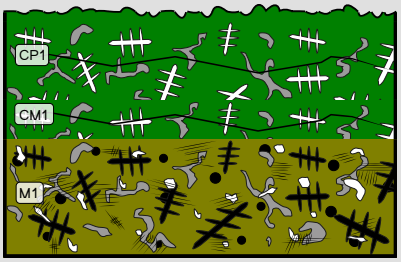
Fig. 11: Stratigraphic representation of the sample taken from the blade fragment of the winged axe in cross-section (dark field) using the MiCorr application. The characteristics of the strata are only accessible by clicking on the drawing that redirects you to the search tool by stratigraphy representation. This representation can be compared to Fig. 7, Credit HE-Arc CR.

The evenly corroded tin bronze contains numerous sulphide inclusions and shows signs of interdendritic corrosion penetrating the metal structure. The Sn enriched surface is decuprified and polluted by the environmental elements such as O, Si, Fe, C, Al (?) and Cl (?). The corrosion crust is composed mainly of a dark green layer with local orange-red cuprite aggregates at the interface with the remaining metal. Both the remnant metallic phases and the Sn-rich corrosion layer can be interpreted as inferior markers, defining the limit of the original surface which is located above. For the above mentioned reasons, the corrosion is thought to be of type 1 according to Robbiola et al. 1998.
