BLADE FRAGMENT OF A WINGED AXE FK43 – TIN BRONZE – MIDDLE BRONZE AGE – SWITZERLAND

Artefact name	Blade fragment of a winged axe FK43
Authors	Marianne. Senn (Empa, Dübendorf, Zurich, Switzerland) & Christian. Degrigny (HE-Arc CR, Neuchâtel, Neuchâtel, Switzerland)
Url	/artefacts/1223/

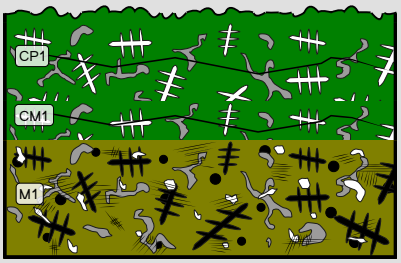
Fig. 11: Stratigraphic representation of the sample taken from the blade fragment of the winged axe in cross-section (dark field) using the MiCorr application. The characteristics of the strata are only accessible by clicking on the drawing that redirects you to the search tool by stratigraphy representation. This representation can be compared to Fig. 7, Credit HE-Arc CR.

The evenly corroded tin bronze contains numerous sulphide inclusions and shows signs of interdendritic corrosion penetrating the metal structure. The Sn enriched surface is decuprified and polluted by the environmental elements such as O, Si, Fe, C, Al (?) and Cl (?). The corrosion crust is composed mainly of a dark green layer with local orange-red cuprite aggregates at the interface with the remaining metal. Both the remnant metallic phases and the Sn-rich corrosion layer can be interpreted as inferior markers, defining the limit of the original surface which is located above. For the above mentioned reasons, the corrosion is thought to be of type 1 according to Robbiola et al. 1998.
