OVAL BRACELET WITH SURFACE DECORATIONS OF LINES AND INDENTATIONS MAH ANC. 2662 – LEADED BRONZE – LATE BRONZE AGE – SWITZERLAND

Artefact name	Oval bracelet with surface decorations of lines and indentations MAH anc. 2662
Authors	Marianne. Senn (Empa, Dübendorf, Zurich, Switzerland) & Christian. Degrigny (HE-Arc CR, Neuchâtel, Neuchâtel, Switzerland)
Url	/artefacts/1224/

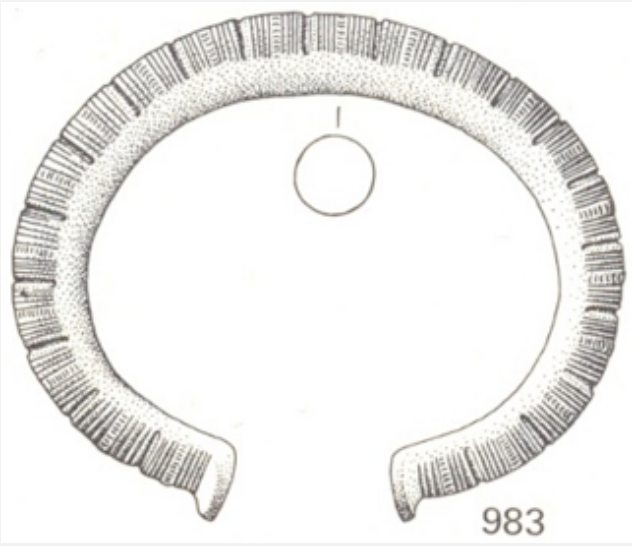
Fig. 1: Oval bracelet with surface decorations of lines and indentations (after Paszthory 1985, Tafel 82),

Description of the artefact	Bracelet decorated on the outside with surface decorations of lines and indentations (Paszthory 1985, 164 - Fig.1). It presents a dense, black patina. Dimensions: Ø = around 6.1cm; WT = 98g.
Type of artefact	Jewellery
Origin	Les Eaux-Vives, Genève, Geneva, Switzerland
Recovering date	Unknown
Chronology category	Late Bronze Age

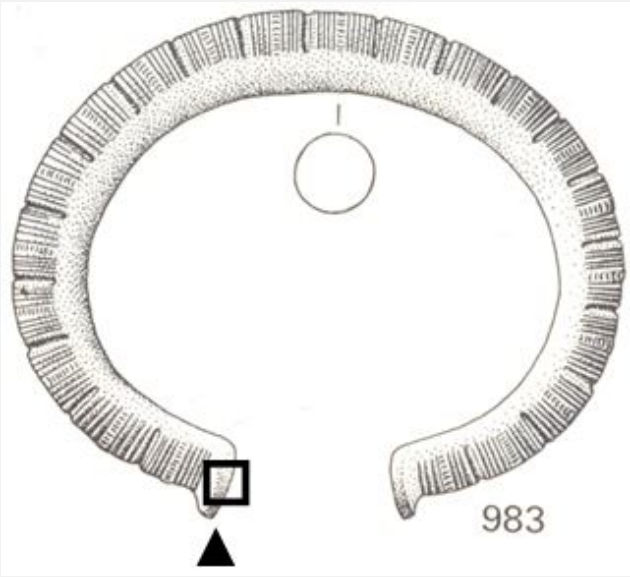
Fig. 2: Location of sampling area,

Description of sample	Two samples were taken from this object – only one is presented here. The sample is a section from one end of the bracelet (Fig. 2). Its dimensions are: L = 1.3mm and W = 0.3mm. The corrosion layer is relatively thick (Fig. 3).
Alloy	Leaded Bronze
Technology	As-cast
Lab number of sample	MAH 77-110-1a
Sample location	Musées d'art et d'histoire, Genève, Geneva
Responsible institution	Musées d'art et d'histoire, Genève, Geneva
Date and aim of sampling	1977, study of black and iron rich surface deposit on the object

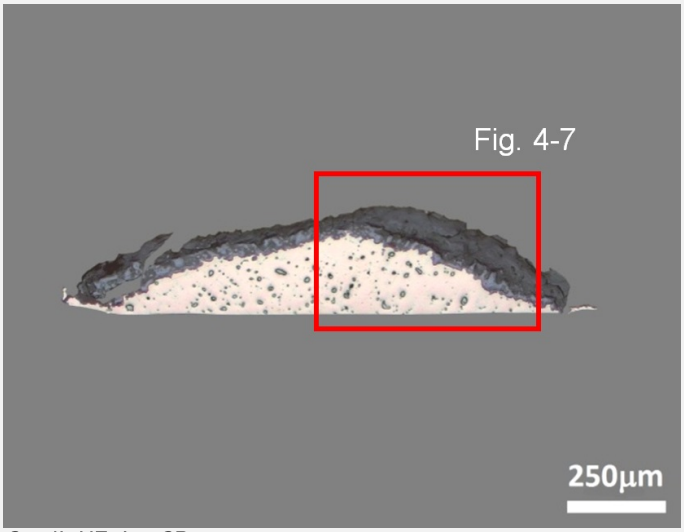
Fig. 3: Micrograph of the cross-section of the sample taken from the bracelet with surface decorations of lines and indentations showing the location of Figs. 4 to 7,

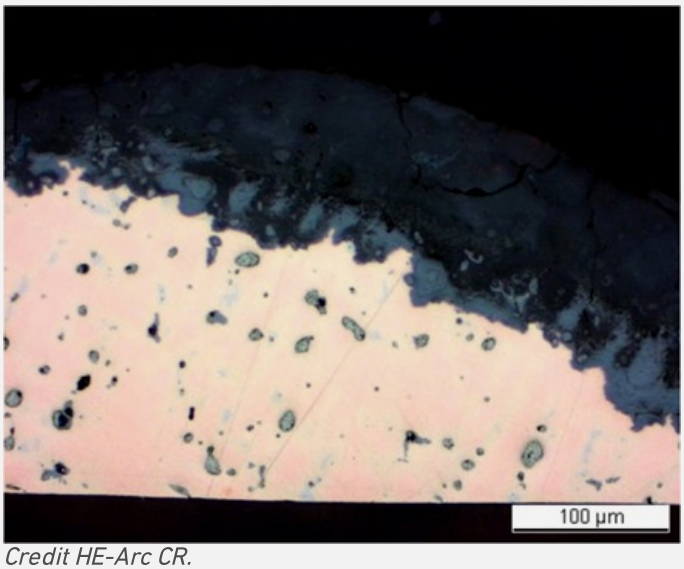
The remaining metal is a leaded bronze (Table 1) with low porosity, light and dark-grey inclusions (Fig. 4). In bright field the unetched alpha-delta eutectoid appears light-blue (Fig. 4). Etching reveals the dendritic structure of an as-cast metal (Fig. 5) with an average hardness of HV1 100. The inclusions appear as dark-grey (Pb-rich) and light-grey (copper sulphide) (Fig. 5 and Table 2) while the alpha-delta eutectoid is white (Fig. 5). The pink alpha phase is cored.

Fig. 4: Micrograph of the metal sample from Fig. 3 (detail), unetched, bright field. The metal is in pink, the Pb-rich inclusions in light-grey, the copper sulphide inclusions in dark-grey and the alpha-delta eutectoid in light-blue,

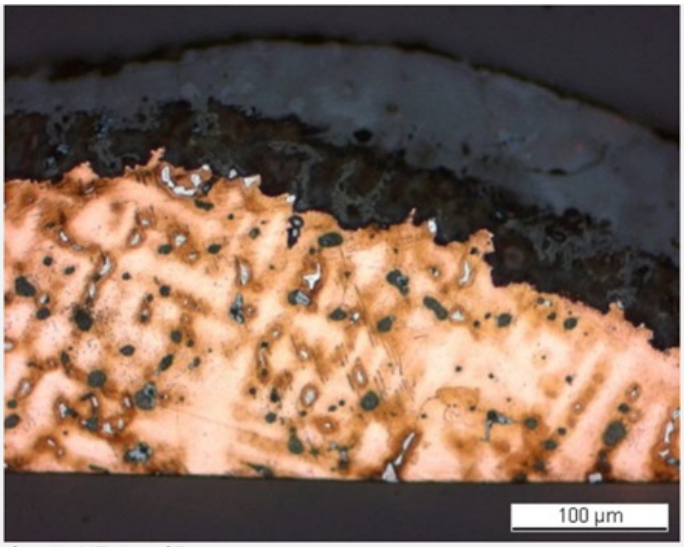
Fig. 5: Micrograph similar to Fig. 5, etched, bright field. The dendritic structure of the leaded bronze is revealed with the alpha-delta eutectoid in white and the alpha phase in pink. The colour difference of the alpha phase is due to coring,

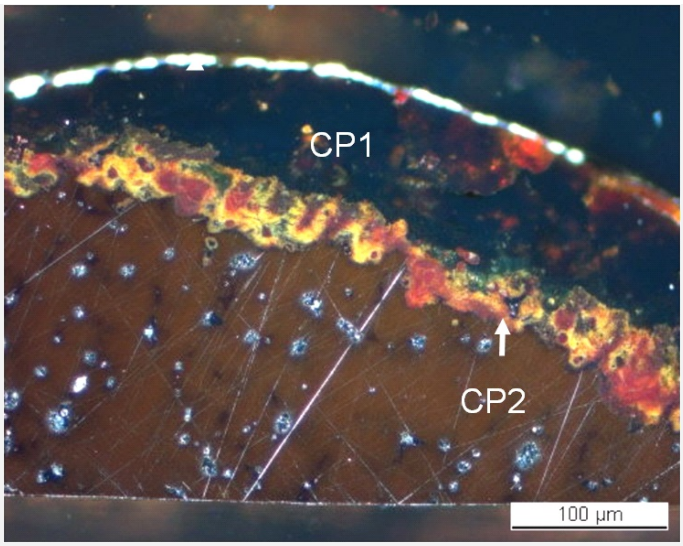
The corrosion crust has an average thickness of 80µm. It is composed of two layers (Fig. 6). The inner layer (CP2), which appears grey in bright field (Fig. 4), retains a Sn-rich dendritic ghost structure (Table 3 and Fig. 5). In polarized light, this layer is a mixture of reddish and yellow-brown corrosion products with some green areas (Fig. 6). The reddish parts have a composition similar to cuprite/Cu2O (Table 3). The adjacent dense, cracked layer, which appears dark-grey in bright field (CP1), is mainly composed of Fe,O and Sn with Sn,O and Fe-rich and Fe and O-rich zones contaminated with Si while being depleted of Cu (Fig. 8). In polarised light, it is dark, almost black with some red areas. In areas it contains Ag, Fe and Sn-rich inclusions with traces of Pb and Cu (Fig. 7 and Table 3).

Fig. 6: Micrograph similar to Fig. 4 and corresponding to the stratigraphy of Fig. 8, polarised light. From bottom left to top right: the metal in brown, the dendritic ghost structure in red, yellow-brown and green and the outer corrosion layer in black with some red areas. The thin white line is a crack,

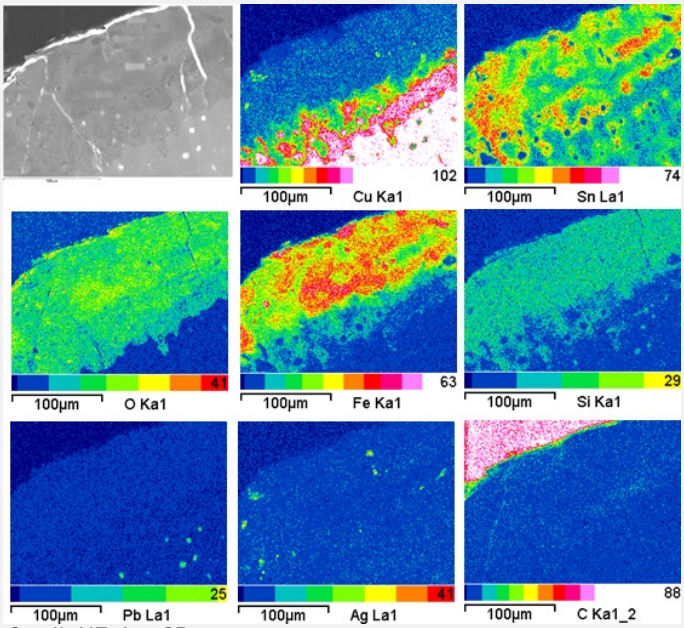
Fig. 7: EDS elemental chemical distribution in an SEM image (detail of Fig. 4, reversed picture). Method of examination: SEM/EDS, Laboratory of Analytical Chemistry, Empa,

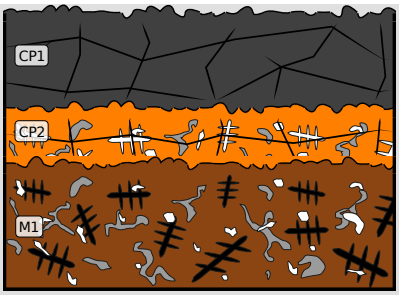
Fig. 8: Stratigraphic representation of the sample taken from the bracelet with a dense, black lake patina in cross-section (dark field) using the MiCorr application. The characteristics of the strata are only accessible by clicking on the drawing that redirects you to the search tool by stratigraphy representation. This representation can be compared to Fig. 6, Credit HE-Arc CR.

The surface of the cast leaded bronze has been replaced by a Fe/Sn-rich corrosion that retains a dendritic ghost structure. It is composed of a mixture of copper oxides (cuprite?) and a Sn-rich corrosion product (cassiterite?). The outer corrosion layer is composed of Fe-O and Sn-O-Fe areas depleted of Cu, but contaminated with Si. The enrichment in Fe seems to be the same as for the formation of patinas from lake contexts. However the outer corrosion layer was not formed in anaerobic conditions. Since the original surface is absent (destroyed) we refer to type corrosion 2 after Robbiola et al. 1998.
