MILITARY ID TAG 5668-MXX-1008-1 - ZN PB ALLOY - MODERN TIMES - FRANCE

Artefact name Military ID tag 5668-MXX-1008-1

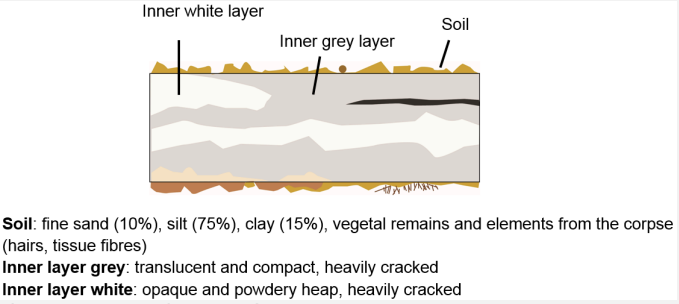
Fig. 3: Stratigraphic representation of fragment b of the military tag by macroscopic observation,

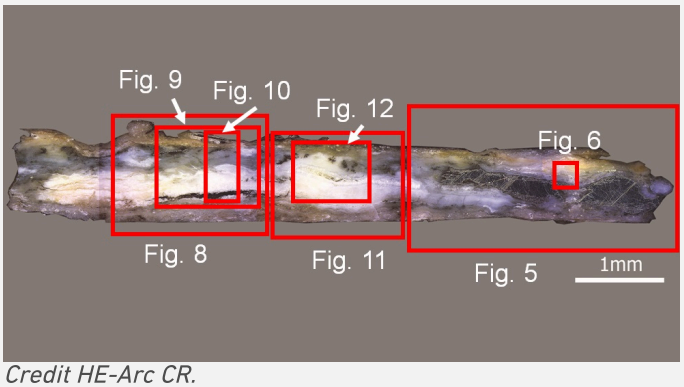
Fig. 4: Micrograph of the cross-section of fragment b of the military tag showing the location of Figs. 5, 6 and 8 to 12. Unetched, dark field, 50x,

Description of sample	This sample was cut out of fragment b in Fig. 1. The cross-section shows the entire thickness of the plate (L = 8 mm, W= 1 mm). The corrosion goes through the whole metal thickness but a metallic core remains (Figs. 4 and 5).
Alloy	Zn Pb Alloy
Technology	Cold worked (laminated)
Lab number of sample	None
Sample location	HE-Arc CR, Neuchâtel, Neuchâtel
Responsible institution	Pôle d'Archéologie Interdépartemental Rhénan, Sélestat, Alsace
Date and aim of sampling	2013, metallography and chemical analyses

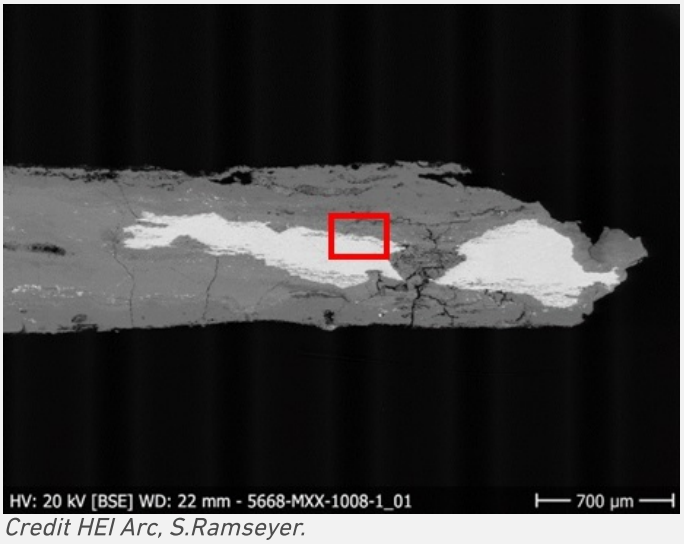
The remaining metal is a zinc alloy (Table 1) containing 1.8% in weight lead. Lead appears in the metal in the form of small flattened white Pb inclusions (Fig. 6), confirming the manufacturing technique, namely lamination. The etched metal does not show any specific microstructure (Fig. 7).

Elements	Zn	Pb
mass%	98	2

Table 1: Chemical composition of the metal. Method of analysis: SEM-EDS, Lab of Electronic Microscopy and Microanalysis, IMA (Néode), HEI Arc.

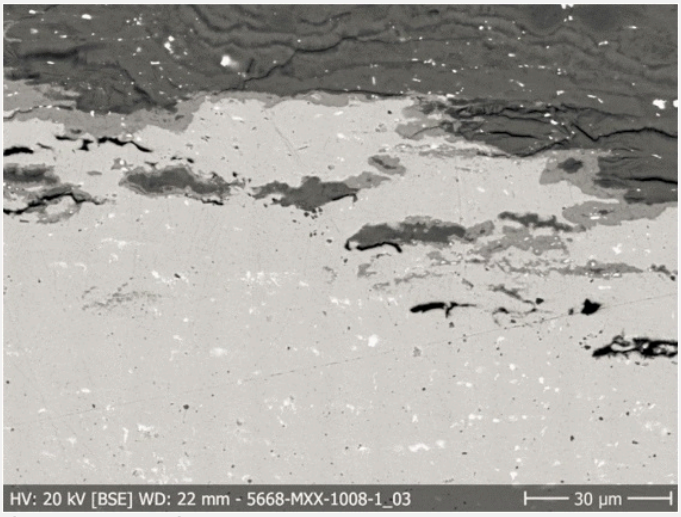
Fig. 5: SEM image of the cross-section, from Fig. 4 (detail), BSE-mode. Note the presence of Pb inclusions all through the thickness of the heavily cracked corrosion layers. The SEM image of Fig. 6 is marked by a rectangle,

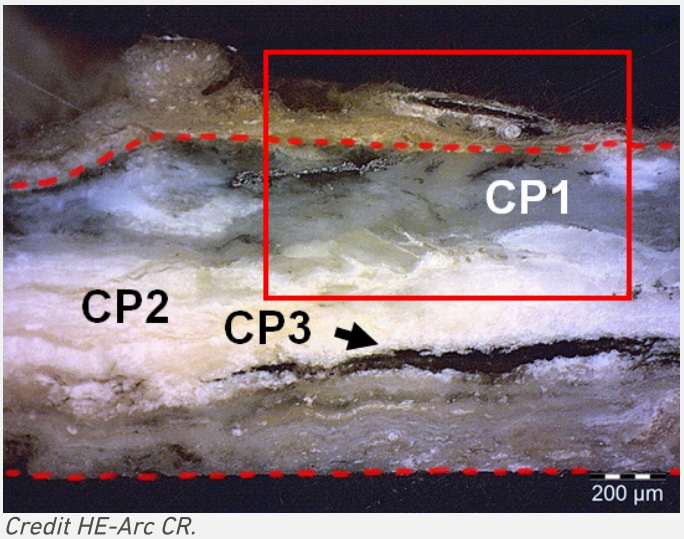
The corrosion structure is multi-layered: several corrosion products overlap. However they are not all continuous layers, since some of them are isolated. Most of the corrosion products layers show structural voids (up to 100 µm thick) and some cracks inside. Three layers can be distinguished (Fig 8 and Figs. 16 or 17 - only Fig. 16 is detailed below) which have the same elements but in different proportions (Figs. 9, 10 and table 2):

- Inner grey layer – CP1 (up to 1 mm thick) is a translucent, compact layer and constitutes most part of the corrosion products. Corroded metal appears inside this layer rich in Zn and O (Table 2) as lead inclusions within a black corrosion product (Figs. 8 and 10). Sulphur has also been detected by SEM-EDS inside this layer, near the surface, where the colour turns into grey-orange (zinc sulfide or sulphates but to be confirmed, table 2).

Elements	O	Zn	Pb	S
Inner grey layer (CP1)	++	+++	+	
Black inclusions		+	+++	
Inner white layer (CP2)	++	+++	+	
Inner black layer (CP3)	++	+++	+	
Inner grey-orange layer	+	++		++
Remnant metal phase		+++	+

Table 2: Chemical composition of the different corrosion layers from Fig. 10. Method of analysis: SEM-EDS, Lab of Electronic Microscopy and Microanalysis, IMA (Néode) (+++: high concentration, ++ medium concentration, + low concentration, nd: not-detected).

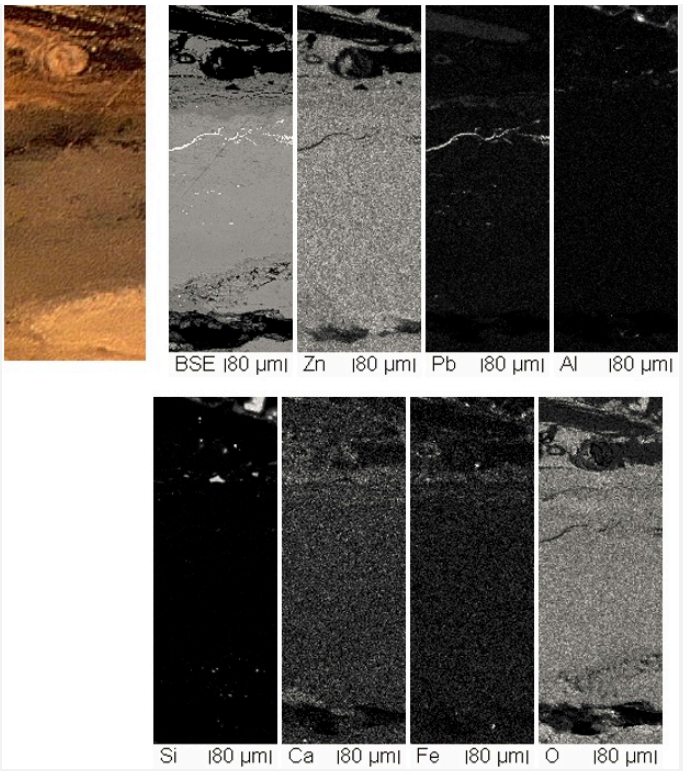
Fig. 10: SEM image of the cross-section from Fig. 9 (detail), SE-mode, and elemental chemical distribution. Method of examination: SEM/EDS, Lab of Electronic Microscopy and microanalysis, IMA (Néode), HEI Arc,

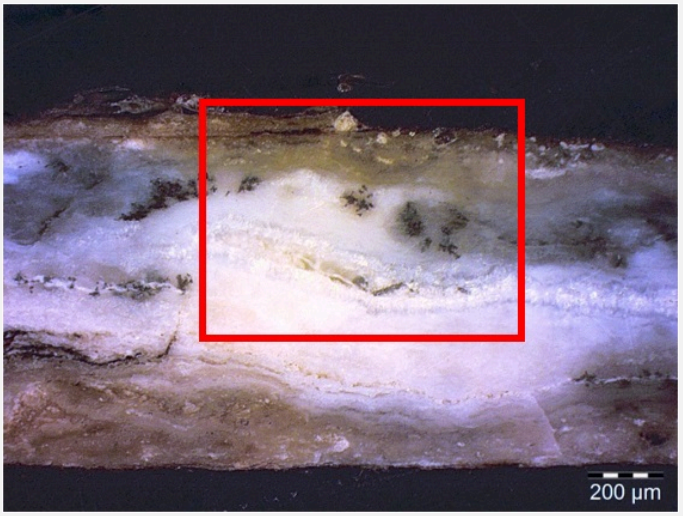
- Inner white layer – CP2 (up to 0.6 mm thick) is an opaque and powdery heap, occurring in different places inside inner grey layer and sometimes near the surface, as pitting corrosion. The interface between inner layers grey and white is gradual. Localized aggregates showing a crystalline microstructure of thickness of 50 µm are located against the walls of a structural void, inside the white corrosion product (Figs. 11 and 12).

Fig. 11: Micrograph of the cross-section, from Fig. 4 (detail), unetched, dark field, 50x. The micrograph of Fig. 12 is marked by a rectangular,

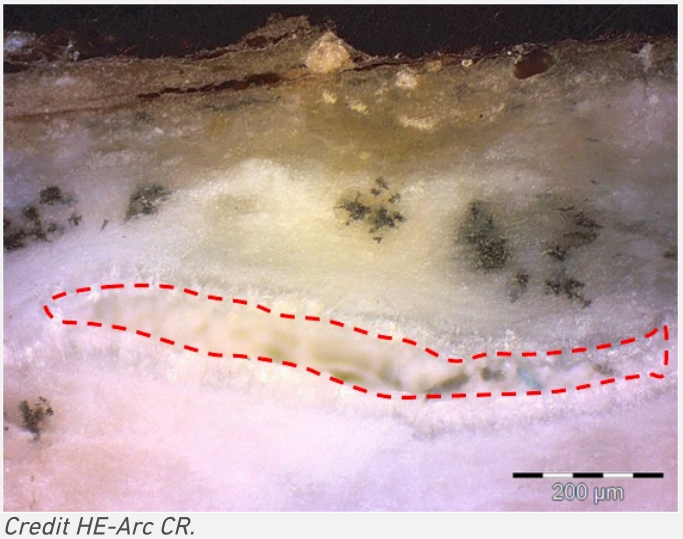
Fig. 12: Micrograph of the cross-section, from Fig. 9 (detail) unetched, dark field, 100x. Structural void (dotted red line) with aggregates,

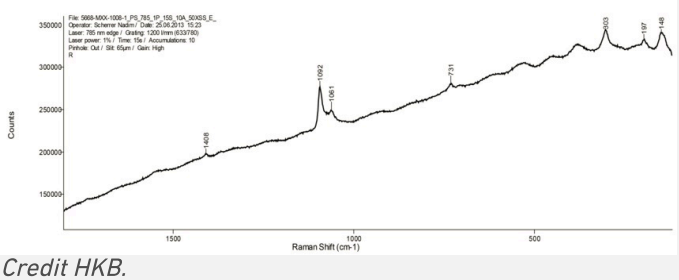
The inner grey layer (CP1, Figs. 8 and 16) has been identified by FTIR as a zinc carbonate (smithsonite), mixed with other unidentified corrosion products. Raman spectra seems to confirm it (Fig. 13). The exact composition of the inner white layer (CP2) is unknown. It shows a bluish fluorescence under UV light and has been identified by FTIR as a mixture of zinc oxides and carbonates, that could be zinc hydroxycarbonates (hydrozincite). Raman spectroscopy shows also a mixture of carbonates and other corrosion products (Fig. 14). The inner black layer (CP3) is a zinc carbonate as well, identified by FTIR and Raman spectroscopy (Fig. 15) appearing as a vein between layers of grey and white (Fig. 8).

Fig. 13: Raman spectrum of the inner grey layer (CP1 on Fig. 8, ZnCO3 – smithsonite?). Settings: laser wavelength 532nm, acquisition time 10s, one accumulation, filter D2 (0.75-0.8mW), hole 500, slit 80, grating 600. Method of analysis: Raman spectroscopy, Art Technological Laboratory, Departement Conservation HKB,

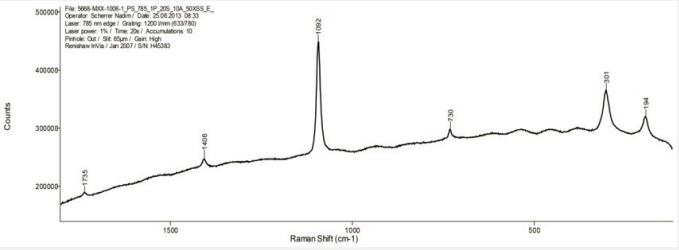
Fig. 14: Raman spectrum of the inner white layer (CP2 on Fig. 8, zinc hydroxycarbonate?). Settings: laser wavelength 532nm, acquisition time 10s, one accumulation, filter D2 (0.75-0.8mW), hole 500, slit 80, grating 600. Method of analysis: Raman spectroscopy, Art Technological Laboratory, Departement Conservation HKB,

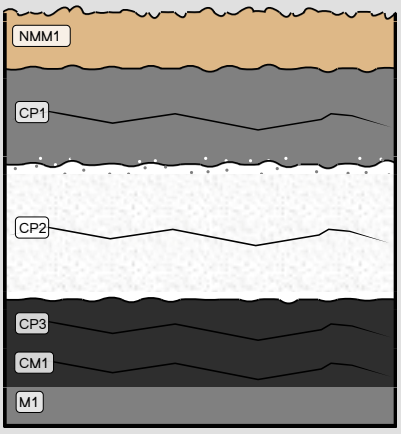
Fig. 16: Stratigraphic representation of fragment b of the military tag in cross-section (dark field) using the MiCorr application. The characteristics of the strata are only accessible by clicking on the drawing that redirects you to the search tool by stratigraphy representation. This representation can be compared to Fig. 10, Credit HE-Arc CR, M-J.Scholl.

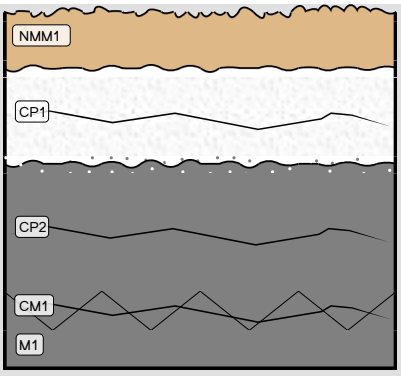
Fig. 17: Stratigraphic representation of fragment b of the military tag in cross-section (dark field) using the MiCorr application. The characteristics of the strata are only accessible by clicking on the drawing that redirects you to the search tool by stratigraphy representation. This representation is different from Fig. 10 due to the inversion of CP1 and CP2. Furthermore, CP3 is not represented, Credit HE-Arc CR, M-J.Scholl.

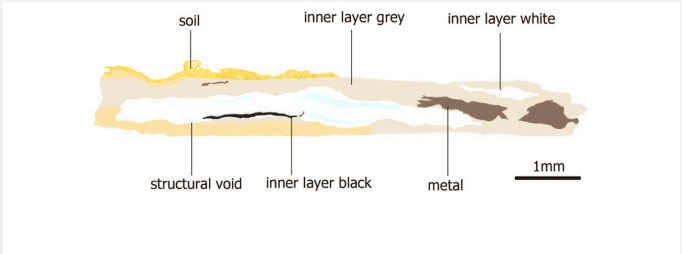
Fig. 18: Improved representation of the stratigraphy of corrosion layers of the military tag from visual observations and analyses,

The military tag is made of a laminated sheet of zinc-lead alloy. The corrosion has entirely penetrated the objet leaving though some spots of remaining original metal inside the corrosion products. Lead particles are not affected by the corrosion process. The main corrosion products are zinc carbonates (smithsonite) and hydroxycarbonates (hydrozincite) but mixtures of different corrosion products can occur. These corrosion products are intermixed and heavily cracked.
