FRAGMENT OF A BED STRUCTURE 03 12751-20.2.5 - TIN BRONZE - ROMAN TIMES - SWITZERLAND

Artefact name	Fragment of a bed structure 03 12751-20.2.5
Authors	Marianne. Senn (Empa, Dübendorf, Zurich, Switzerland) & Christian. Degrigny (HE-Arc CR, Neuchâtel, Neuchâtel, Switzerland)
Url	/artefacts/1226/

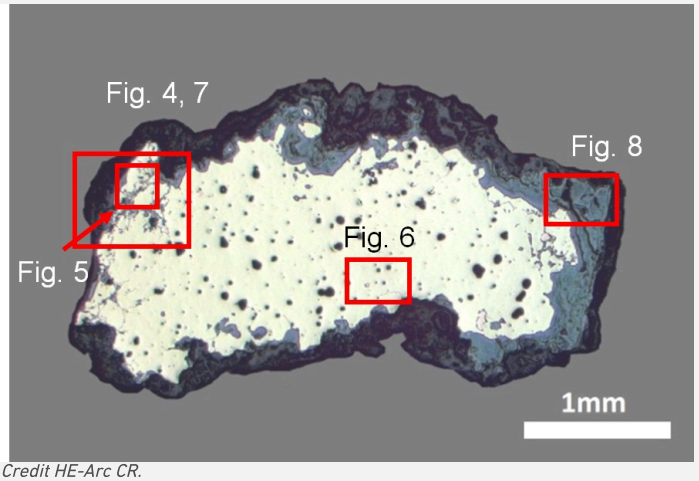
MiCorr stratigraphy(ies) – Bi

The metal - corrosion products interface is irregular (Fig. 3) and the average thickness of the corrosion crust is 300µm. The latter can be divided into four layers (Fig. 4). In bright field, the inner layer (CP4) is medium grey and dense. In polarised light it is dark-red/orange (Fig. 7). It is Sn-rich, contains O and Cl but is Cu depleted (Table 3 and Fig. 8). The next layer (CP3) is as well medium grey in bright field and light-red in polarised light. It has a composition similar to cuprite/Cu2O (Table 3). This was confirmed by Raman spectroscopy (Fig. 9). The third layer (CP2) is thin, is light grey in bright field and contains black pores. Under polarised light it looks brilliant black (Fig. 7) and is rich in Cu with Sn and O (Fig. 8). Using XRD, it was identified as a mixture of tenorite/CuO, cuprite/Cu2O and cassiterite/SnO2 (Krieg 2009). Raman spectroscopy could only detect tenorite in this layer (Fig. 10). In bright field the thick outer layer (CP1) is marbled in dark-grey and black, in polarised light it appears blue-green (Fig. 7). XRD analysis gave a composition close to malachite/Cu2CO3(OH)2 (Krieg 2009). In the present study no C was detected (Fig. 8), but Raman spectroscopy confirmed its presence (Fig. 11). The spectrum obtained shows a good match with published spectra (Bouchard and Smith 2003). Peaks are similar to those expected for malachite but most of them have a Raman shift: 3322, 1503, 1108, 1073, 759, 731, 603, 540, 442, 357, 276, 225, 186, 163 cm^{-1}. The underlined Raman shifts correspond to the peaks of greatest intensity. Environmental elements such as Si are concentrated on the top surface (Fig. 8).

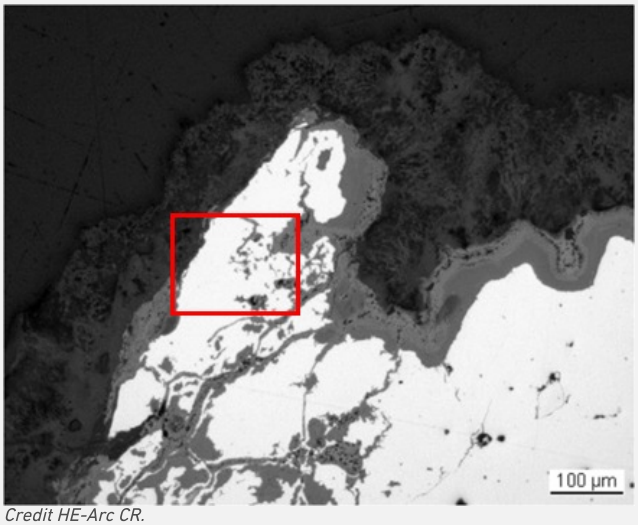
The remaining metal is a porous tin bronze (Table 1) with tiny iron oxides inclusions (Table 2) and secondary re-deposited copper. Intergranular corrosion has developed locally inside the metal (Figs. 4 and 5). The etched alloy shows a structure principally consisting of large polygonal grains, some of which include strain lines (Fig. 6). Locally an isolated alpha + delta eutectoid can be seen. Much smaller twinned grains can be found on the left side of the sample (Fig. 5). The average hardness of the metal is HV1 100. However on the left side of the sample, where the grains are smaller and twinned, the hardness is much higher (more cold work followed by annealing).

Fig. 4: Micrograph of the metal sample from Fig. 3 (detail), unetched, bright field. From bottom right to top left we observe: the metal (in white) with porosity (in black) and the corrosion layer (in light and dark-grey). The micrograph of Fig. 5 is marked by a rectangle,

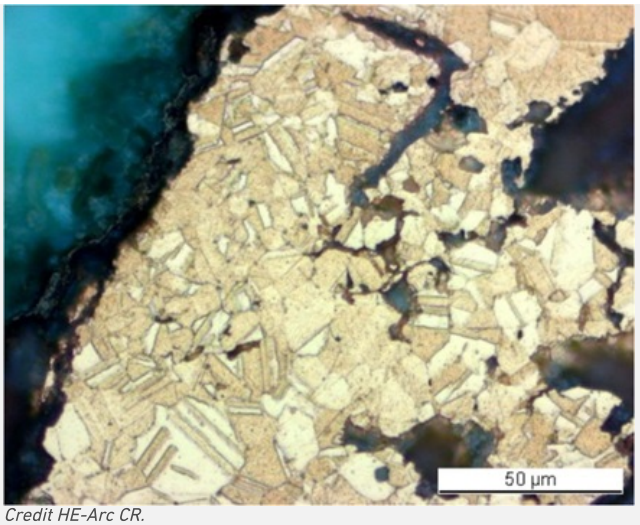
Fig. 5: Micrograph of the metal sample from Fig. 3 (detail of Fig. 4), etched, bright field. The metal shows a structure of mostly small polygonal grains with twins,

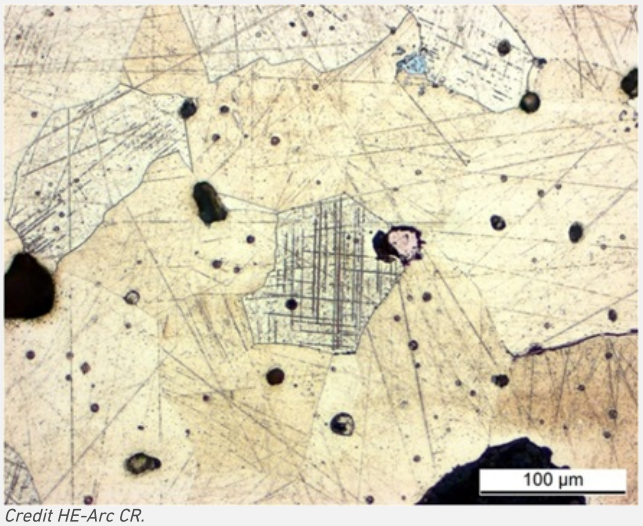
Fig. 6: Micrograph of the metal sample from Fig. 3, etched, bright field. The metal shows a structure consisting of large polygonal grains including strain lines. Pores are in black, remnants of the Sn-rich eutectoid phase in grey and secondary deposited copper in pink,

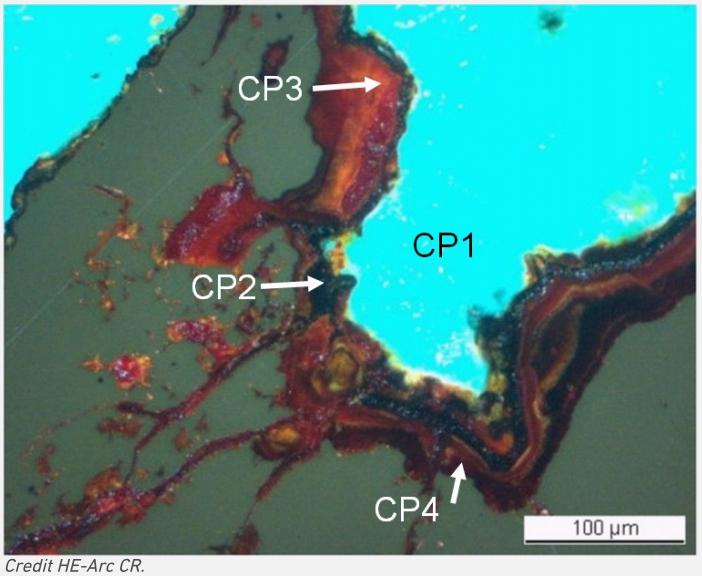
Fig. 7: Micrograph showing the metal - corrosion crust interface from Fig. 3 (detail of Fig. 4) and corresponding to the stratigraphy of Fig. 12, polarised light. From bottom left to to right: In grey the metal, in dark-red/orange CP4, in light red CP3, in black (with pores) CP2 and in green-blue CP1,

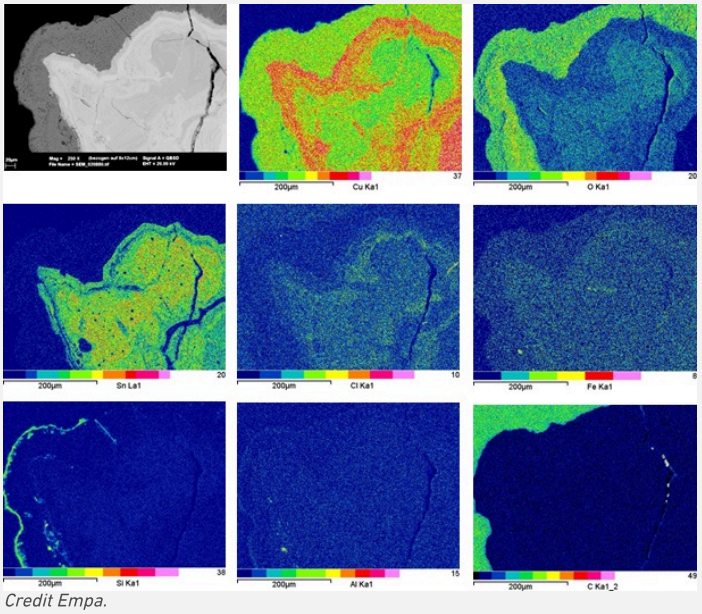
Fig. 8: SEM image, BSE-mode, and elemental chemical distribution of the selected area from Fig. 3 (reversed picture, detail). Method of examination: SEM/EDS, Laboratory of Analytical Chemistry, Empa,

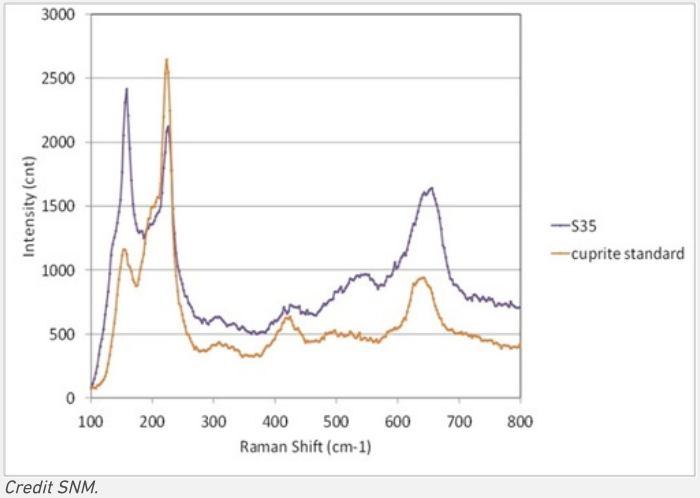
Fig. 9: Raman spectrum of CP3 (S35) from Fig. 7 compared to a cuprite standard spectrum. Settings: laser wavelength 532nm, acquisition time 20s, one accumulation, filter D2 (0.75-0.8mW), hole 1000, slit 100, grating 600. Method of analysis: Raman spectroscopy, Lab of Swiss National Museum, Affoltern a. Albis ZH,

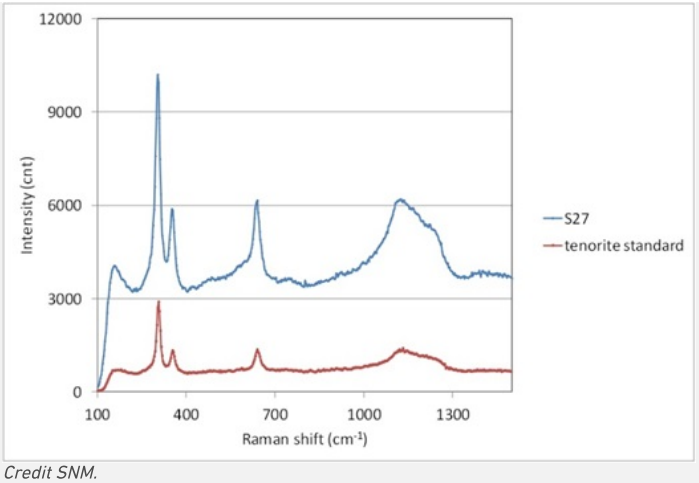
Fig. 10: Raman spectrum of the black layer (CP2) with pores (S27) from Fig. 7 compared to a tenorite standard spectrum. Settings: laser wavelength 532nm, acquisition time 100s, one accumulation, filter D1 (7.5-8mW), hole 500, slit 80, grating 600. Method of analysis: Raman spectroscopy, Lab of Swiss National Museum, Affoltern a. Albis ZH,

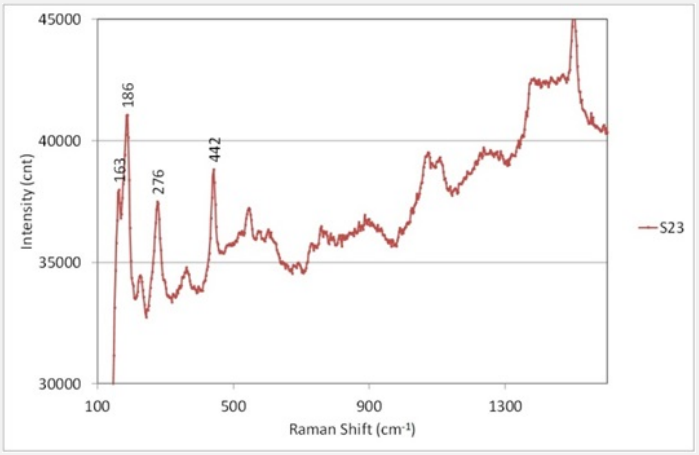
Fig. 11: Raman spectrum of the green outer corrosion layer (CP1) from Fig. 7. Settings: laser wavelength 532nm, acquisition time 80s, one accumulation, filter D2 (0.75-0.8mW), hole 500, slit 80, grating 600. Method of analysis: Raman spectroscopy, Lab of Swiss National Museum, Affoltern a. Albis ZH,

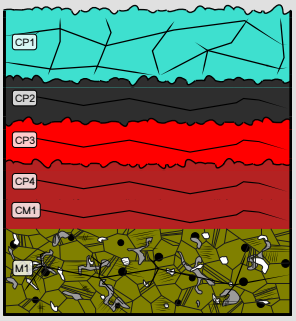
Fig. 12: Stratigraphic representation of the sample taken from the bed structure in cross-section (dark field) using the MiCorr application. The characteristics of the strata are only accessible by clicking on the drawing that redirects you to the search tool by stratigraphy representation. This representation can be compared to Fig. 7, Credit HE-Arc CR.
