FRAGMENT OF A BED STRUCTURE 03 12751-20.2.5 - TIN BRONZE - ROMAN TIMES - SWITZERLAND

Artefact name	Fragment of a bed structure 03 12751-20.2.5
Authors	Marianne. Senn (Empa, Dübendorf, Zurich, Switzerland) & Christian. Degrigny (HE-Arc CR, Neuchâtel, Neuchâtel, Switzerland)
Url	/artefacts/1226/

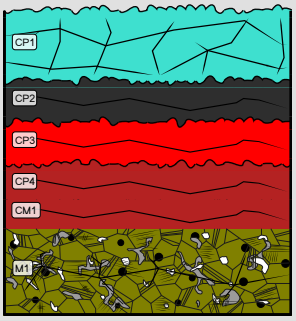
Fig. 12: Stratigraphic representation of the sample taken from the bed structure in cross-section (dark field) using the MiCorr application. The characteristics of the strata are only accessible by clicking on the drawing that redirects you to the search tool by stratigraphy representation. This representation can be compared to Fig. 7, Credit HE-Arc CR.
