FRAGMENTS OF OENOCHOE GV132-01 US26-OBJ.10 - TIN BRONZE - ROMAN TIMES - SWITZERLAND

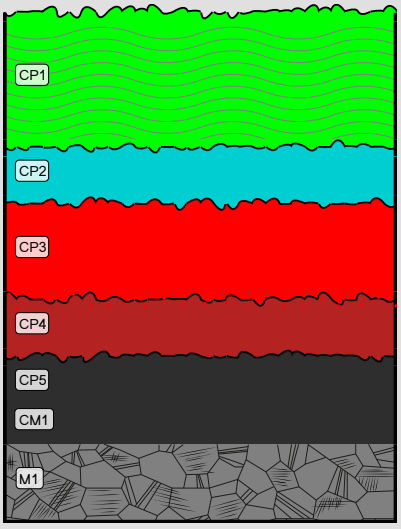
Fig. 13: Stratigraphic representation of the sample taken from the oenochoe base in cross-section (dark field) using the MiCorr application. The characteristics of the strata are only accessible by clicking on the drawing that redirects you to the search tool by stratigraphy representation. This presentation can be compared to Fig. 11, Credit HE-Arc CR, C.Degrigny.

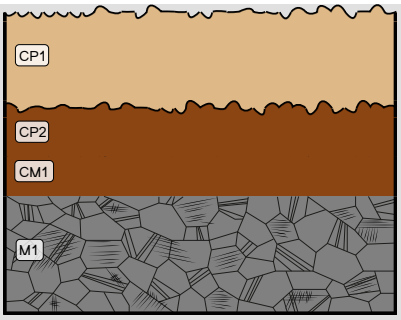
Dark green layer (**CP1e**)	Cu, O, P
Grey layer (**CP1i**)	Sn, O, P
Blue layer (**CP2i**)	Cu, Cl, O
Red layer (**CP3i**)	Cu, O
Black layer (**CP5i**)	Sn, O
Brown layer (**CP4i**)	Cu, Sn, O

Fig. 14: Improved stratigraphic representation of the multi-layered pustule form of the oenochoe from visual observations and analyses,

The metal of the oenochoe's base is a tin bronze. The polygonal and twinned grains with strain lines show that the base has been repeatedly cold worked and annealed with a final cold work. The metal is either well preserved or heavily corroded with the formation of pustules that go through the whole thickness of the metal. The limit of the original surface corresponds to the top surface of the dark brown layer. In the presence of a pustule it is highly deformed but discernible by the tin enriched surface. The corrosion is multiform. The well preserved and only lightly corroded areas are of Robbiola type 1 (Robbiola 1998), the pustules however are of the Formigli type (Formigli 1975).
