SITULA EMT09-554.665 - TIN BRONZE - IRON AGE - SWITZERLAND

Artefact name	Situla EMT09-554.665
Authors	Christian. Degrigny (HE-Arc CR, Neuchâtel, Neuchâtel, Switzerland) & Marie-Jeanne. Scholl (HE-Arc CR, Neuchâtel, Neuchâtel, Switzerland) & Valentin. Boissonnas (HE-Arc CR, Neuchâtel, Neuchâtel, Switzerland)
Url	/artefacts/1229/

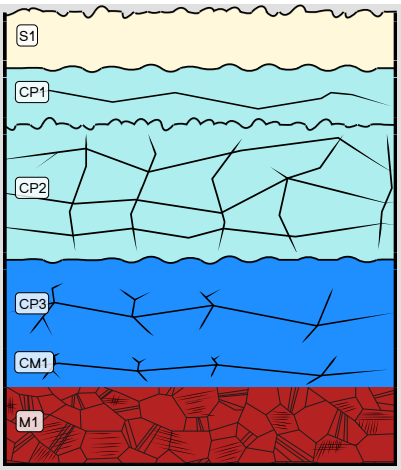
There are 2 stratigraphies (Fig. 14 corresponding to the interior face of the situla and Fig. 15 to its exterior face). The strata are similar in composition but their coding is different: CP1 to CP3 in Fig. 14 correspond to CP3 to CP5 in Fig. 15. Since the stratigraphy of Fig. 15 is more complete, the composition of each of its strata is given below.

Fig. 14: Stratigraphic representation of the sample taken from the detached fragment of the situla in cross-section (dark field) using the MiCorr application. The characteristics of the strata are only accessible by clicking on the drawing that redirects you to the search tool by stratigraphy representation. This representation shows the interior face and can be compared to Fig. 8 (bottom red rectangle), Credit HE-Arc CR, M-J.Scholl.

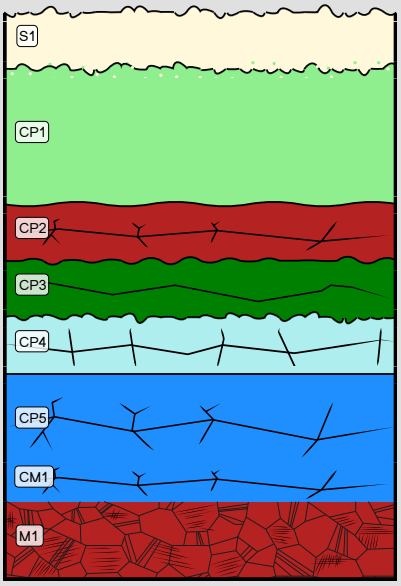
Fig. 15: Stratigraphic representation of the sample taken from the detached fragment of the situla in cross-section (dark field) using the MiCorr application. The characteristics of the strata are only accessible by clicking on the drawing that redirects you to the search tool by stratigraphy representation. This representation shows the exterior face and can be compared to Fig. 8 (top red rectangle), Credit HE-Arc CR, M-J.Scholl.
